**Town of Palm Beach**

# Master Plan for the Town Docks and Accessory Structures

Bulkhead Inspection Town of Palm Beach Docks Master Plan

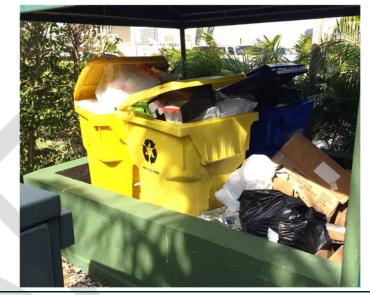
Figure 6.3: Trash at Australian Dock Collection Area

Trash and recycling bins are located within the parking lot at each dock. However, the volume of trash has increased due to an increasing trend towards on-line shopping and associated packaging (Figure 6.3). Feedback from the public and dock patrons is that the trash collection areas are often unsightly. One option is to relocate all trash collection to the Department of Public Works (DPW) area and install a trash compactor to minimize the trash volume. Additional dock staff is recommended to facilitate daily collection and transport of trash to the DPW. This will improve aesthetics and allow existing trash collection areas to be converted to additional parking.

Relocate trash and oil collection to DPW.

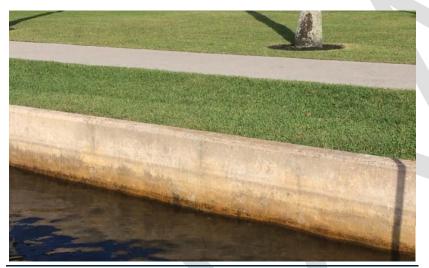
Figure 8.4: Bulkhead Fronting the Town Docks

The bulkhead is comprised of steel sheet pile, with a vertical concrete face and 11-inch wide concrete cap. The cap elevation is approximately 5.5 feet MLLW. Scour at the base of the seaward side of the bulkhead has exposed the sheet pile.

It is recommended that the bulkhead be replaced by constructing a steel sheet pile bulkhead less than one foot in front of the existing bulkhead. A concrete cap will be placed on top of the sheet pile, and the system will be tied into the existing bulkhead. It is proposed to raise the elevation of the cap of the new bulkhead by two feet to account for sea level rise and provide additional storm surge protection. This would still be lower than the current outfall section of the bulkhead. It would also be possible to create a continuous seating area along the wall by refinishing and widening the surface of the current wall for a sitting surface and using the new bulkhead as the backrest. A seat wall height is typically 1.5 to 2 feet high.

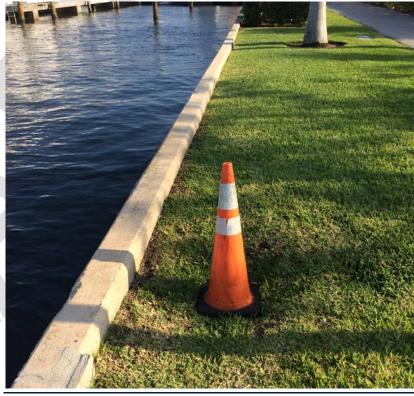
Figure 8.5: Backfill Loss behind the Bulkhead

There are two areas where backfill is being lost behind the bulkhead, which indicates a crack in the bulkhead. There are also several areas where the bulkhead cap is cracked and spalling. In short, the bulkhead is showing its age (estimated at more than 40 years old). Spot repairs of the bulkhead will be required periodically but likely increasing in frequency over time until the bulkhead must ultimately be replaced.

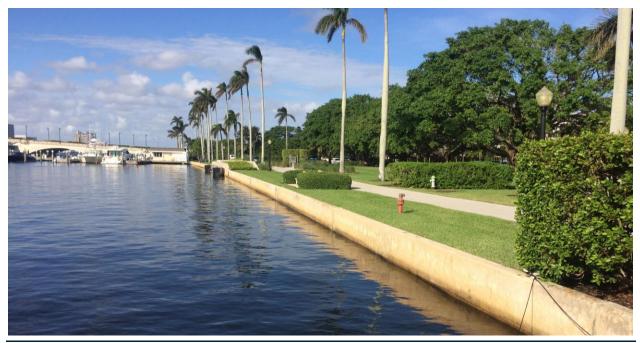
In summary, the bulkhead appears to be fair condition though in need of spot repairs where the cap is cracked and backfill is being lost. Continued deterioration of the bulkhead is expected over time with repairs being required more frequently. The Town should consider rehabilitating the bulkhead within the next several years.

Figure 2.1: Sta 8+80 looking north. View of seaward face of the bulkhead at high tide.

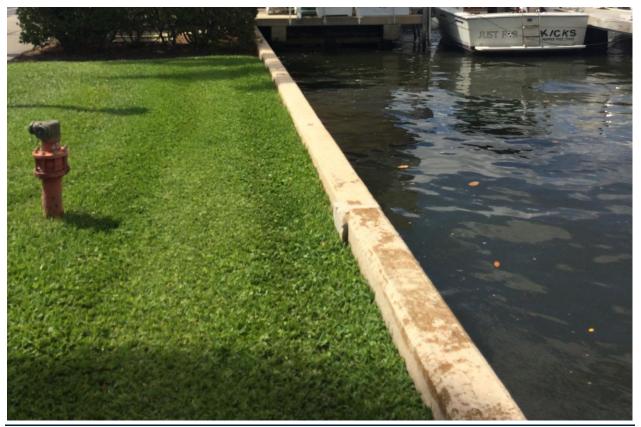
The bulkhead from Sta 0+16 to Sta 14+00 is uniform in construction style. It is comprised of an 11-inch wide concrete cap with 1.5-inch chamfers. Overall, the cap is in fair condition though showing its age with pitting and cracking. Backfill extends to the cap in some areas, while in others, there is approximately a six-inch lip between the grass and the seawall (Figure 3.1).

Figure 3.1: Sta 8+00 looking south. View of backfill close to the bulkhead cap elevation.

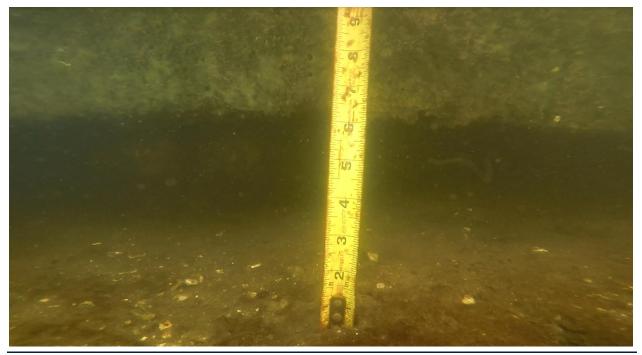
A smooth concrete face extends down the seaward face of the bulkhead. The concrete face stops between six inches and 24 inches above the bottom along almost the entire length of the bulkhead. Steel sheet piling (Figure 3.2) with periodic tie backs (Figure 3.3) are visible within this gap. It is unknown whether the concrete was initially poured to grade and then the bottom was eroded or whether it was designed and constructed with this gap intentionally.

Figure 3.2: Sta 20+00. Gap between concrete face and bottom exposing the sheet pile

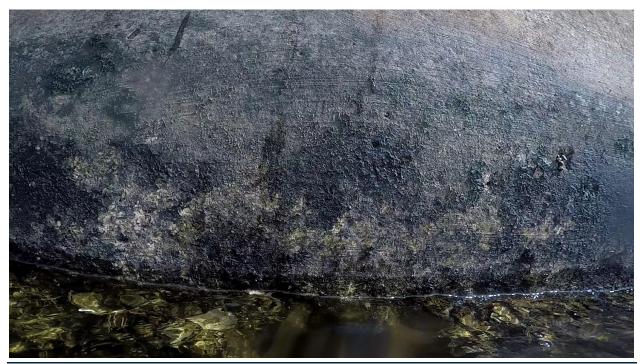
The concrete face has marine growth starting close to the high water mark (Figure 3.4), though the marine growth is more dense below the mean low water elevation (Figure 3.5). Some rust coloration is visible around some marine growth suggesting that the sheet pile extends into the concrete cap portion of the bulkhead, but it was not possible to determine the top elevation of the sheet piling (Figure 3.6).

Figure 3.4: Sta 2+90. Typical bulkhead face transition from exposed concrete to the concrete covered in marine growth within in the intertidal zone.

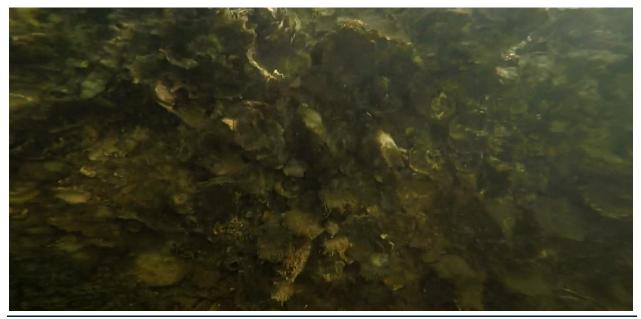
Figure 3.5: Typical marine growth on the concrete face of the bulkhead.

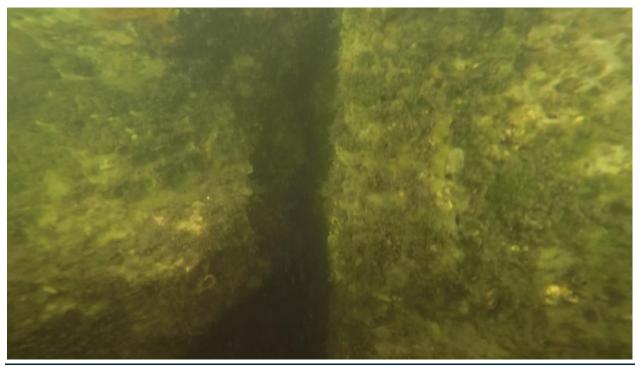
There are expansion joints in the concrete every 20 feet. Filler has been placed in these joints, but in many instances the filler has been degraded, and joint between two adjacent concrete sections extends back to the sheet pile (Figure 3.7).

Figure 3.7: Sta 0+70. Crack at an expansion joint in the vertical concrete face.

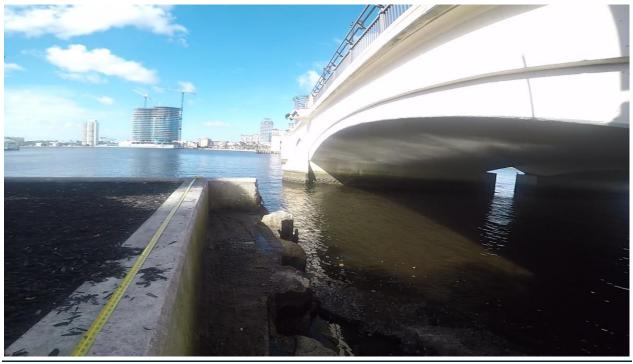
Figure 3.8: Sta 0+02 looking west. Corrugated face and offset cap.

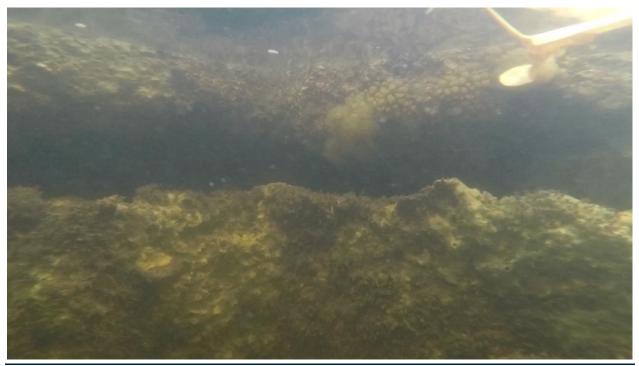
There are numerous cracks in the lower face of the bulkhead, though there was no apparent loss of backfill to indicate that these cracks extend far enough back to violate the integrity of the bulkhead.

Figure 3.9: Sta 0+03. Horizontal cracks in the concrete bulkhead.

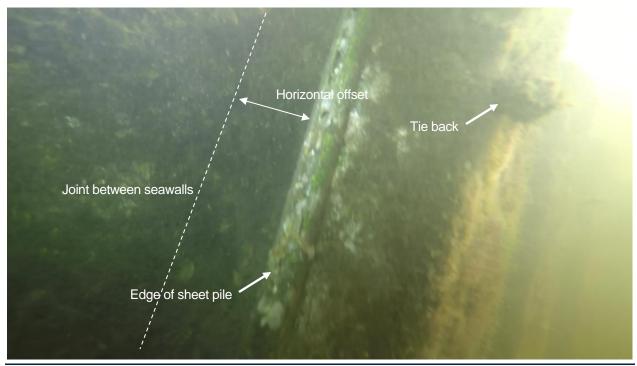
Figure 3.11: Sta 14+55 looking south. This is the start of the different bulkhead style.

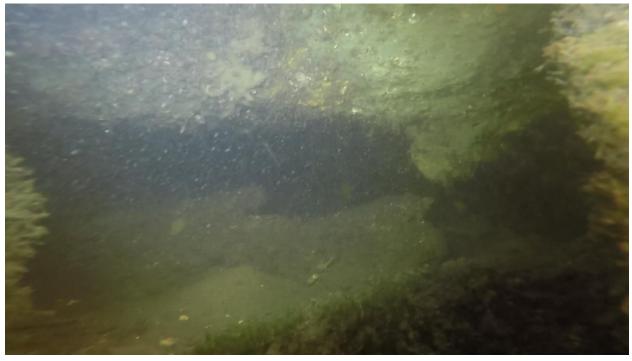
Figure 3.12: Sta 15+15. Gap underneath the corrugated section of the bulkhead and vague outline of a secondary sheet pile wall in the background.

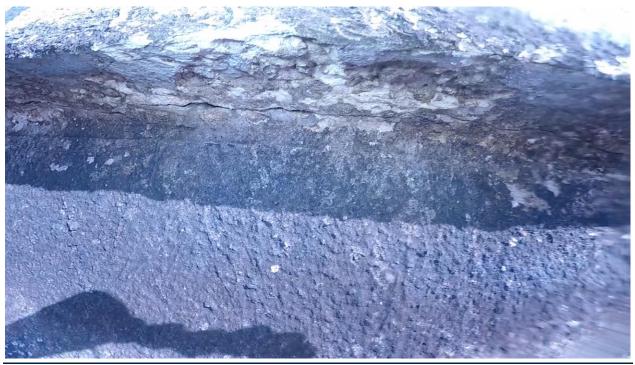
Figure 3.13: Sta 15+00. Cracking, spalling and deterioration underneath the lip along the parapet bulkhead section.

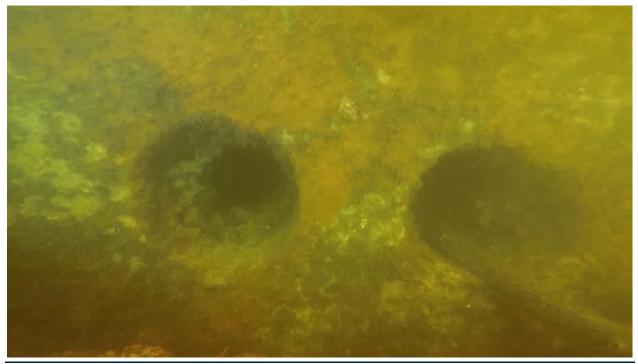
Figure 3.14: Sta 0+84. Western end of outfall structure looking east. Note the cable entering the eastern opening.

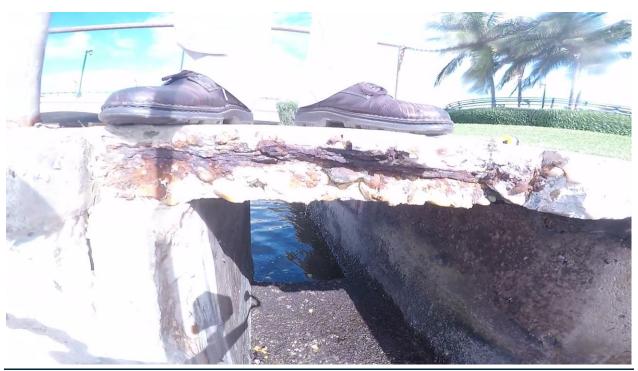
Figure 3.15: Sta 0+88 looking north. Spalling and rebar exposure and corrosion of the walkway to the outfall structure.

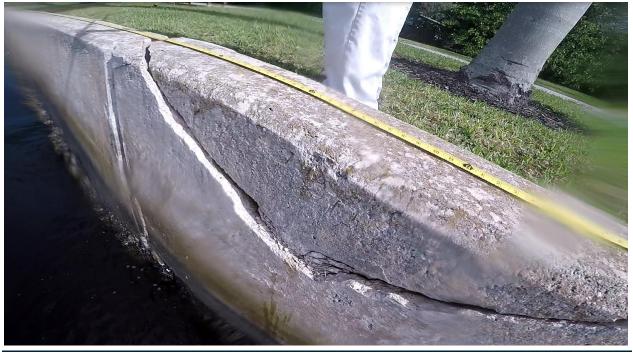
There is a five-foot long section of cracked and dislocated concrete cap at Sta 2+10. The crack is arched and extends approximately one-foot below the cap, so the bottom of the crack remains above the mean high water line.

Figure 3.16: Sta 2+10. Crack and dislocated concrete cap.

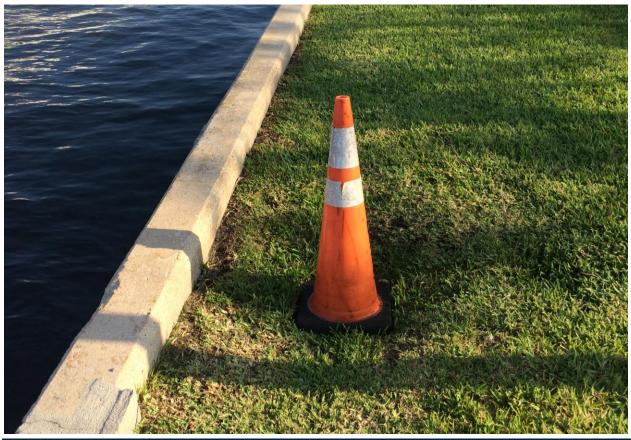
Figure 3.17: Sta 10+80. Area with backfill loss.
