# **KNOFF & ASSOCIATES, INC.**

Re: 2016 Roof Condition Evaluation Report  
Bid #2016-27, Town of Palm Beach item #13  
Par 3 Golf Course Maintenance Bldg., 2345 S. Ocean Blvd.

Re: 2016 Roof Condition Evaluation Report

Par 3 Golf Course Maintenance Bldg., 2345 S. Ocean Blvd

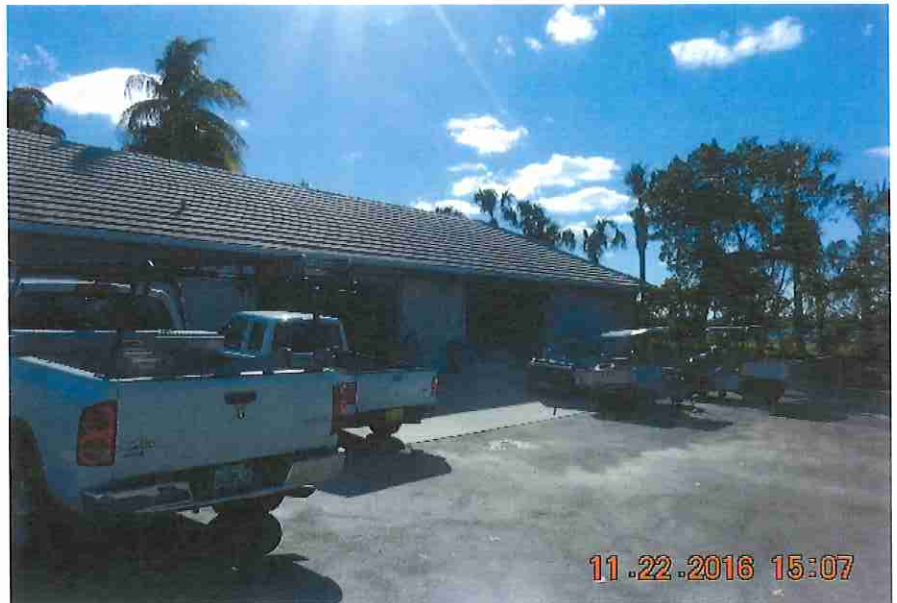
#1 Front view

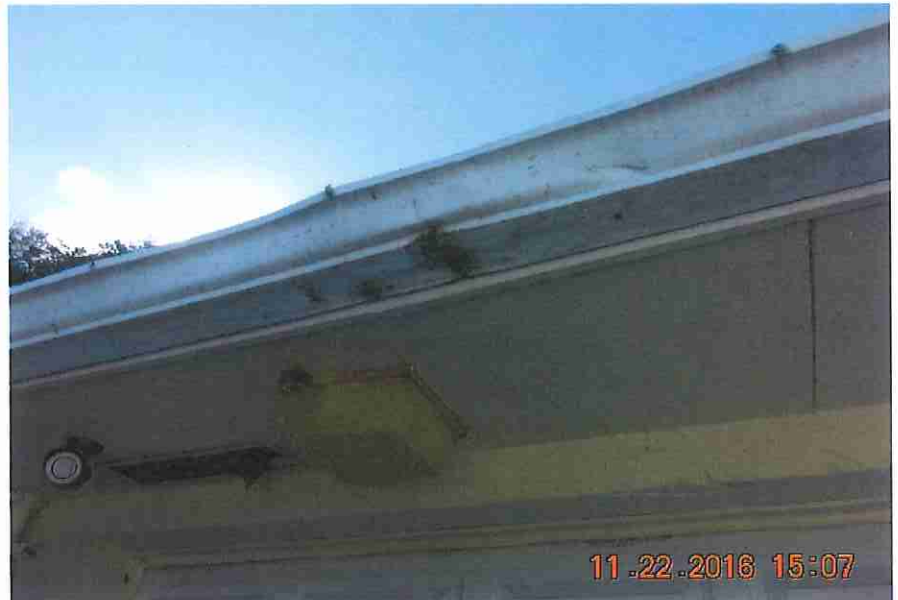
My walk around the building at ground level found the seamless gutter system heavily damaged, at the southeast corner and west end of the north side. Both areas suffer from equipment impact damage.

#2 Damaged gutter at overhead  
door, east side.

- 1) The new tile system should be a #30/SBS Hot Asphalt applied Modified membrane, with the tile set in a large Pad of Polyfoam adhesive, to provide the best wind resistance values available today.
- 2) The new gutters should stop short of the two overhead doors, then be supplemented by installing sloped water diverters over each door, to direct the water to the gutters. This will prevent future impact damage, in the concrete ramp areas.

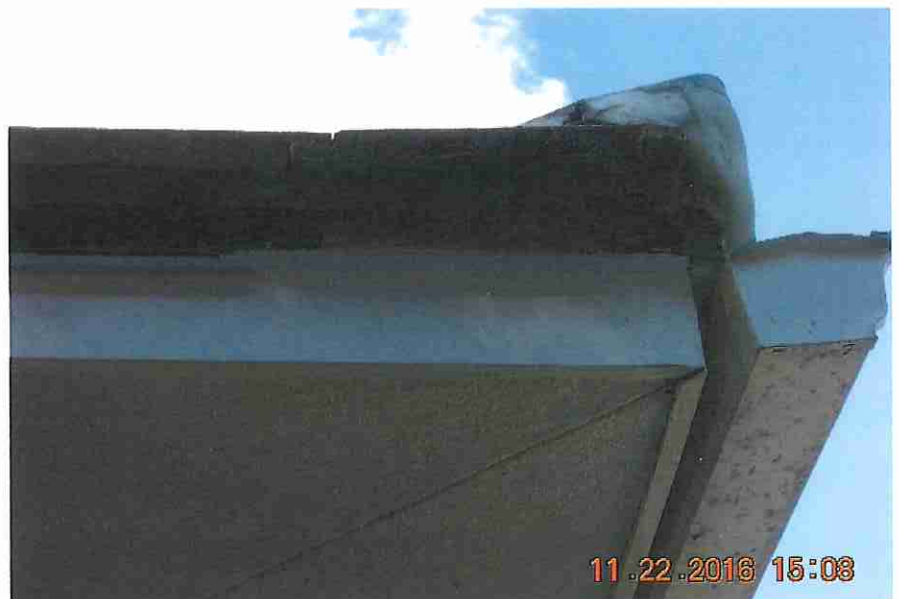
#3 Missing (deteriorated) copper  
eave drip south side, east end.

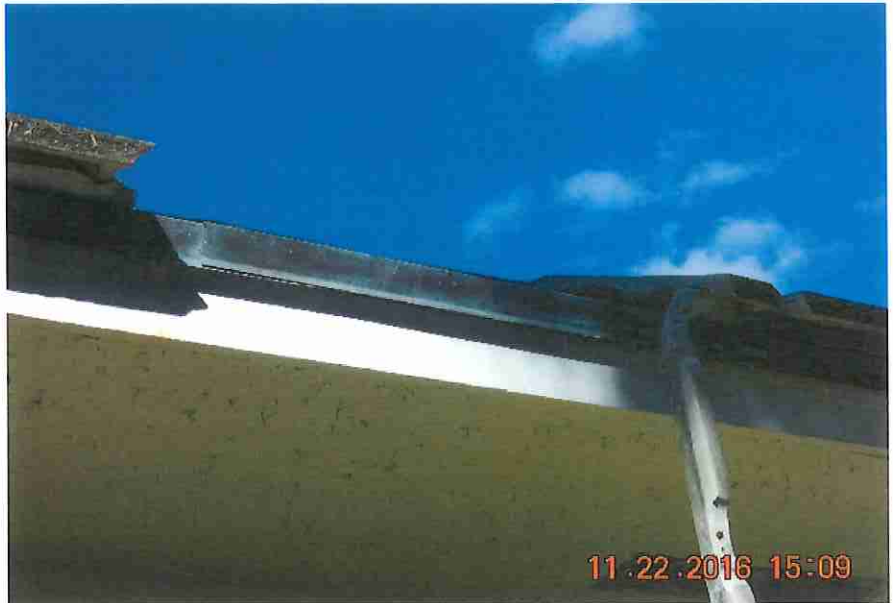
#4 Example of numerous areas  
where eave tile course is dam-  
aged and missing.

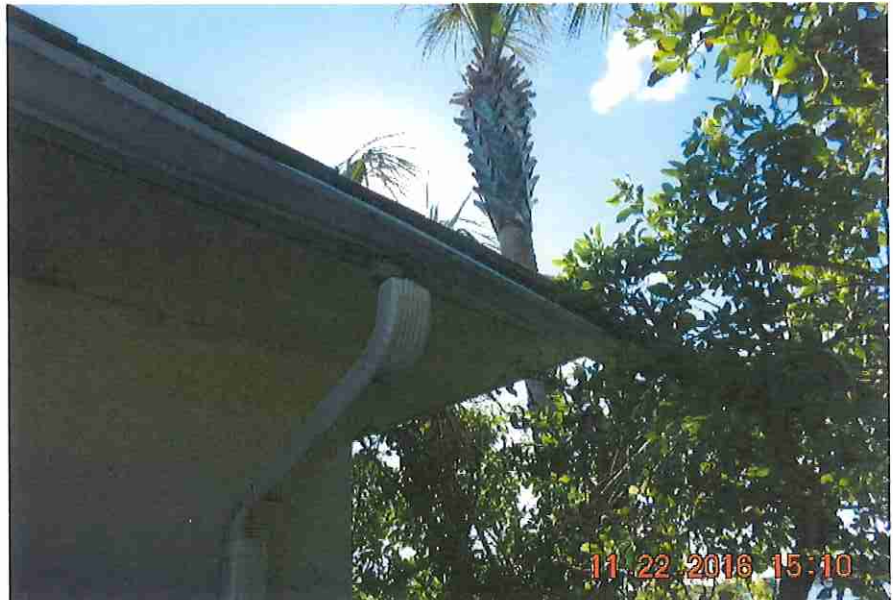
#5 Damaged gutter and down-  
spout, north side, west end.

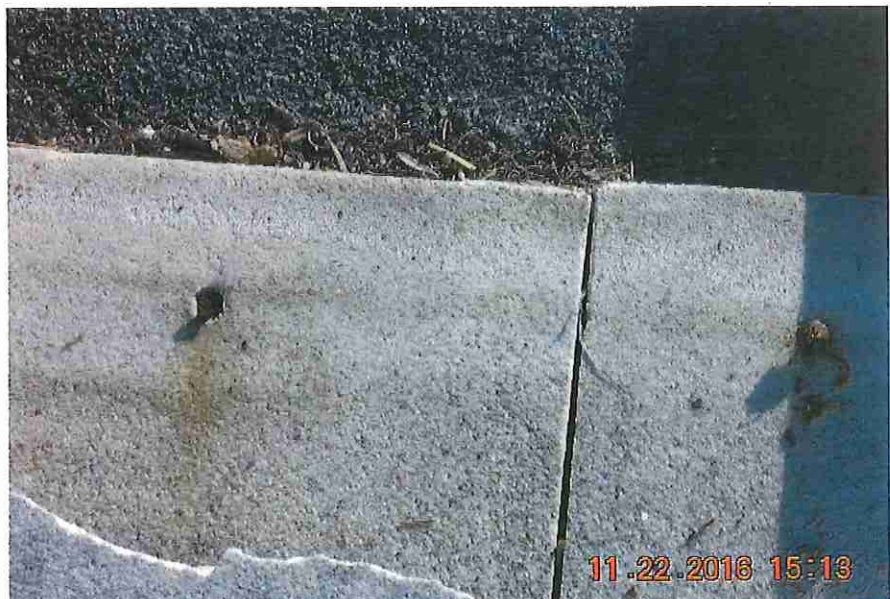
Access to the roof immediately noted loose and sliding tile on all four of the sloped sides, with the worst areas being the long south side. Closer examination found the tile to be "nailed-on" using what I will guess was an electro-plated pneumatic type gun nail, which is now in various stages of sever rust to total failure.

#6 Example of "rusted" failing  
nails, for tile system.

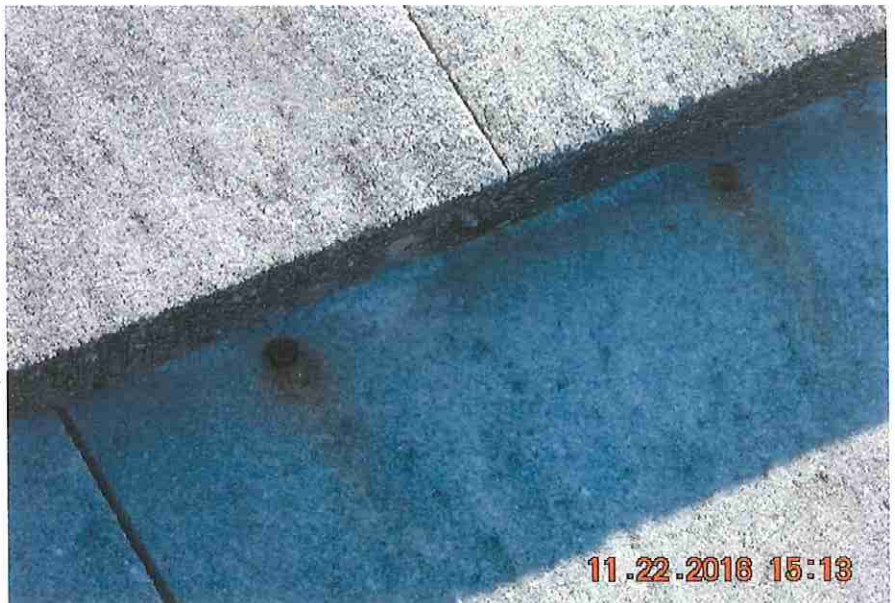
#7 Tile row, which does not even cover previous tile row, nails.

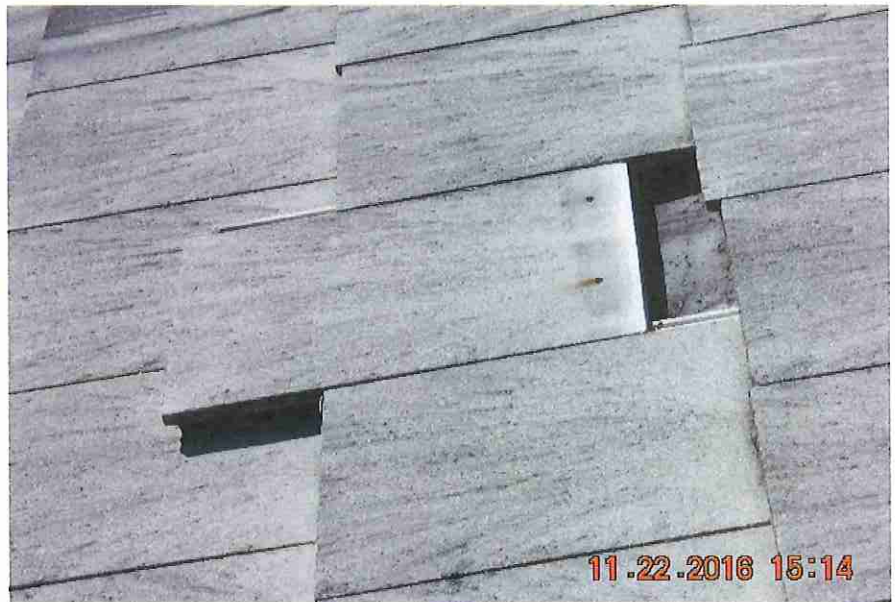
My real concern here is the large quantity of loose tile, which can become airborne missiles in a high wind event, posing a "life safety" risk to persons and property.

#8 Example of loose sliding tile, throughout roof.

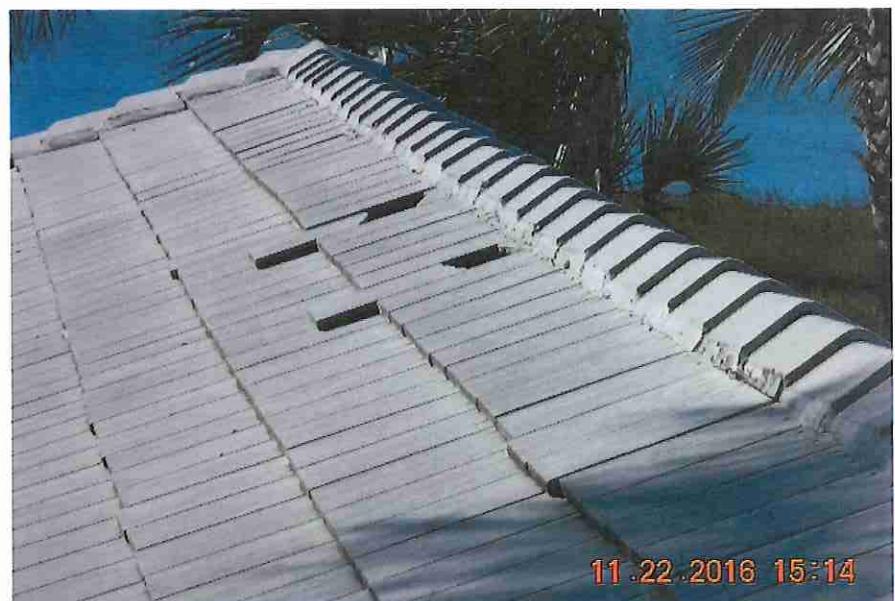
#9 Overview of similar sliding tile.

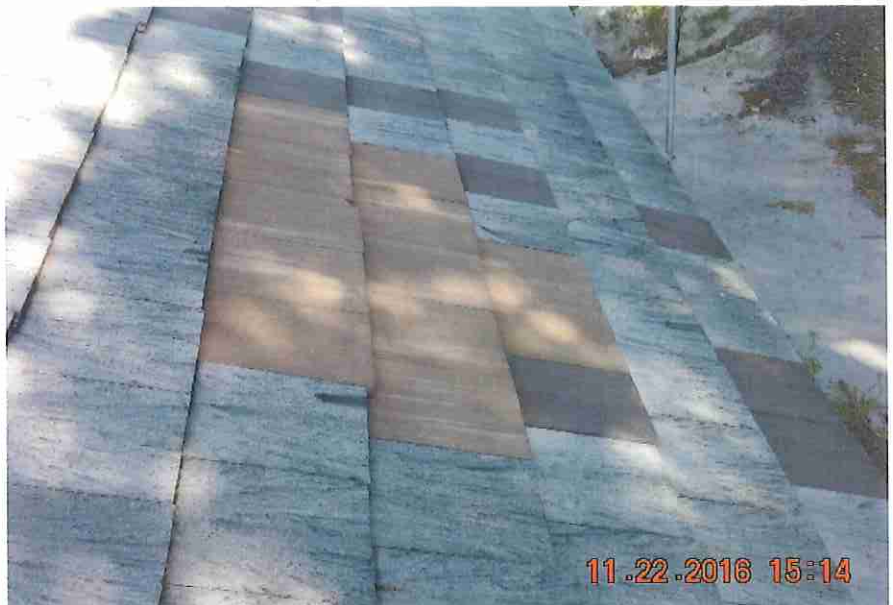
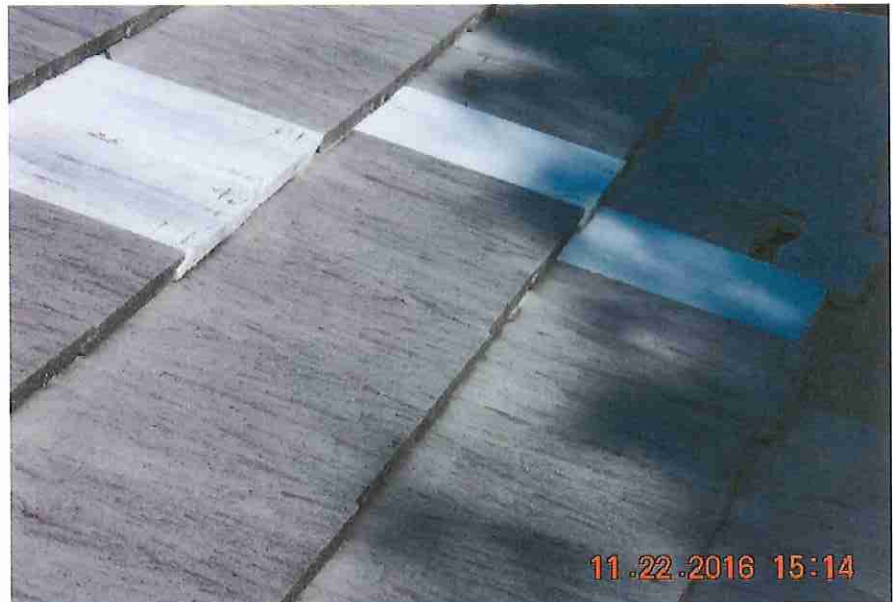
Additionally there appears to have been 4-5 areas of various size repairs, to the south and west sides, an indicator of a roof failure in process. Within these repairs I noted fractured membrane, with some minor deck wood decay, along the south side eave, towards the west end (photo 12).

#10 Example of recent large  
repair area, at south side, east  
end of roof.

#11 Same caption as photo 10.

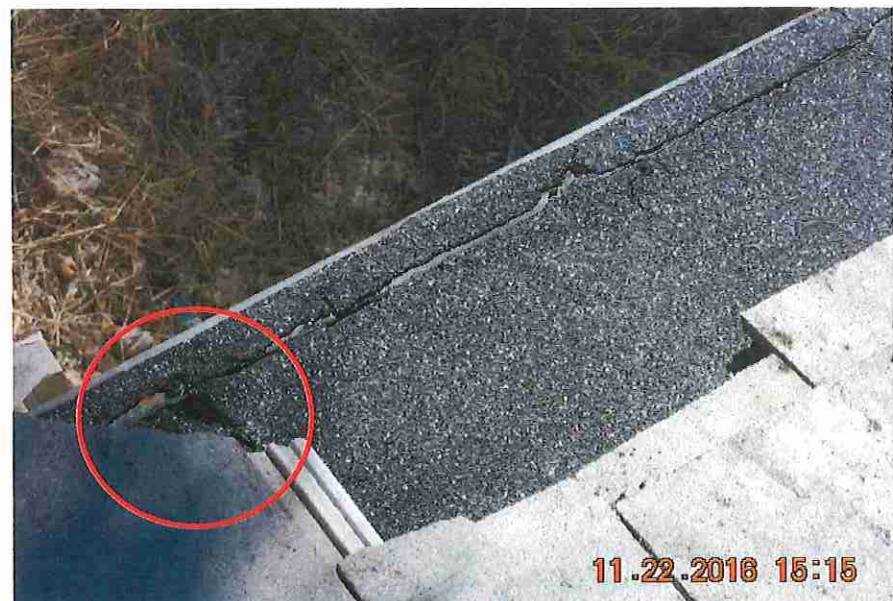
#12 Exposed organic mem-  
brane split open and wood de-  
cay beneath. (red circle)

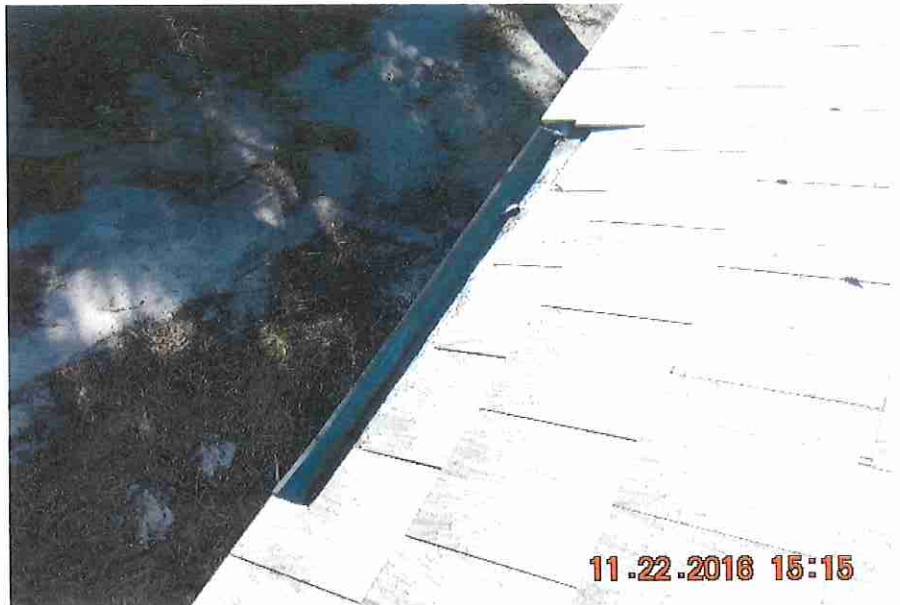
#13 Water diverter above rear  
entry door.

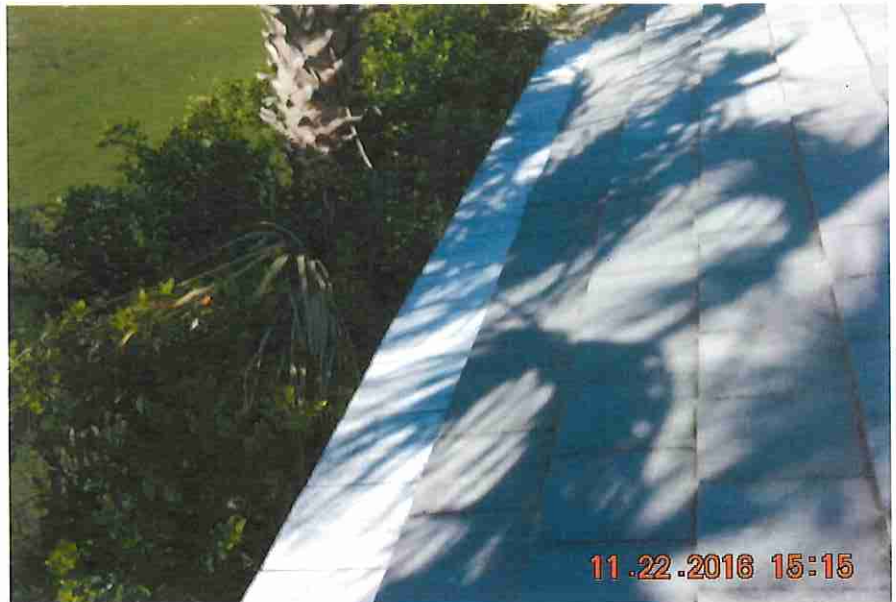
#14 Long eave repair at west  
end.
