KNOPF & ASSOCIATES, INC.

November 29, 2016

Re: 2016 Roof Condition Evaluation Report
Bid #2016-27, Town of Palm Beach, Item #16
Par 3 Cart Storage (Old Clubhouse)

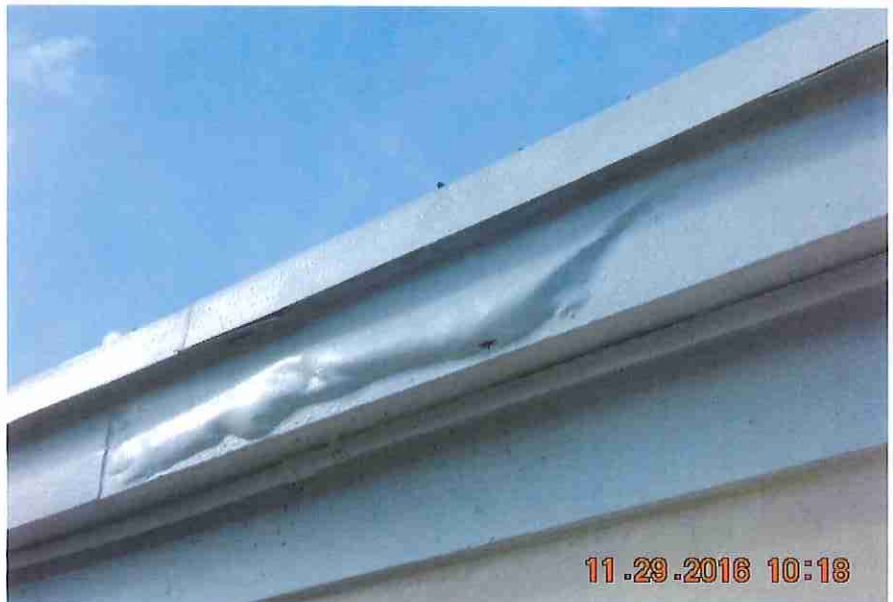
A walk around the facility at ground level found two (2) pockets of entrapped water in the paint coating on the east side wood fascia. These water pockets were punctured to relieve the water and reduce the chances of accelerated wood decay (photo 2). Moving around to the west side there is obvious wood decay and water stains on the same fascia, indicating possibly active leak areas from the low slope roof (photos 3 & 4).

#2 Example of water blister in paint at fascia, east side, typical of 2.

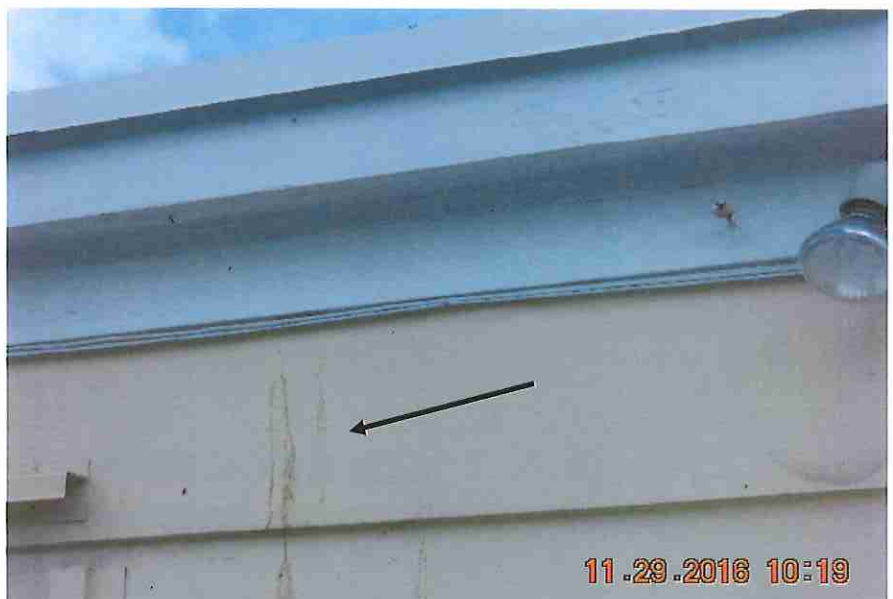
#3 Possible roof leak area at west side. Water stains from fascia.

Thought should be given to replacing the decayed fascia section, then proper preparation and painting of the fascia and soffit areas.

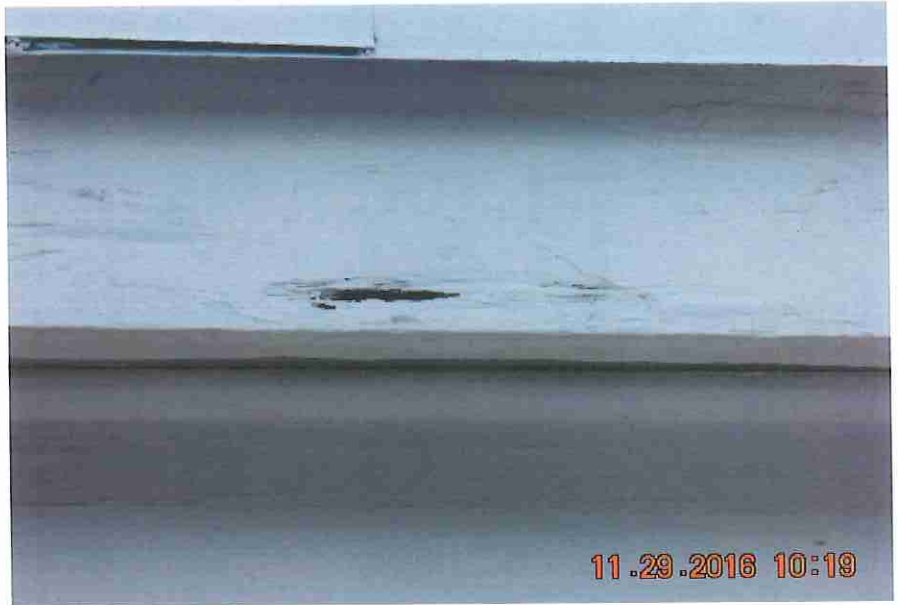
#4 Decayed fascia west side.

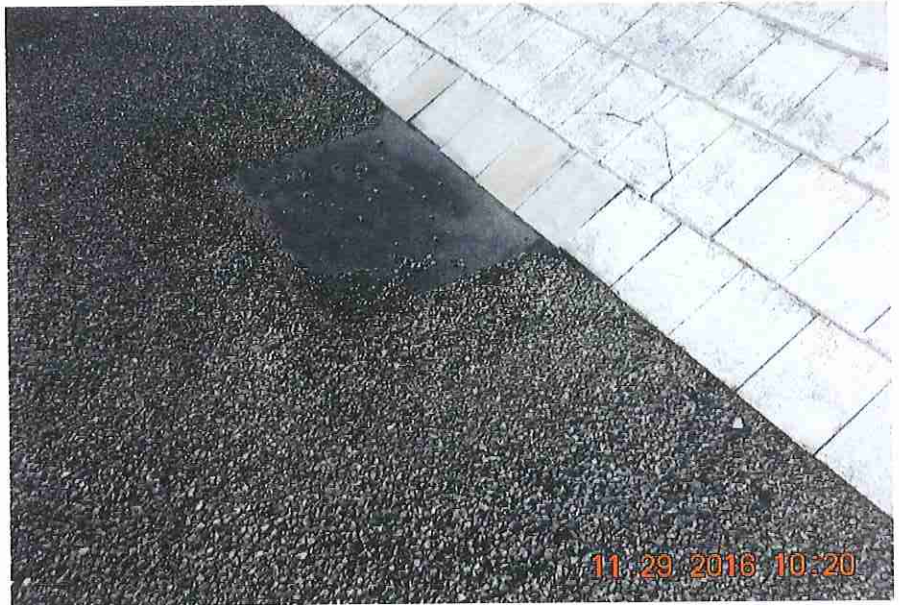
There is one decent size incomplete repair spanning between the low and steep sloped roofs at the east side (photo 5). Whomever started this repair should complete same to protect the area from UV degradation.

#5 Incomplete repair at east side, between roof levels.

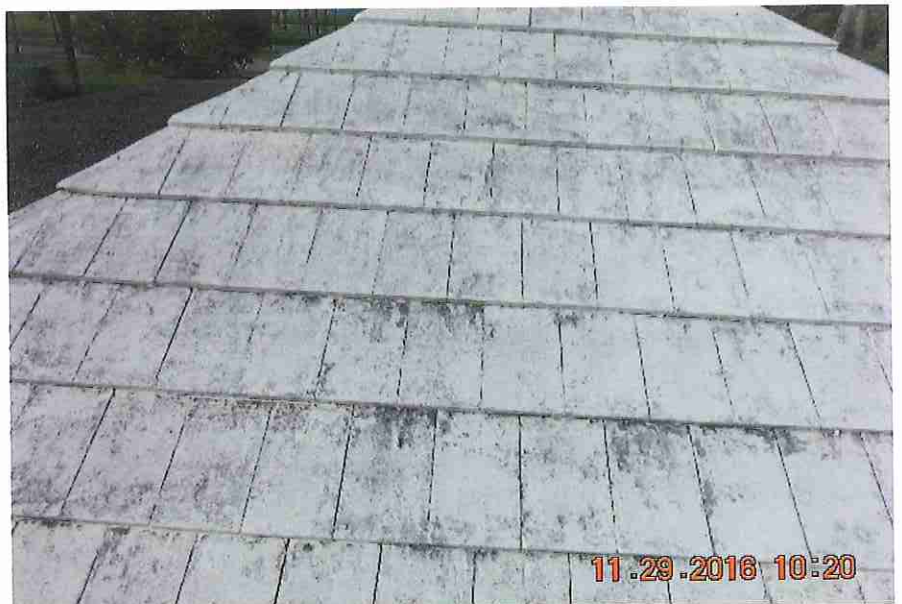
The cement tile roof is a 9" width Bermuda tile, mortar set over a #30/90 organic felt and from its appearance is the same age as the low slope roof. There are a few cracked tile, which remain in place and the white paint topping is discolored and peeling. These tile should be replaced.

#6 Overview of failing paint on tile

Having completed my review of the site conditions, I am of the opinion, with proper repairs, of both roofs, cleaning and painting of the tile areas, the Town can expect four (4) perhaps five (5) years more service life.

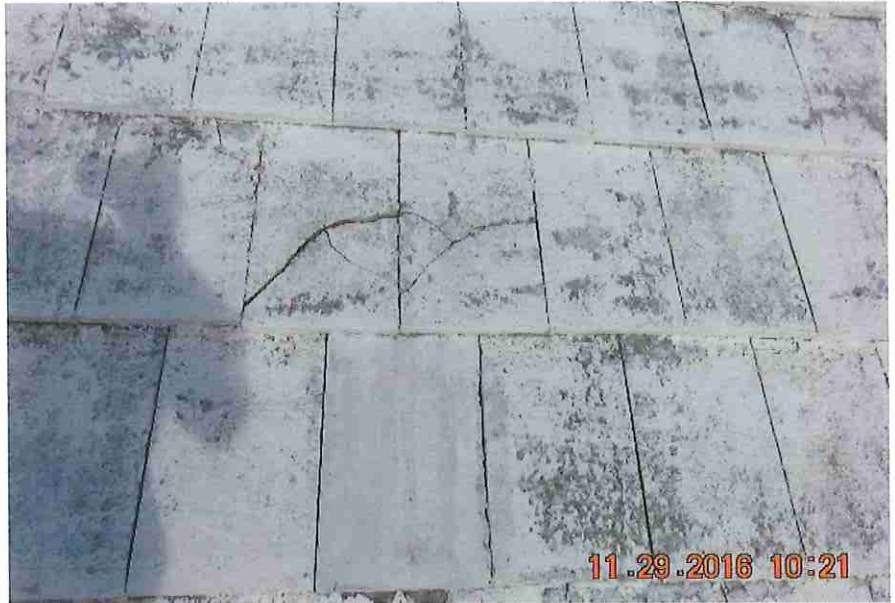
#7 Example of random cracked
tile.
