**Tree Evaluation Worksheet**

Tree #: 2  
 Latin Name: Lonchocarpus violaceus, Dicot  
 Common Name: Lancepod Tree  
 Address: 1 Via Sunny  
 Location on Property: Extreme NW corner of property, 15' S of NPL, 12' E of WPL  
 GPS: 26°42'43" N 80°2'57" W

Historic/Specimen Tree Inspection Report prepared by: King Tree Service  
 Certified Arborist: Richard Maxwell

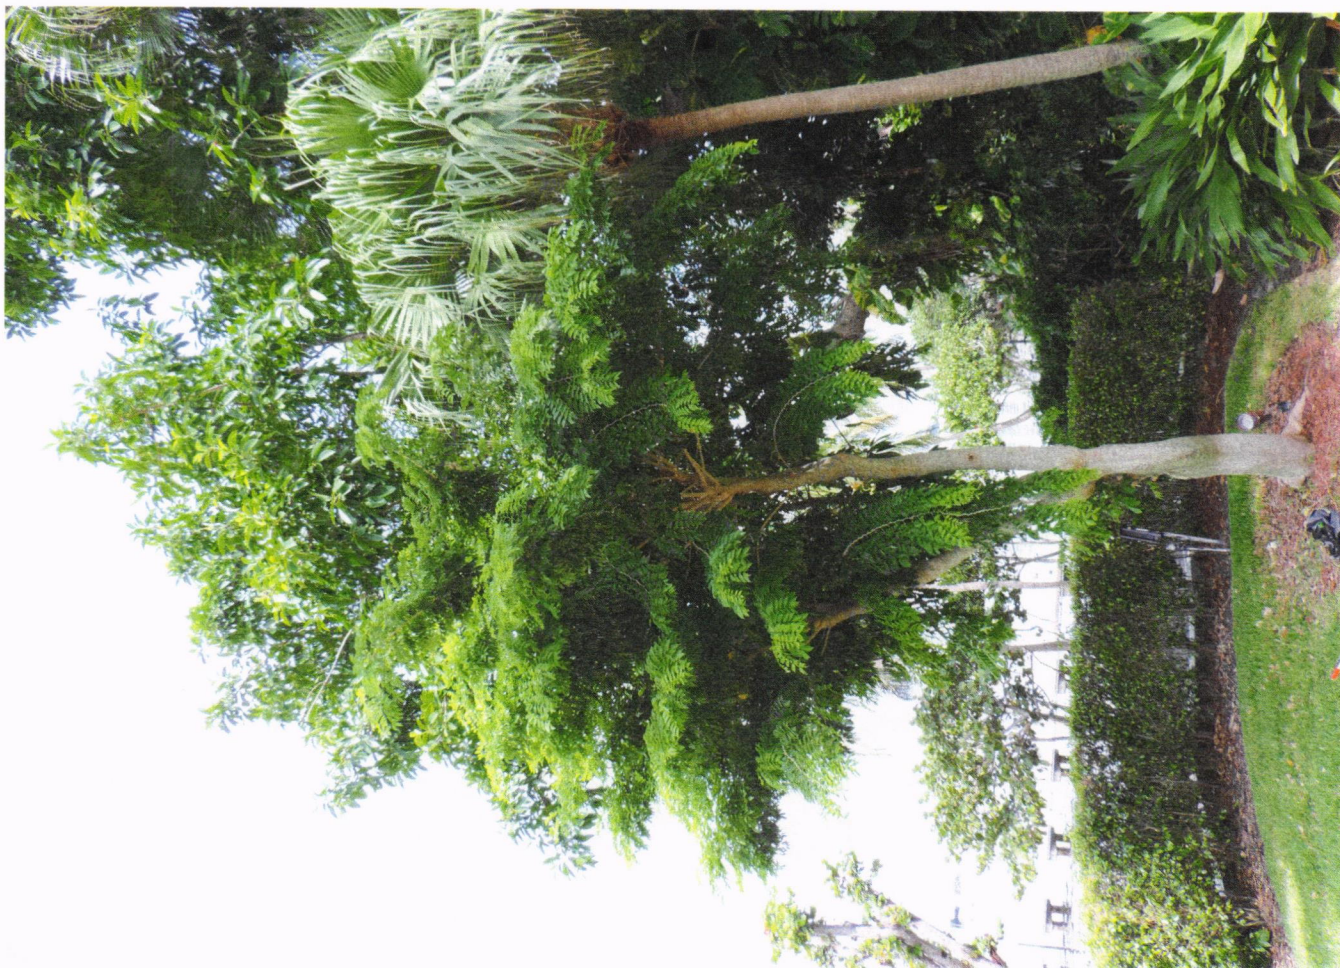
DBH: 6.9", 5.3"  
 Leaf to Wood Mass Ratio: 4  
 Limb/Branch Structure: 3  
 Defects: Y  
 Decay: N  
 Conks/Fruiting Bodies Present: N  
 Co-Dominant Branches: Y  
 Included Bark: Y  
 Pruning Recommendations: Clean/deadwood and remove south facing 2" dia. sucker off s. side of n. trunk @ 4' above grade.  
 Fertilization Recommendation: Good Nutrition - Continue existing program  
 Ornamental Pest Control: Disease/Insect Not Visible  
 Designation Recommendation: Keep  
 Additional Comments: Girdling roots getting worse pruning & girdling root work will get this tree to a 4 rating

DBH: 8.0", 6.5"  
 Leaf to Wood Mass Ratio: 1 2 3 4 5  
 Limb/Branch Structure: 1 2 3 4 5  
 Defects: Y  
 Decay: Y  
 Conks/Fruiting Bodies Present: Y  
 Co-Dominant Branches: Y  
 Included Bark: Y  
 Pruning Recommendations: Other: remove suckers below 12'  
 Fertilization: Good Nutrition - Continue existing program  
 Visible nutrient deficiencies - recommend fertilization  
 Other:  
 Ornamental Pest Control: Disease/Insect Visible  
 Recommended Treatment: Disease/Insect Not Visible  
 Designation Recommendation: Keep Remove  
 Overall Rating: 1 2 3 4 5  
 Additional Comments:
