## **BENTHIC RESOURCE SURVEY SUMMARY REPORT**

### **PALM BEACH INTERNATIONAL BOAT SHOW – FLAGLER MUSEUM**

**TCG PROJECT NO. 09-0032.002**

**AUGUST 2018**

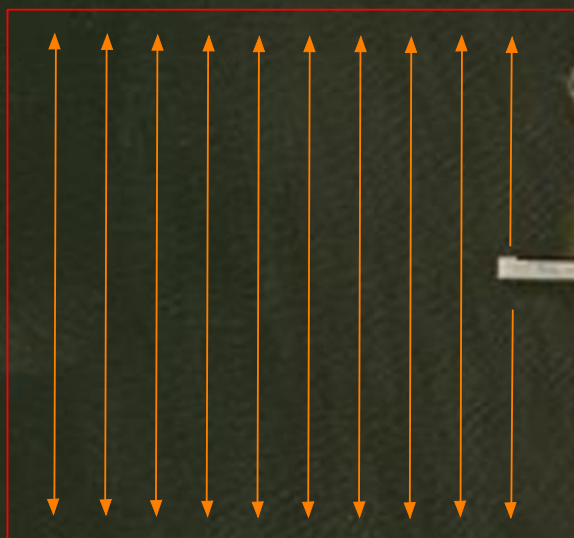
**FIGURE 2**  
**SURVEY AERIALS**

The field work for the benthic resource survey was conducted on August 22, 2018 by four (4) qualified biologists from The Chappell Group, Inc. This work was performed at low tide (outgoing). Line transects were conducted parallel to the shoreline within the ICWW. The survey area was approximately 450' along the shoreline and extended  $\pm 500'$  waterward of the shoreline. Each diver conducted ten (10) line transects along the length of the property to ensure complete coverage of the survey area (Figure 2). The biologists traversed each line along the bottom of the ICWW to determine the presence of any seagrass species and/or other submerged benthic resources. In addition to the line transects, each diver conducted a meandering transect to ensure complete visual coverage and that no additional benthic resources were present adjacent to the subject site.

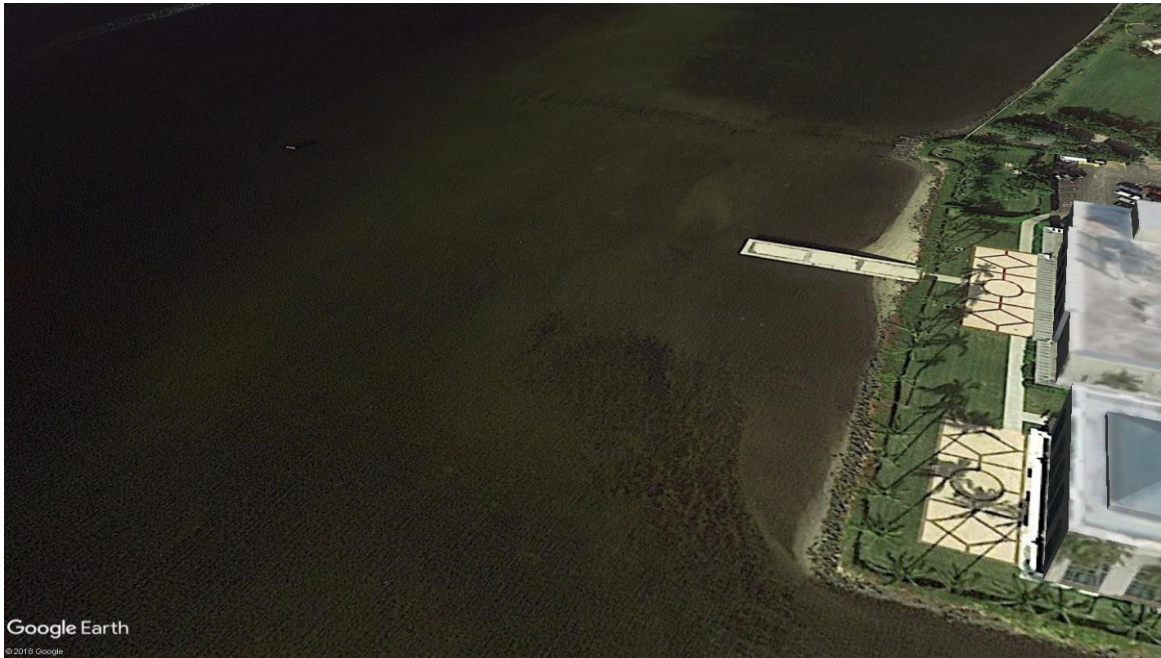
**1. Aerial image taken from google earth depicting entire project site, facing north.**

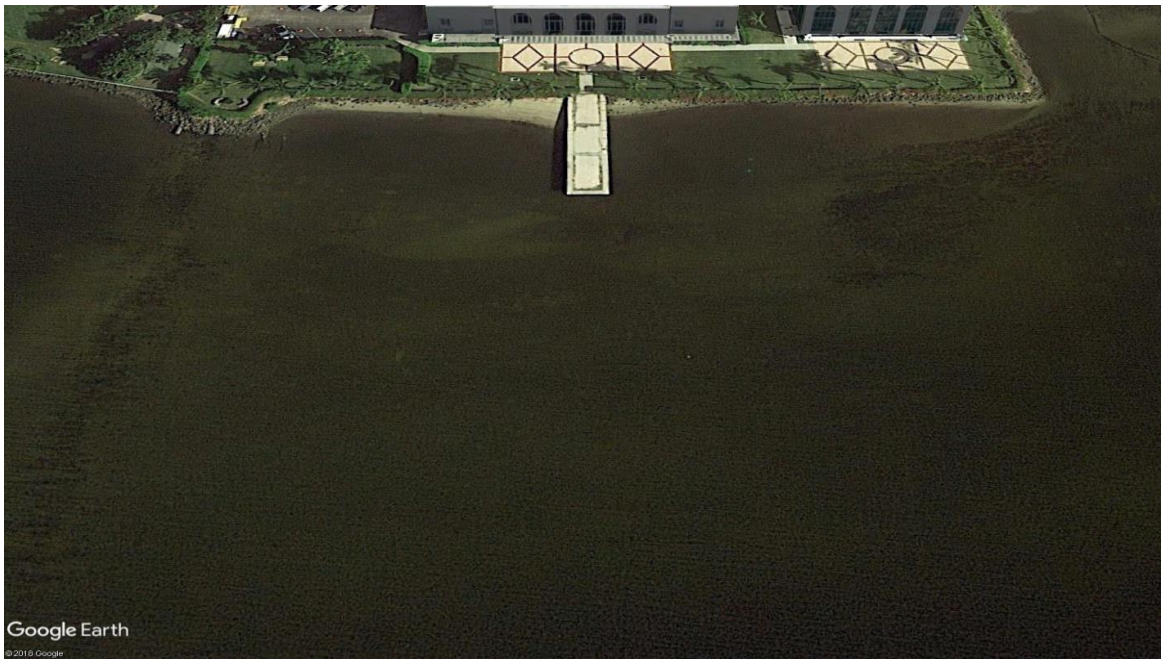
**2. Aerial image taken from google earth depicting entire project site, facing east.**

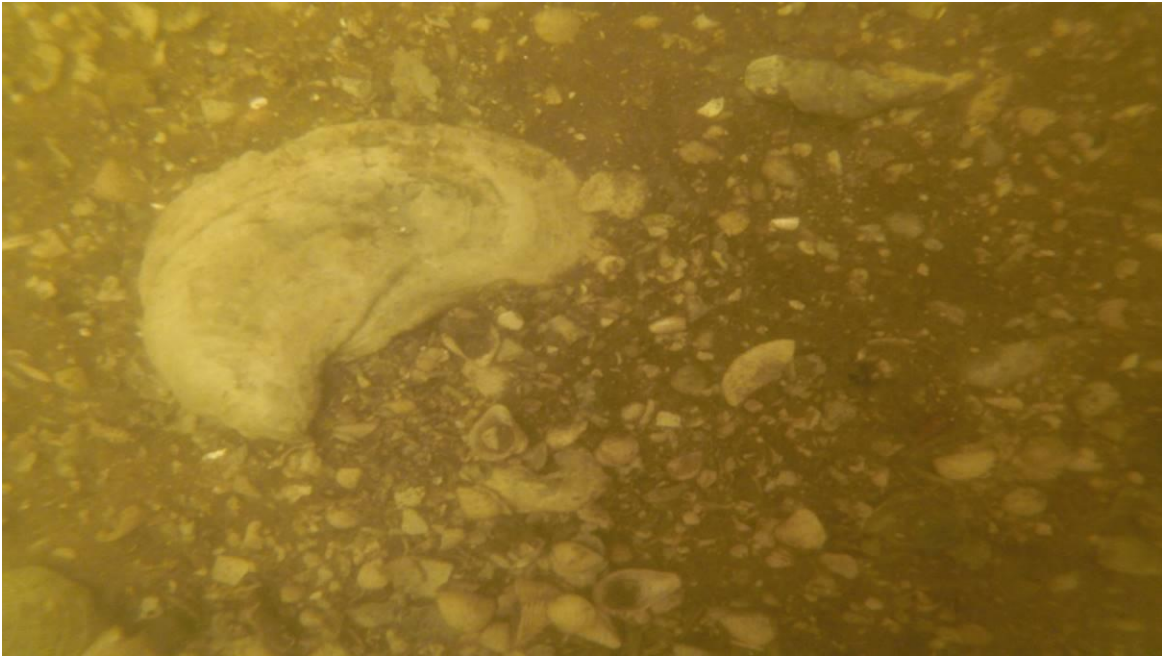
The benthic community of the subject site consisted of sand, crushed shell and rock material (Appendix A). Depths within the survey area varied from 2'-10', with depths increasing towards the center of the Intracoastal Waterway. No seagrasses were observed within the survey area. Macroalgae was observed in shallower depths closer to the shoreline, and no wildlife was observed within the survey area.

**4. Northeastern portion of the subject site,  $\pm 5'$  waterward of the existing shoreline. Note sand, rock, and shell substrate.**

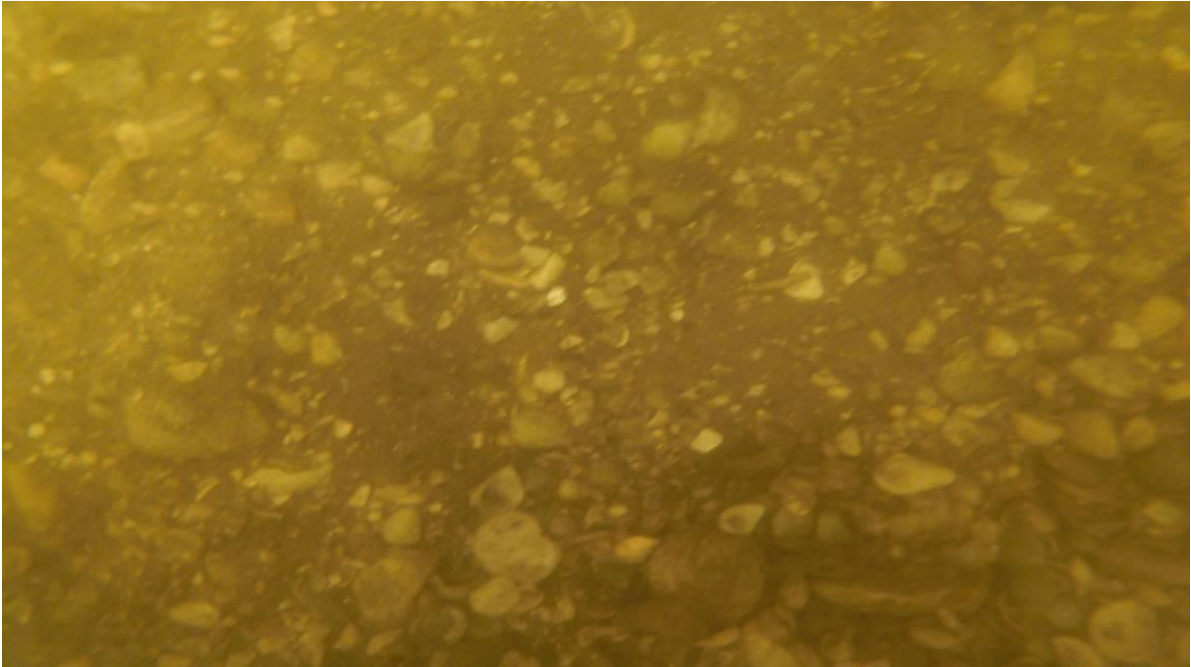
**5. Central portion of the subject site,  $\pm 10'$  waterward of the existing shoreline. Note sand, rock, and shell substrate.**

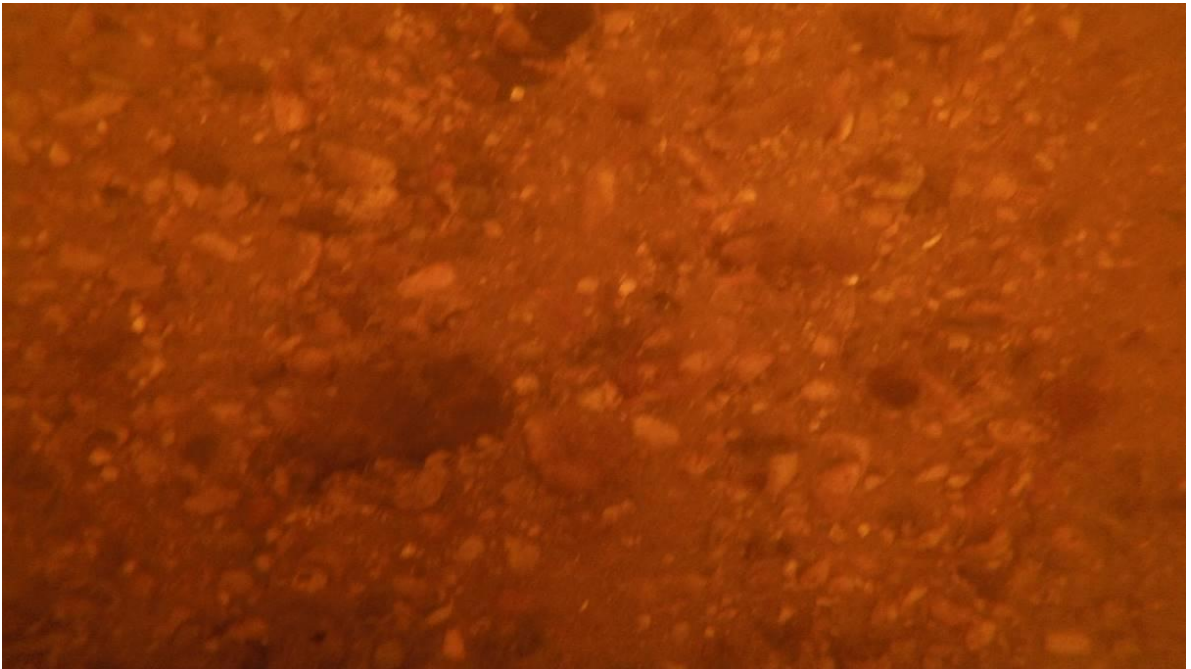
**6. Southwestern portion of the subject site,  $\pm 50'$  waterward of the existing shoreline. Note sand, rock, and shell substrate.**

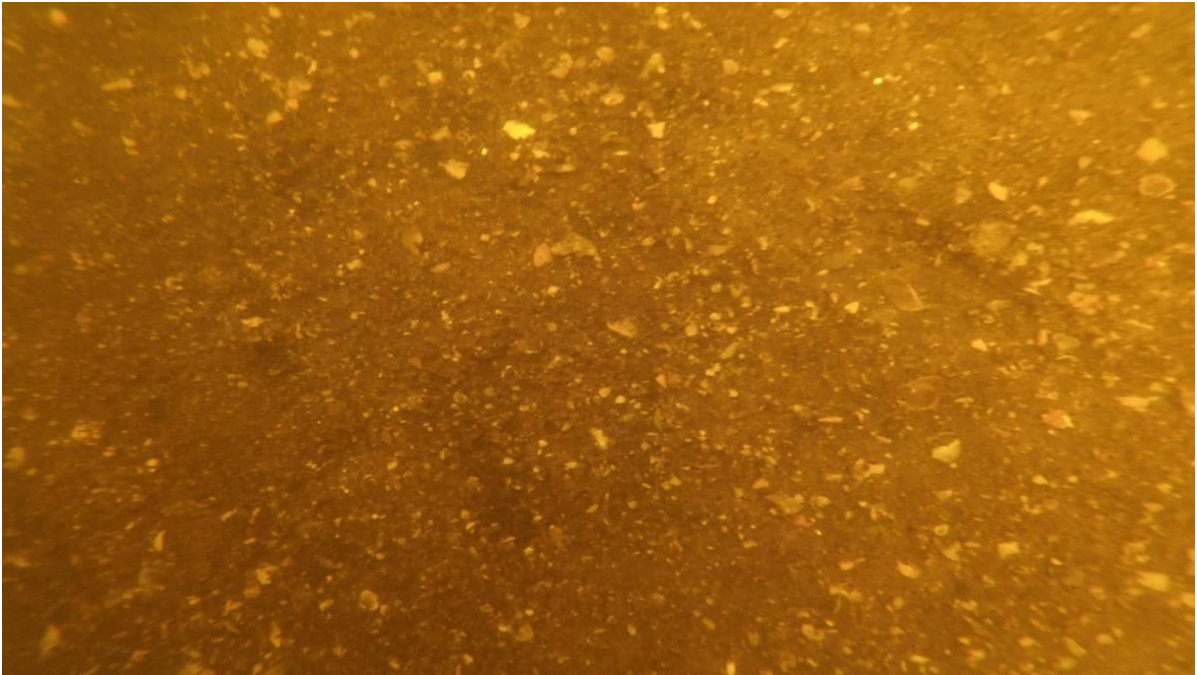
**7. Central portion of the subject site,  $\pm 100'$  waterward of the existing shoreline. Note sand and crushed shell substrate.**

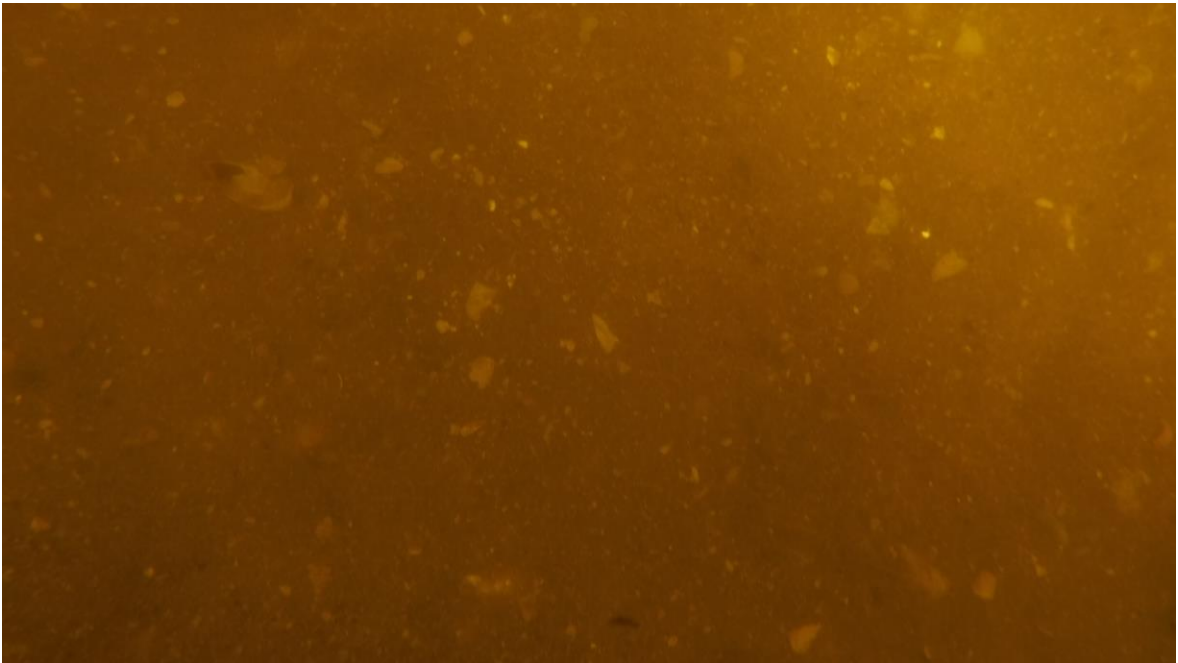
**9. Northeastern portion of the subject site,  $\pm 300'$  waterward of the existing shoreline. Note sand and crushed shell substrate.**

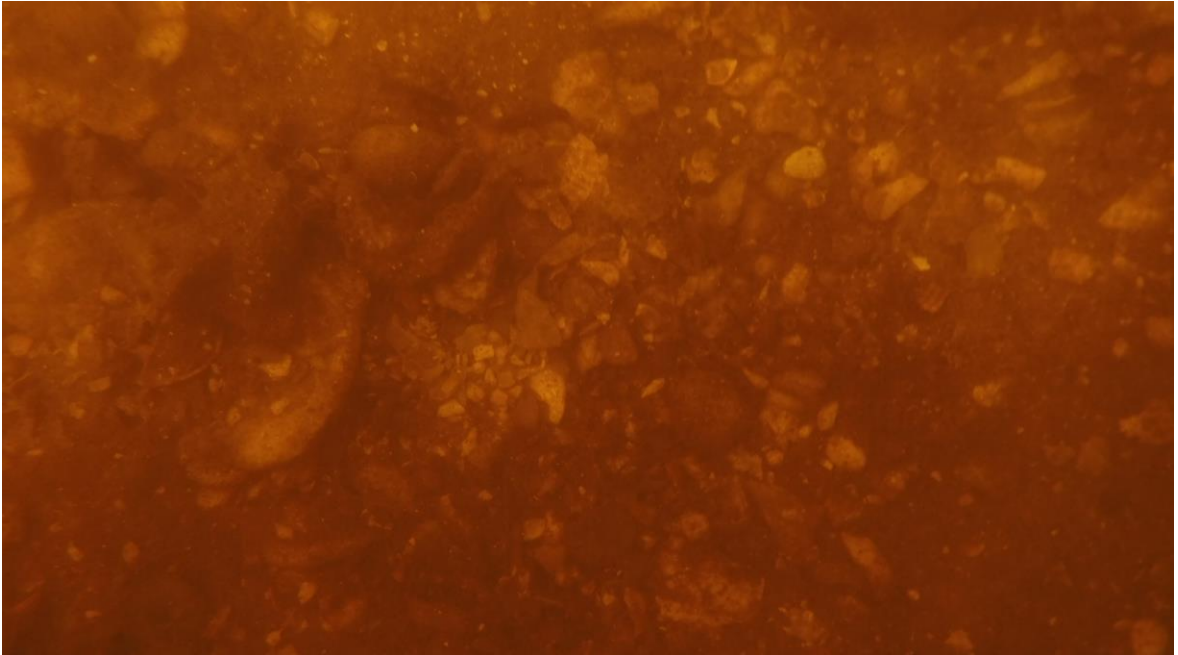
**10. Southwestern portion of the subject site,  $\pm 500'$  waterward of the existing shoreline. Note sand, rock, and shell substrate.**
