## LETTER OF INTENT FINAL SUBMIT

**DATE:** November 9, 2023  
**TO:** Town of Palm Beach, Planning, Zoning & Building Dept.  
**RE:** ARC-23-075\_389 S LAKE DR

On behalf of the Cooperative Apartments of Three Eighty Nine Corporation (“**Applicant**”), Shutts & Bowen LLP (“**Agent**”) respectfully requests Architectural Commission (“**ARCOM**”) approval of a Major Project for exterior façade changes to the Three Eighty Nine Corporation building (“**Building**”) located on a 1.55 acre site at the northeast corner of the intersection of S. Lake Drive and Peruvian Avenue (“**Site**”). The Applicant is seeking to:

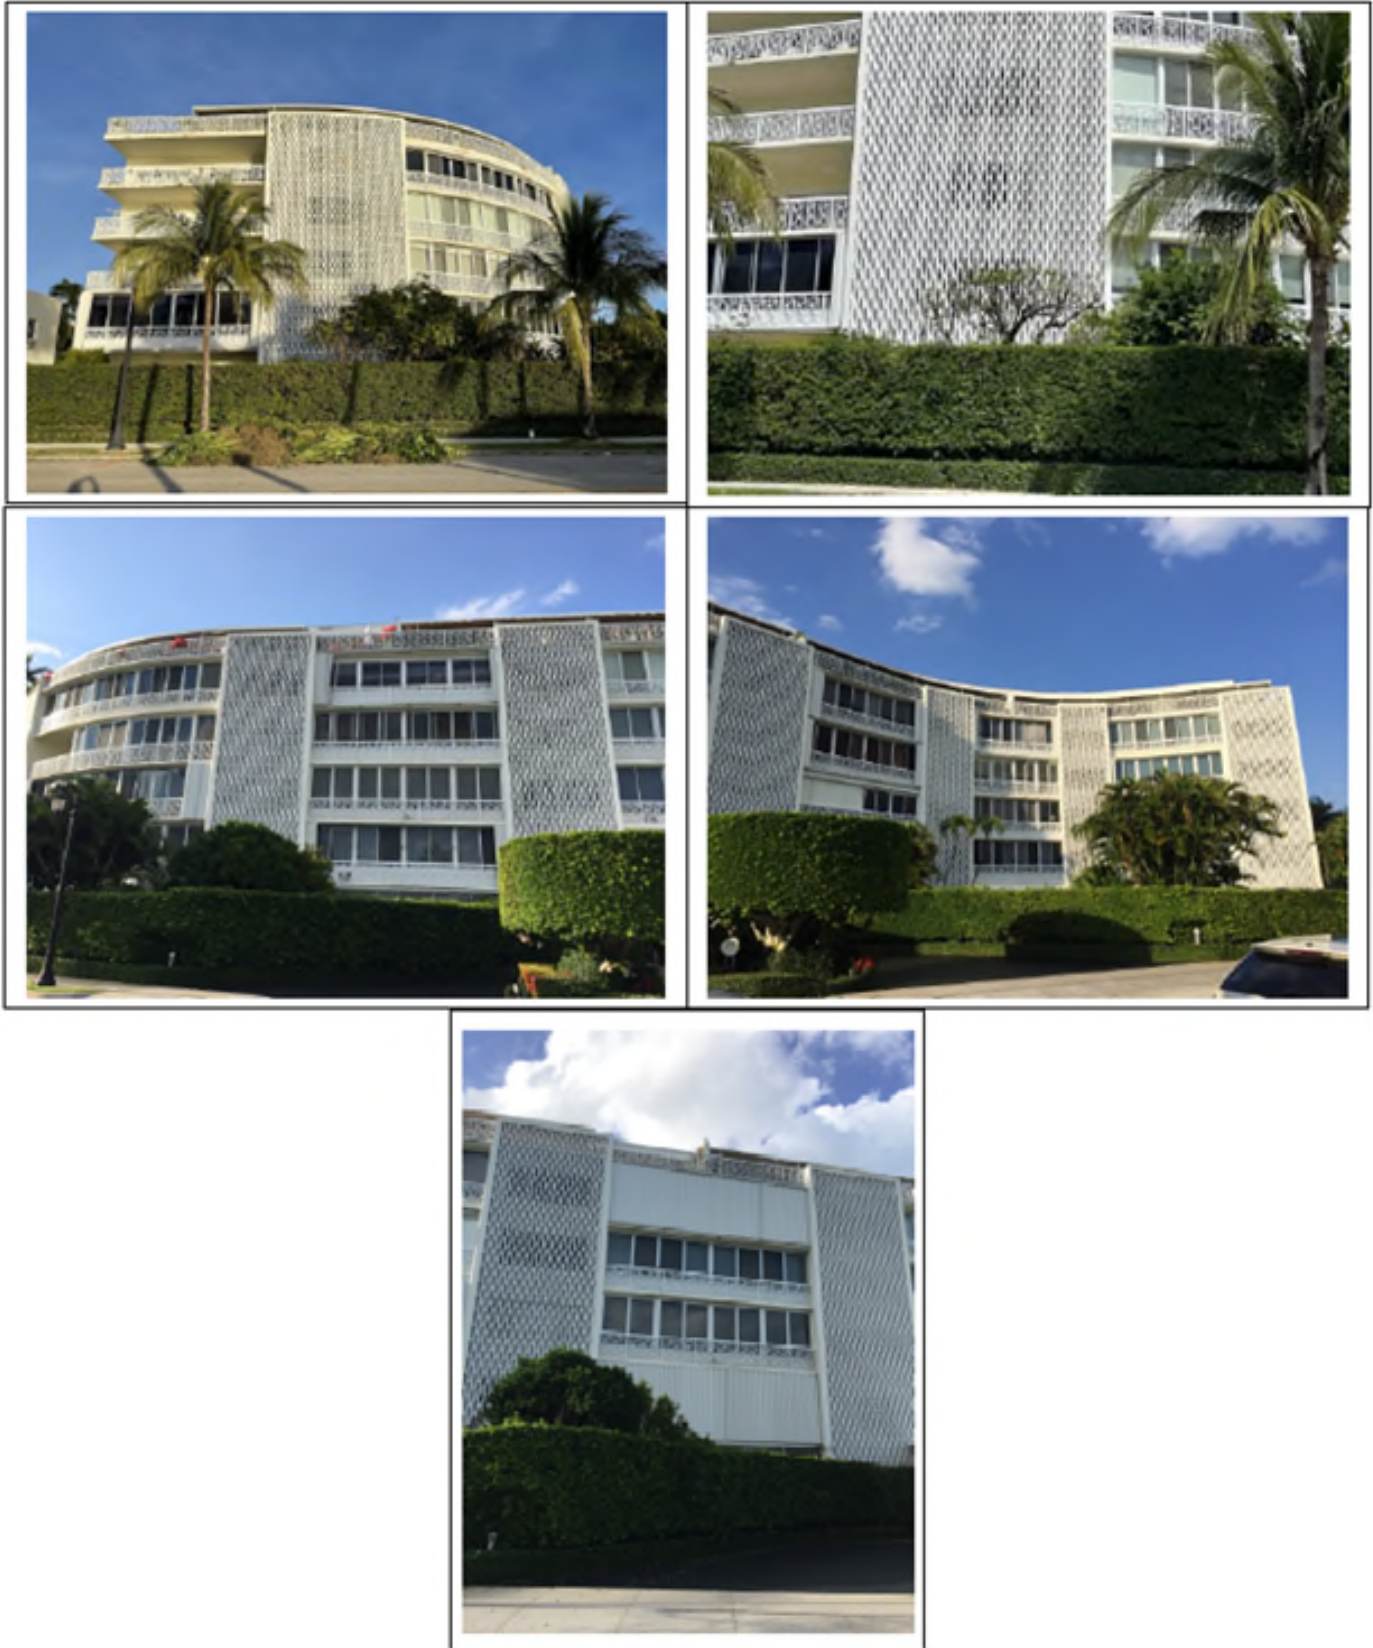
## Images of Exterior of Building with Concrete Lattice

According to the public records, the Building was constructed in 1967 with a Concrete Lattice in front of eight planar breaks along the front façade. The Concrete Lattice was designed with a pedestrian flat face lacking the decorative qualities of the other cast concrete balcony and surface treatments constructed around the same time in the Town. The Concrete Lattice was positioned approximately six inches from the exterior of the Building over the master bedroom windows and was anchored to the vertical concrete columns and to the unreinforced terracotta tile kneewall sections through the use of pinned metal brackets, embedded directly to the terracotta tile. Through the years, unit owners lodged numerous complaints of water intrusion and an inability to maintain, clean, and/or replace their master bedroom windows.

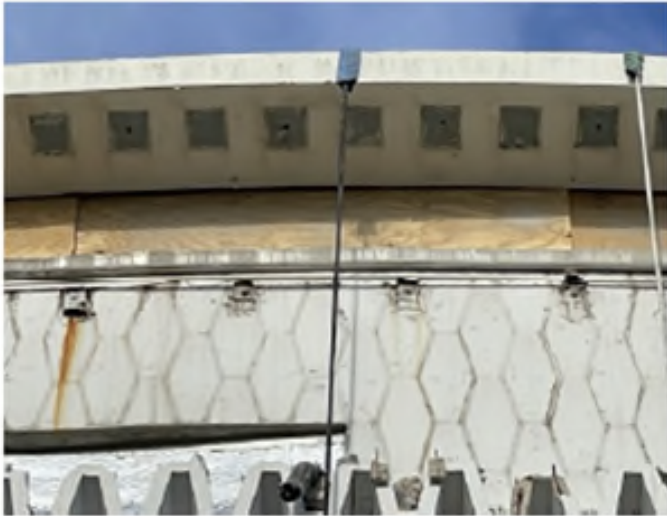
**Damage to Building from Concrete Lattice:**

**Concrete Lattice supports at top of building window**

The removal of the individual precast lattice precast component(s), exposed the widespread damage and degradation, requiring the removal and repair of all the metal support brackets and adjacent areas of delaminated stucco, resulting directly from the long-term infiltration of moisture at and/or adjacent to the existing bracket locations. The six (6) bracket locations per kneewall essentially meant that each individual precast lattice piece was supported on only one leg, further jeopardizing the structural integrity of the lattice panels. Of the 480 identified bracket locations, 60% of the brackets were directly anchored into the unreinforced terracotta tile kneewall locations.

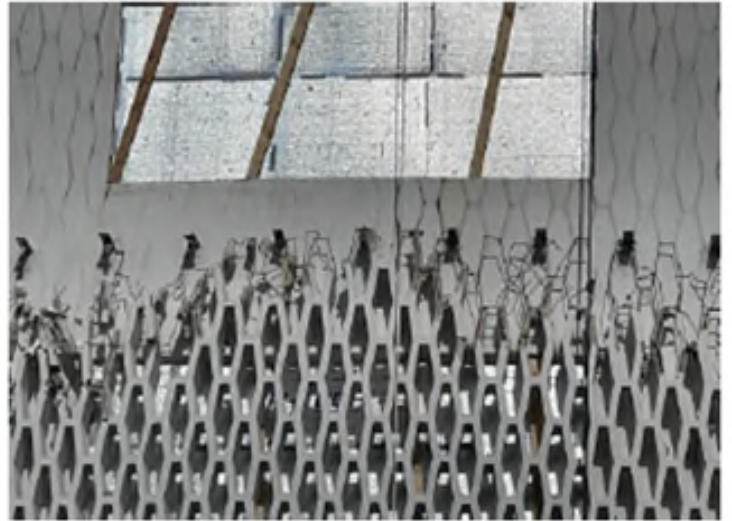
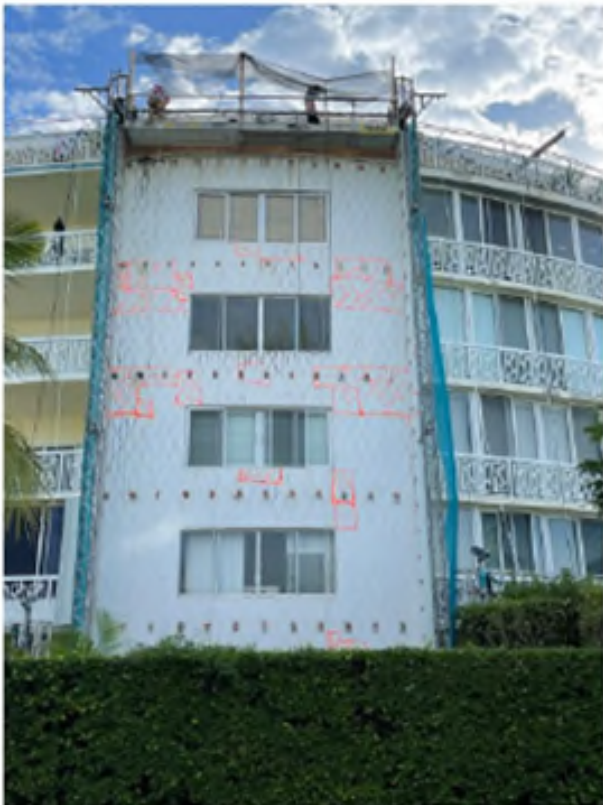
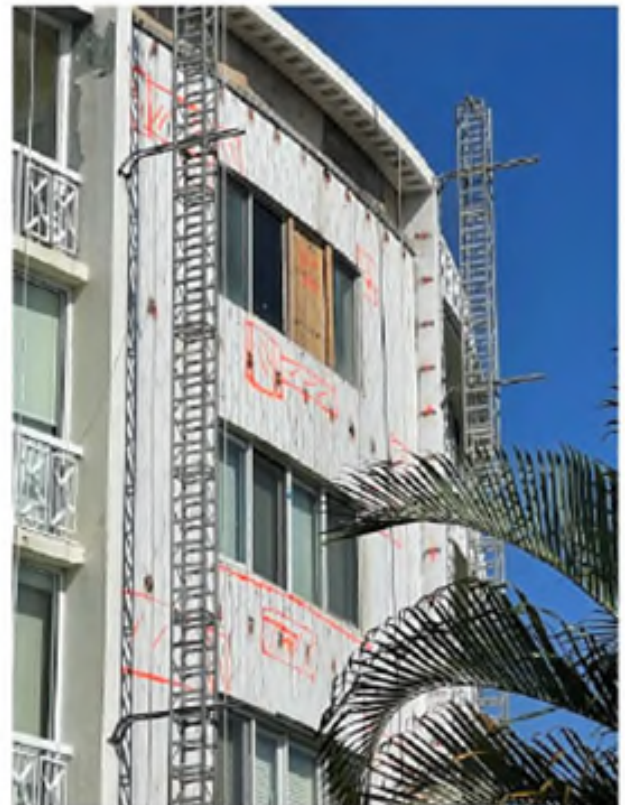
**Concrete Lattice removal & supports under MBR window**

The 389 Corporation concrete restoration and rehabilitation project commenced on September 6<sup>th</sup> 2022; with the initial focus of the project on the removal of the precast concrete decorative lattice sections. Within the first few weeks of the demolition work, it became apparent that the deterioration and degradation of the individual precast panel pieces was significantly worse than originally anticipated, requiring additional shoring to insure the integrity of the panel section during the demolition process. In addition, the exposed terracotta kneewalls revealed the widespread oxidation and failure of the metal support brackets, which were embedded and anchored to the terracotta tile kneewall at typically six (6) locations per kneewall. The lattice was also anchored to the bookend vertical columns on either side of the decorative lattice sections. The demolition process also revealed that the metal support brackets only anchored one of two legs of the two precast lattice elements.

The demolition of the exterior of the master bedroom terracotta kneewall revealed widespread deterioration and damage of the stucco covered, unreinforced terracotta tile kneewalls and the existing glazing components, located directly behind the existing lattice sections. The observed deterioration and damage also included the metal tie-in/support brackets, which are the sole supporting element(s) for the individual, interconnected lattice kneewall panel section pieces. The deterioration of the metal brackets and varying degree(s) of failure of the attachment of the metal brackets to the terracotta tile raised additional concerns with the structural integrity of the lattice system.

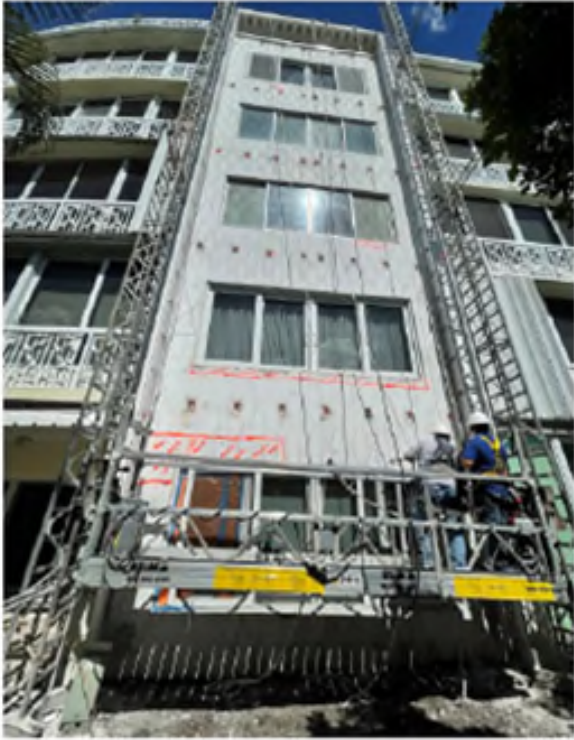
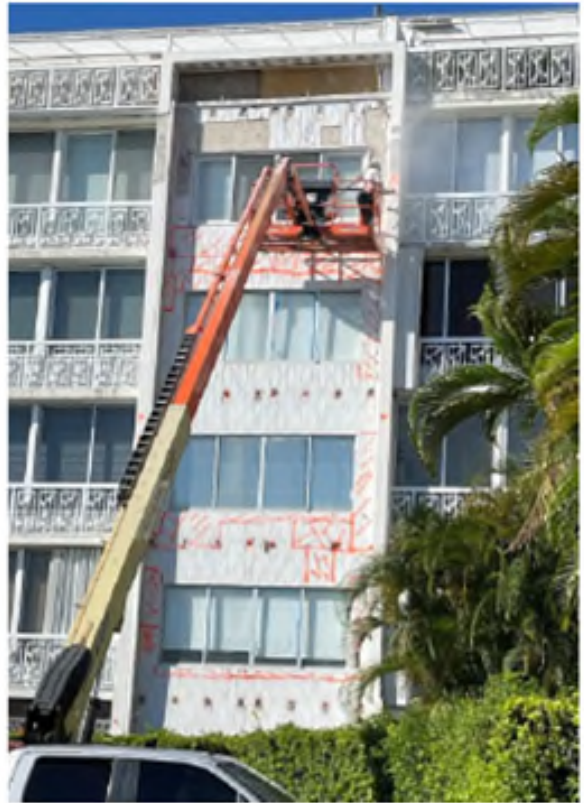
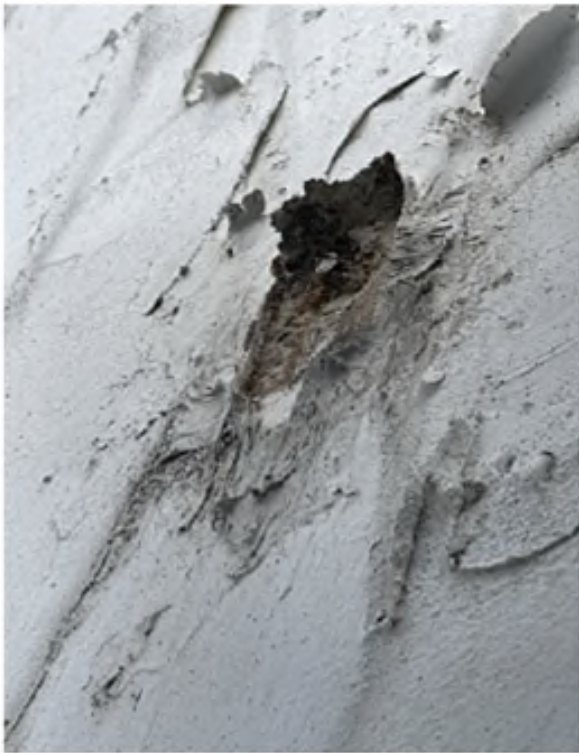
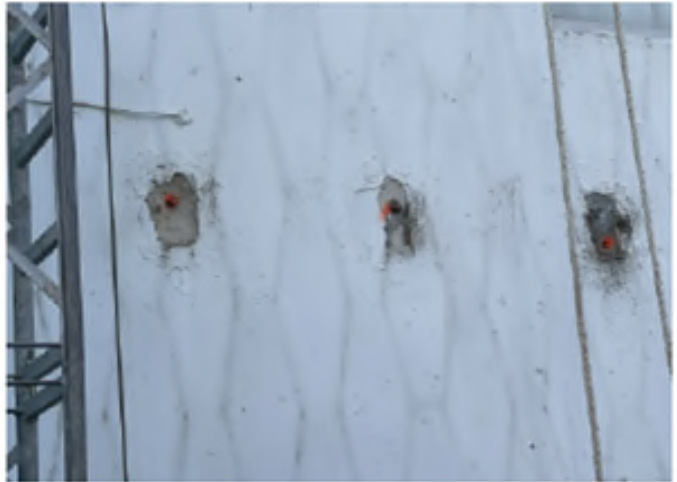
## Damage to Building from Concrete Lattice supports & damaged stucco

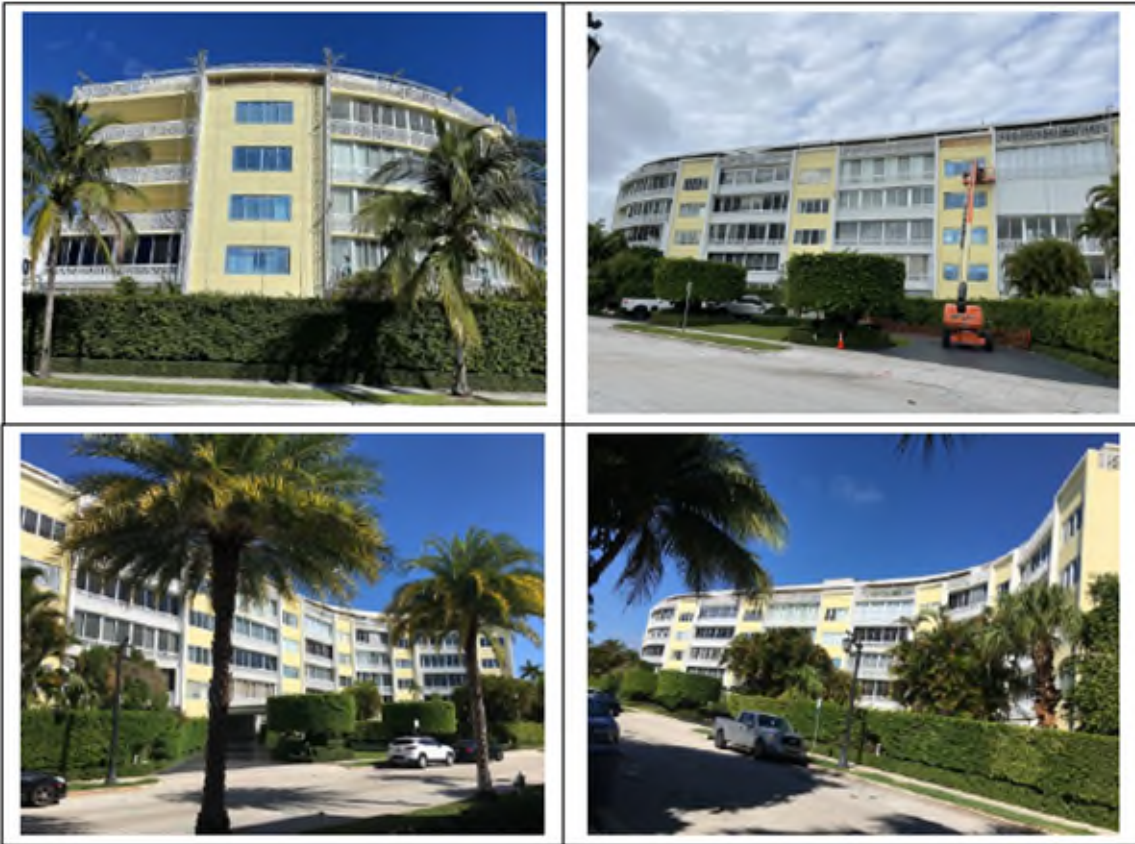
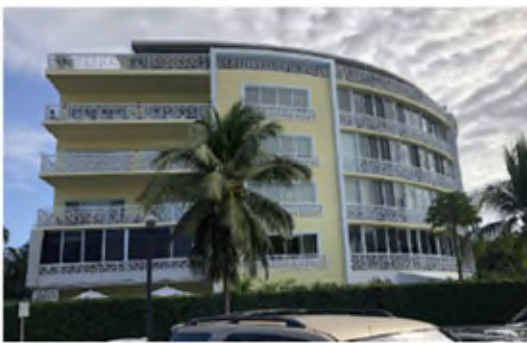
VIEW FROM SOUTH LAKE SIDE DRIVE

Realizing that replacing the Concrete Lattice presented significant safety and maintenance concerns, the Applicant began to explore the option of retaining the solid stucco finish in lieu of another concrete lattice. Because the construction of another concrete lattice would take over a year to manufacture, the Engineer applied a stucco and paint finish to the Building façade as a temporary measure. The Applicant was pleased to discover that the stucco wall finish was aesthetically and architecturally appealing, and in many ways an improvement over the Concrete Lattice. Additionally, the feedback from the neighboring residents was overwhelmingly positive. Considering that the stucco finish was so aesthetically pleasing and well-received by the residents and neighbors, the Applicant requests to keep the stucco, finish these planar breaks with banding around the individual windows, and add a matching railing to each window as an added element so that the final design remains cohesive with the rest of the Building's original design. Lastly, the view from the window units without the Concrete Lattice was vastly improved.

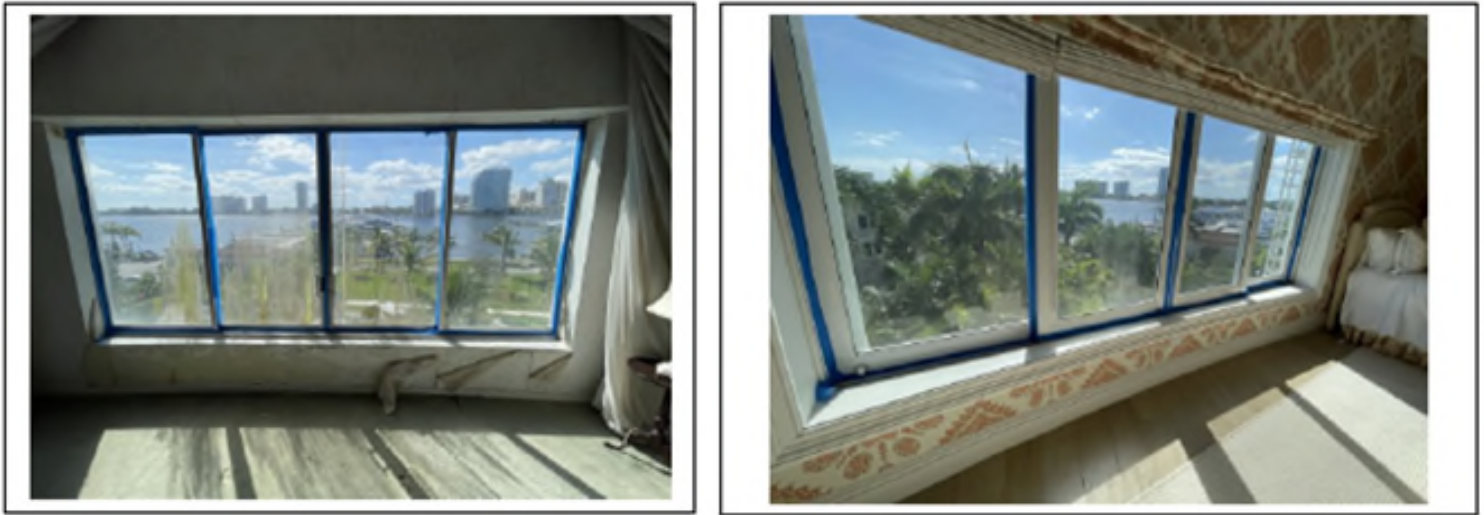
### **Views from Master Bedroom Windows without Concrete Lattice**
