# **TOWN OF PALM BEACH**

## **SHORE PROTECTION BOARD**

### **AGENDA**

**MARCH 27, 2025**

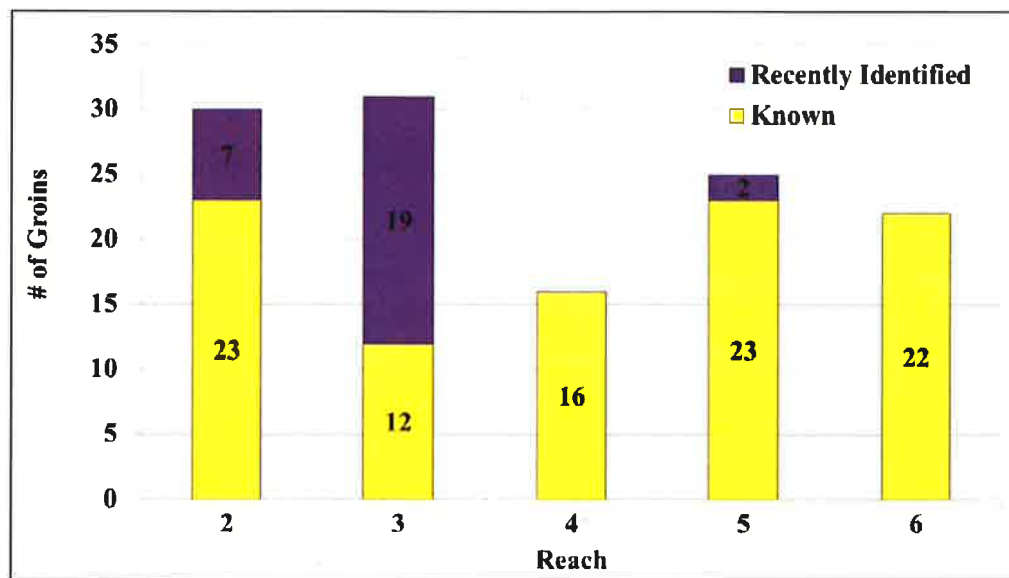
As of the 2014 site visit, there are a total of 121 groins and three (3) shore-parallel structures documented in the Town. This is an additional 28 groin structures compared to the 93 groins documented as of 2012 (CPE, 2012). The beach condition at the time of the site visits greatly influences the visibility of the groins, resulting in known groins and recently identified groins, or portions thereof, being observed at different times. The number of “Known” groins from the prior site visits (I&S, 2009; Coastal Tech, 2011; and CPE 2012) and the number of “Recently Identified” groins from 2014 are shown by Reach in Figure 2. Plan view drawings depicting the locations of the groins are included in Appendix A.

Figure 2. Number of groins by Reach as of 2014.

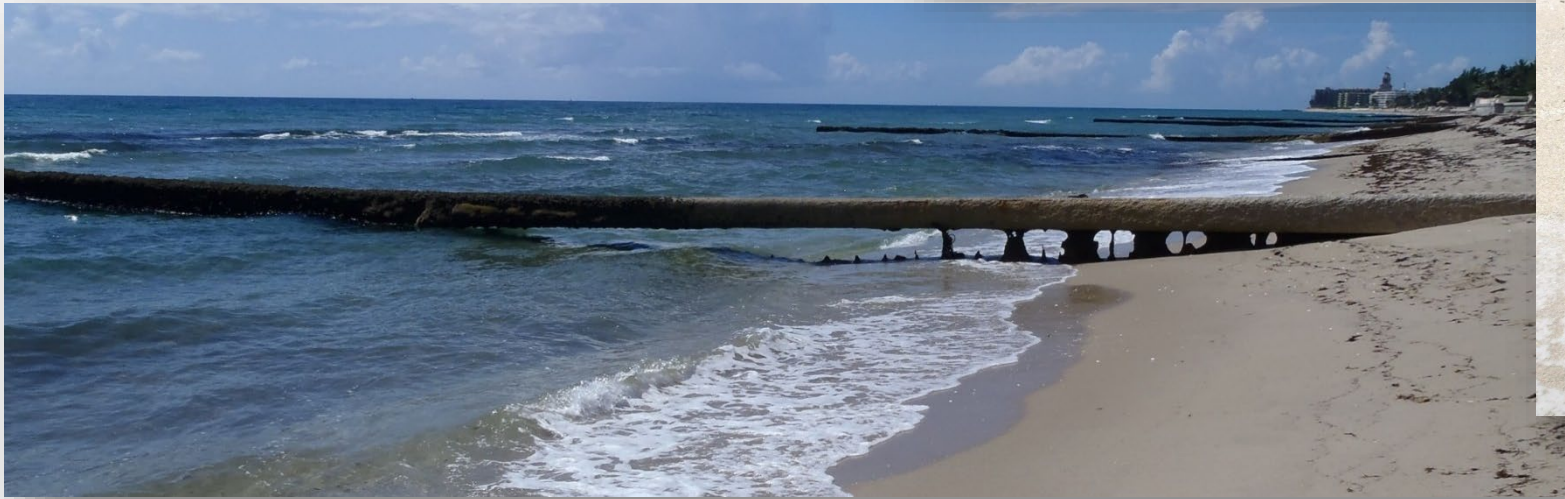
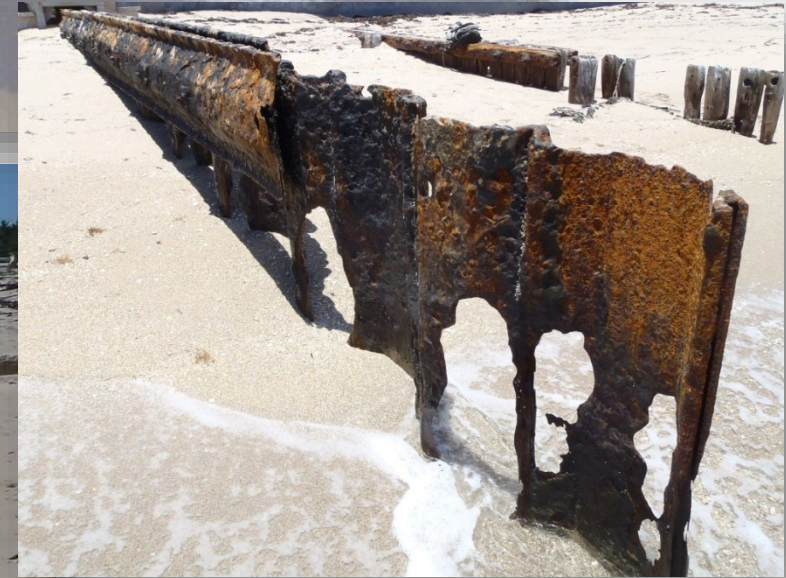
- Steel Sheet Pile
- Concrete
- Various conditions

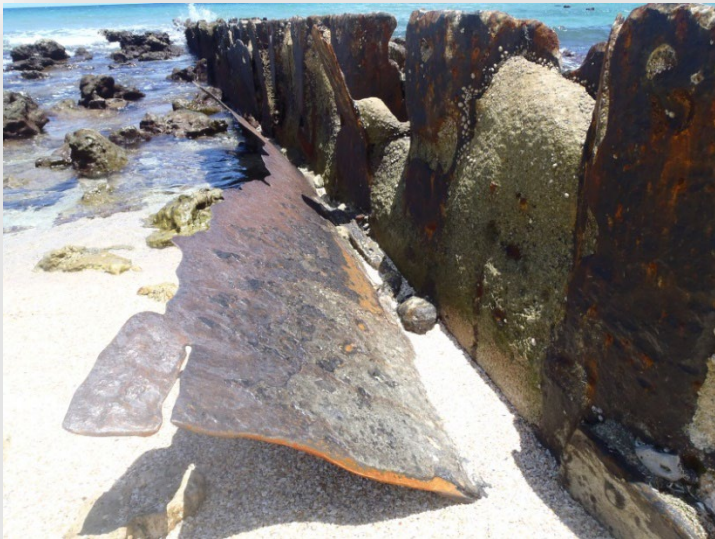
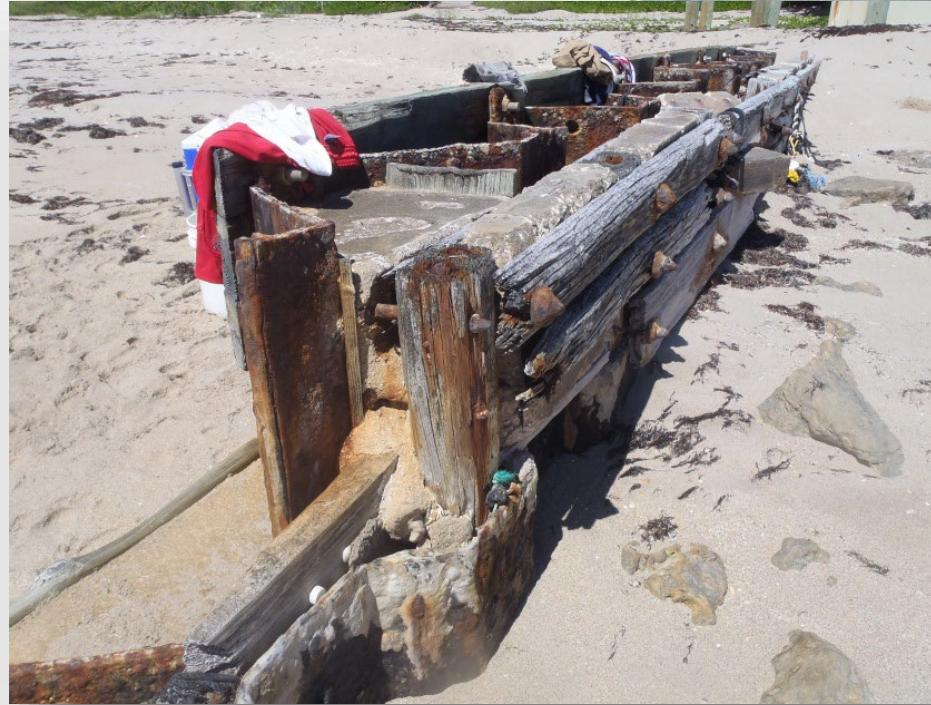
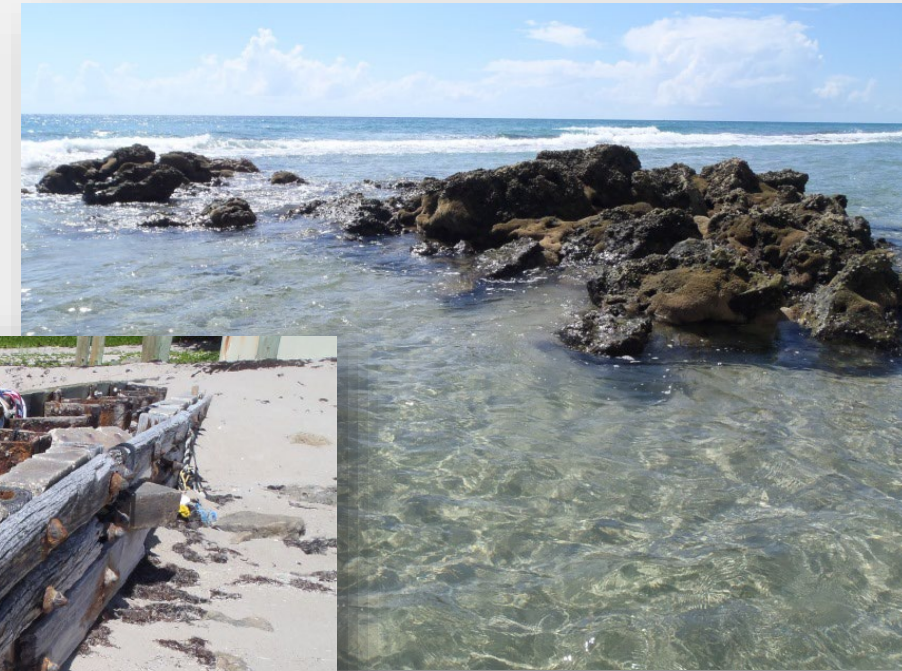
# EXISTING MATERIAL COMPOSITIONS & CONDITIONS

- Timber Piles
- Rock Rubblemound
- Mixed Construction

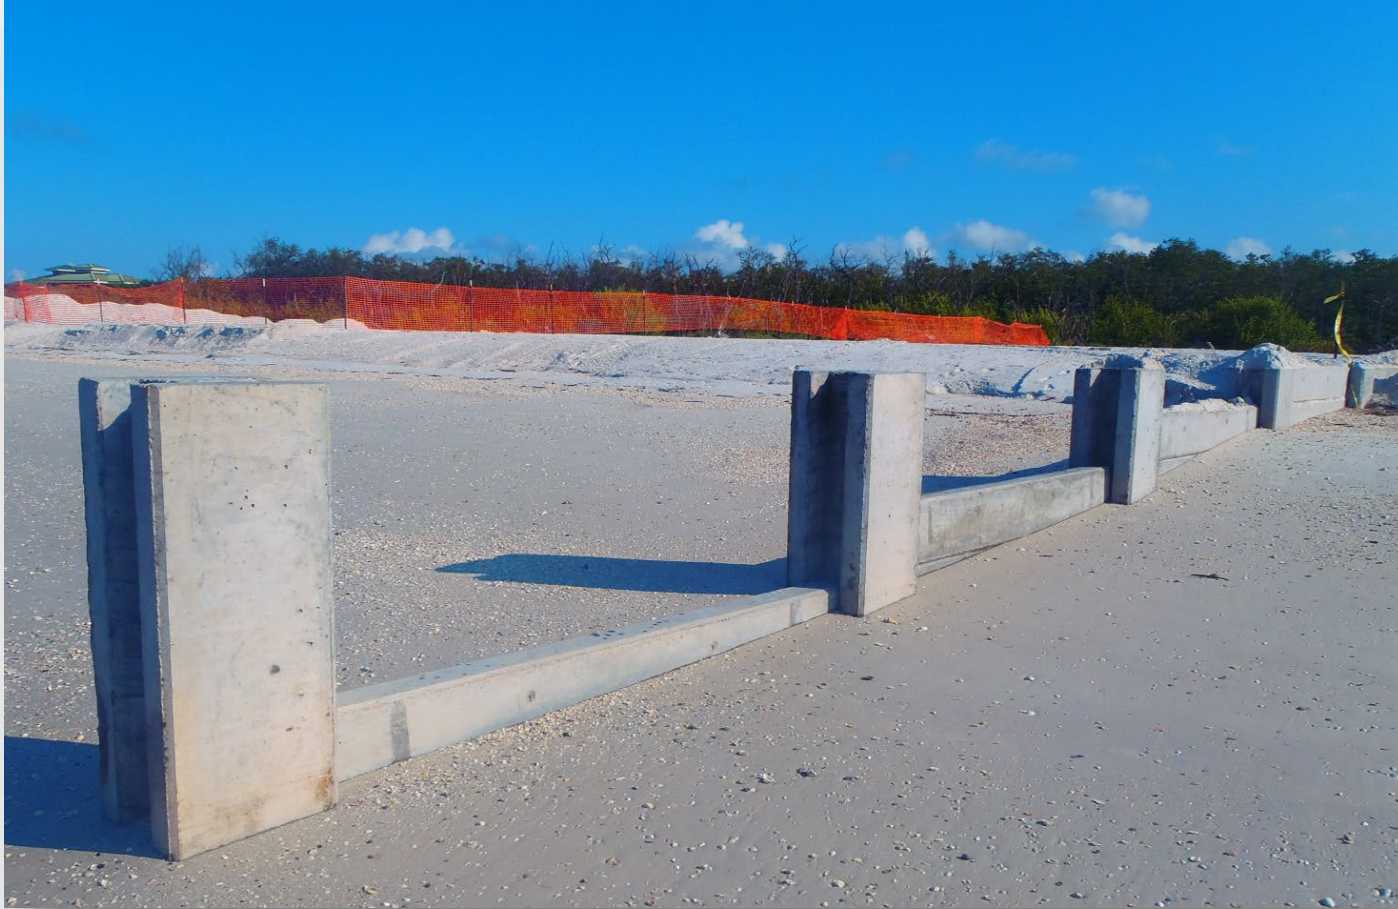
# REPLACEMENT: KING PILE AND PANEL GROIN

- Limited footprint
- Customizable lengths and adjustable
- Minimize sea turtle interactions
- Ease of construction (offsite concrete casting)
- Improve aesthetics and reduce hazards

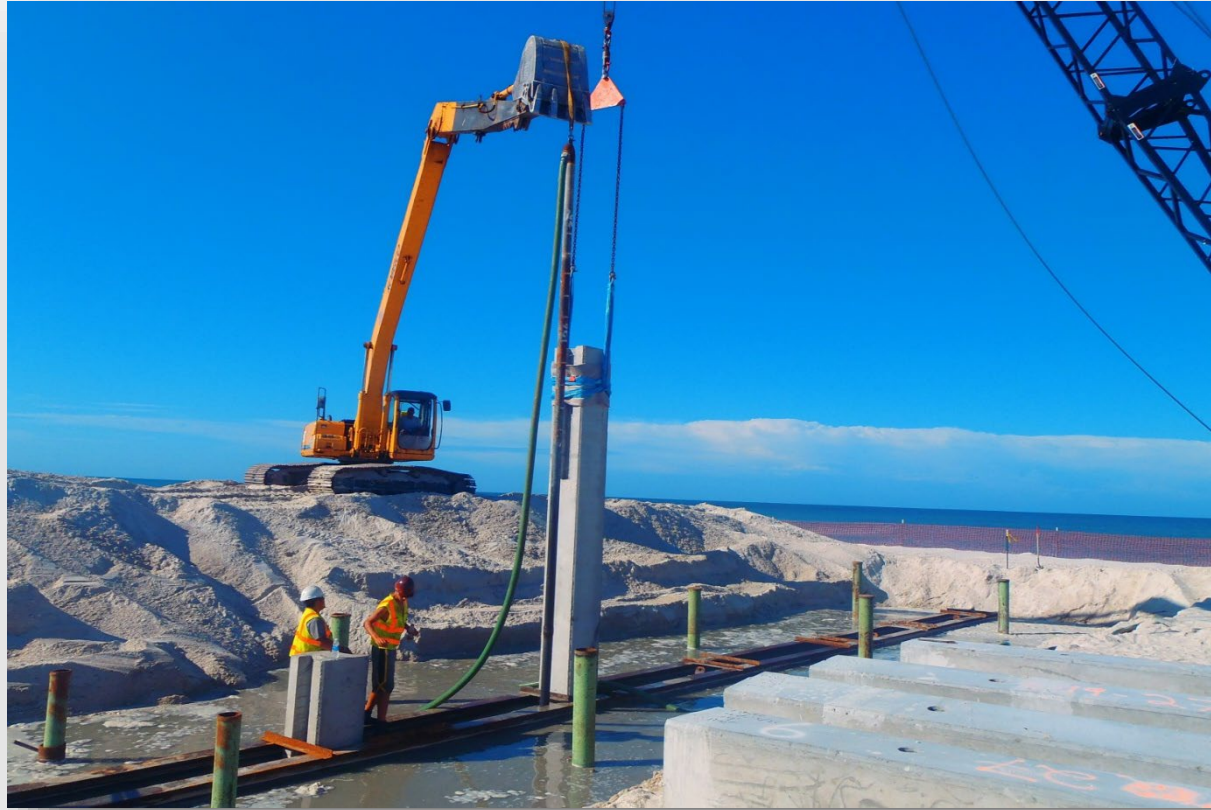
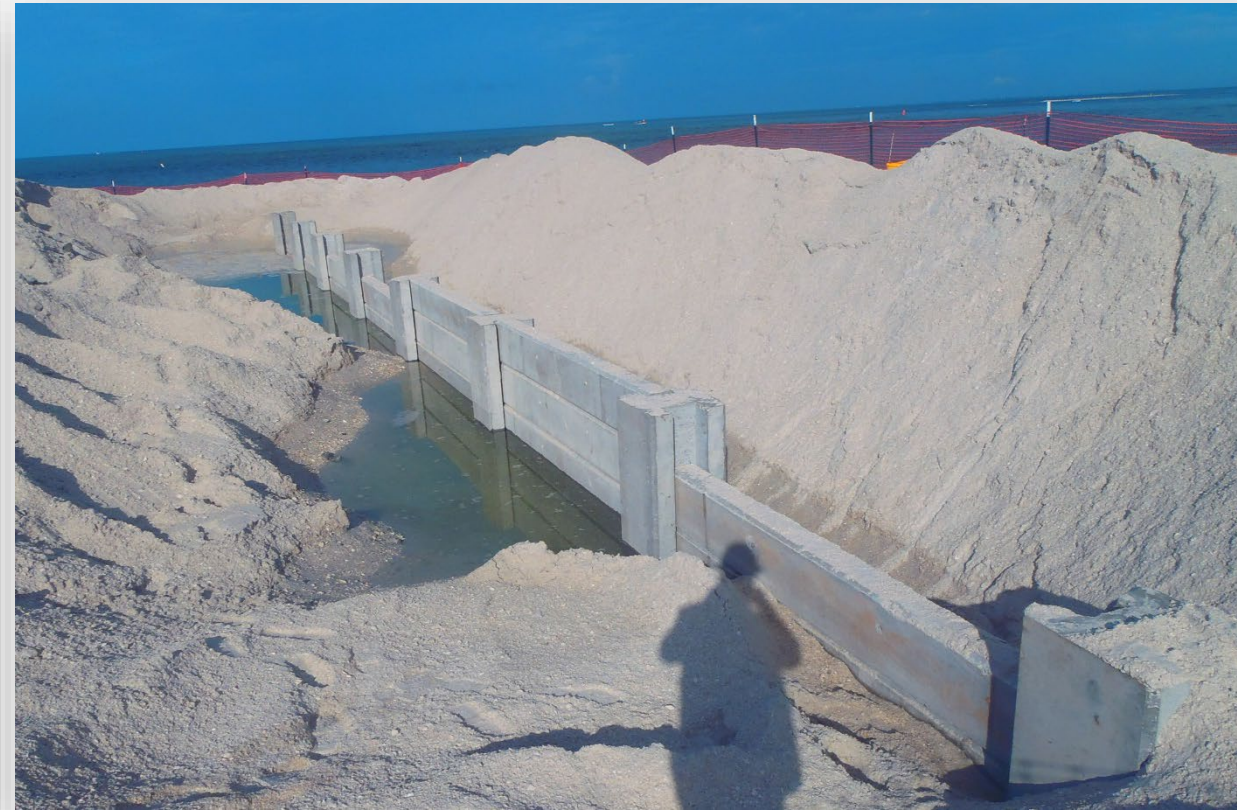
# INSTALLATION: KING PILE AND PANEL GROIN

- Pelican Landing Community Association Erosion Control Project at Big Hickory Island in Lee County, Florida (2013)
