KNOPF & ASSOCIATES, INC.

November 29, 2016

Re: 2016 Roof Condition Evaluation Report
Bid #2016-27, Town of Palm Beach, Item #16
Par 3 Cart Storage (Old Clubhouse)

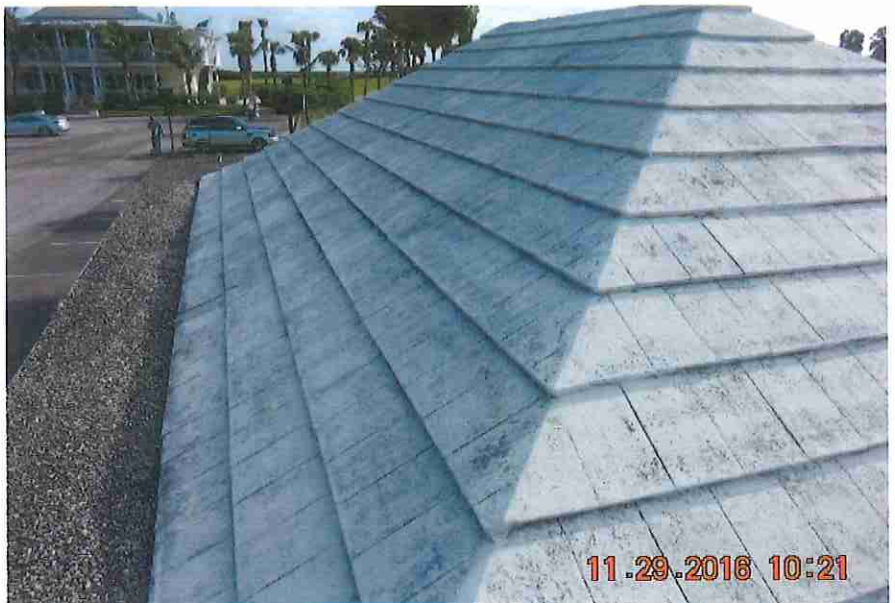
The cement tile roof is a 9" width Bermuda tile, mortar set over a #30/90 organic felt and from its appearance is the same age as the low slope roof. There are a few cracked tile, which remain in place and the white paint topping is discolored and peeling. These tile should be replaced.

#8 Overview of tile, looking
east.
