# Resilient Florida Vulnerability Assessment

Town Council Meeting May 13, 2025

#### Updated Vulnerability Assessment - Accomplishments

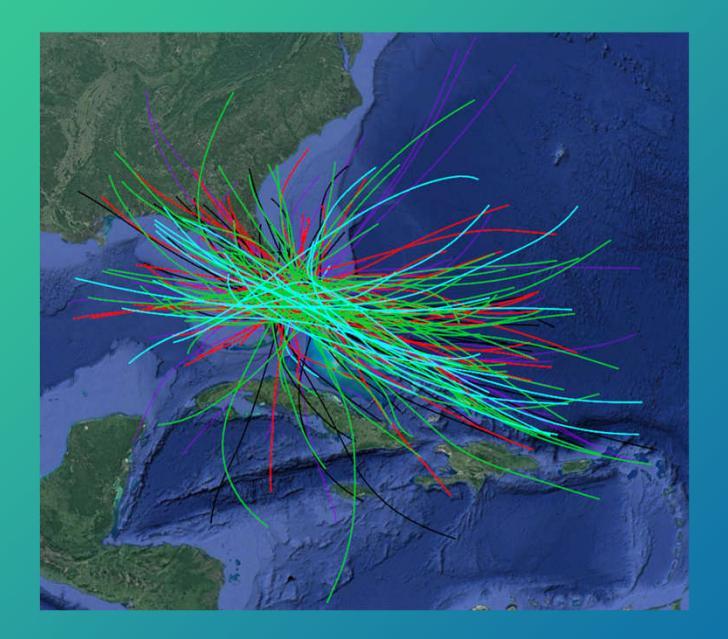
## Present Flood Probability and Depth

Probabilistic approach with hydrodynamic modeling of thousands of storm scenarios

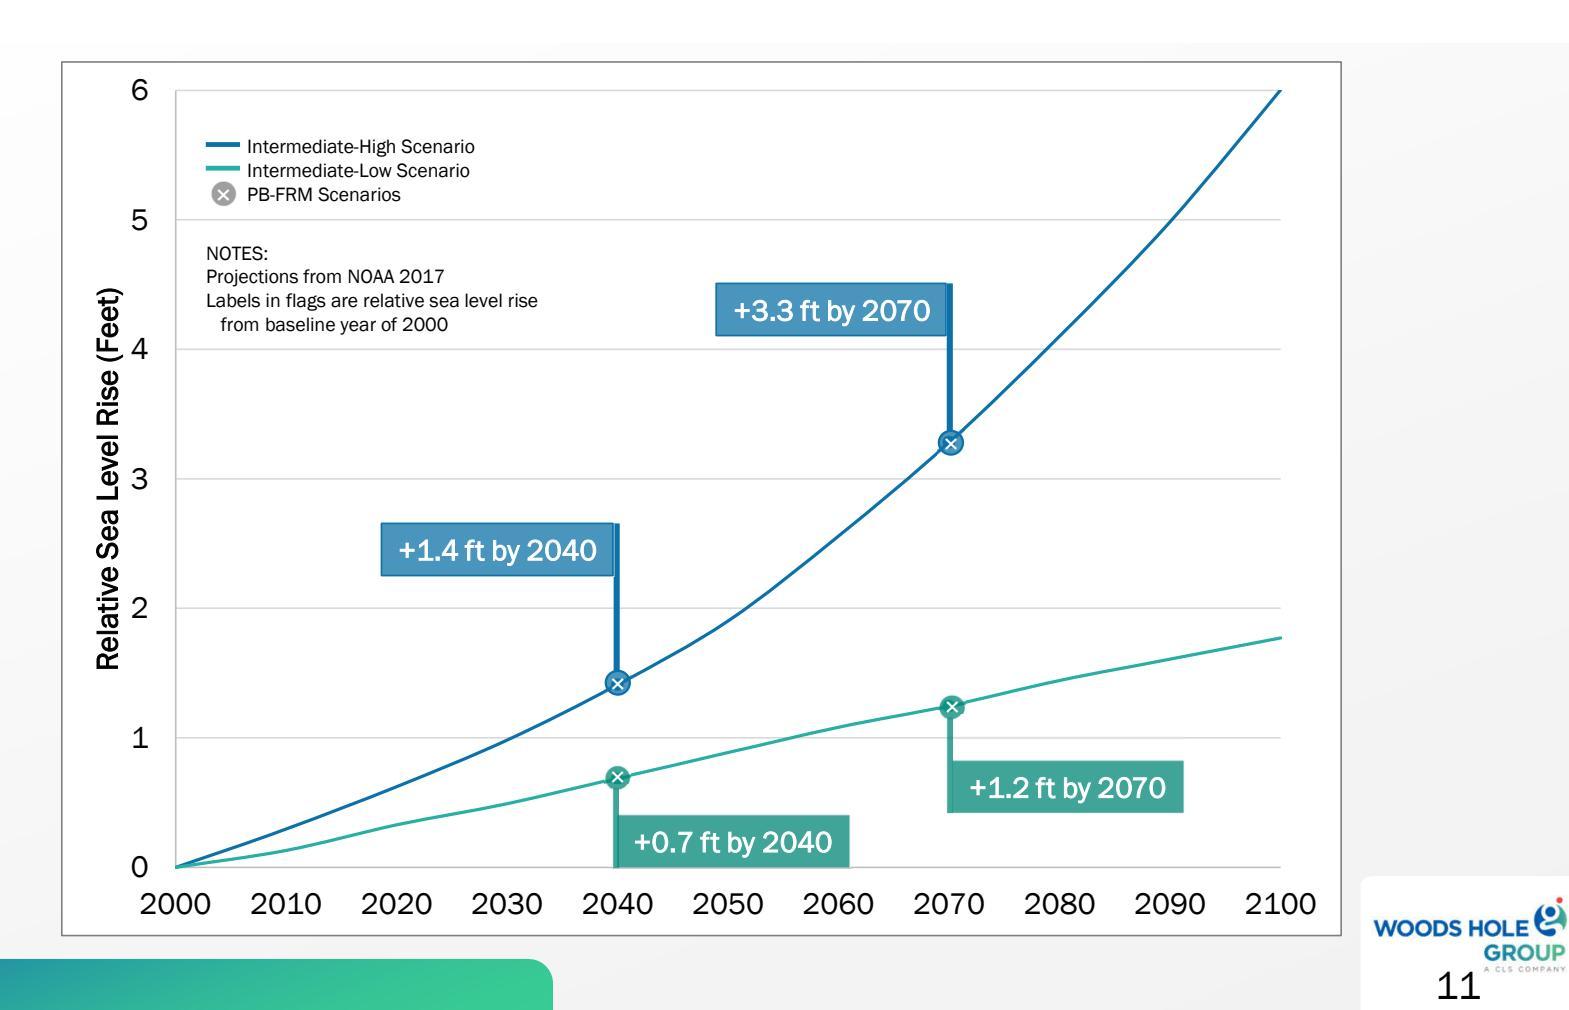
#### Updating Sea Level Rise Scenarios

Intermediate-High and Intermediate-Low for 2040 and 2070

- High tide flooding depth
- > 100-year flooding depth
- > 10-year flooding depth

\*Updated modeling does not include future storm intensification\*

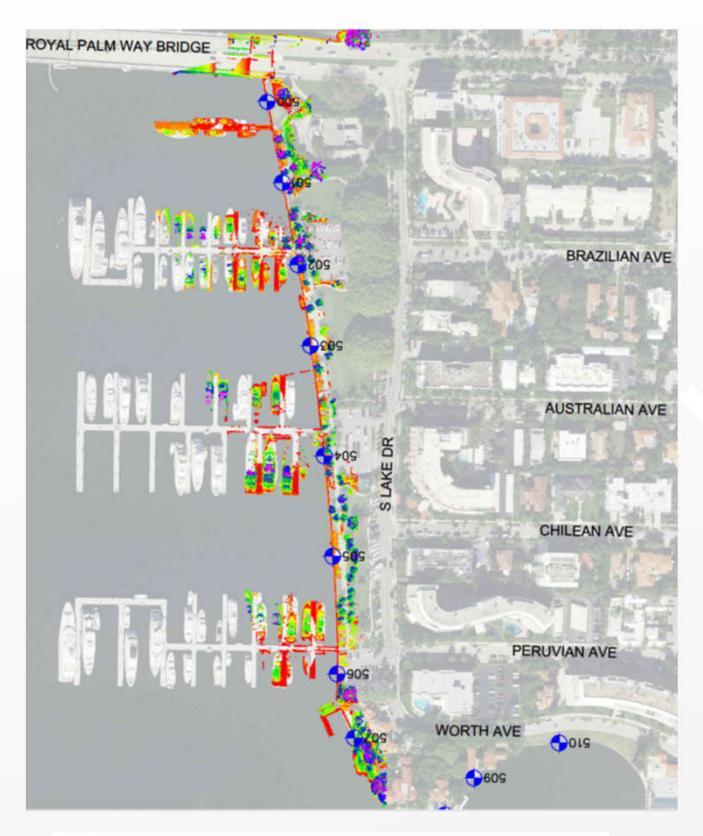
#### High-Resolution Scans & Ground Spot Elevations

- Captures narrow features not picked up by LiDAR - tops of seawalls/bulkheads
- Implements action item from Town's Coastal Resilience Implementation Plan (Level-Up)
- Useful for administering Level-Up's recommended changes to Town bulkhead standards

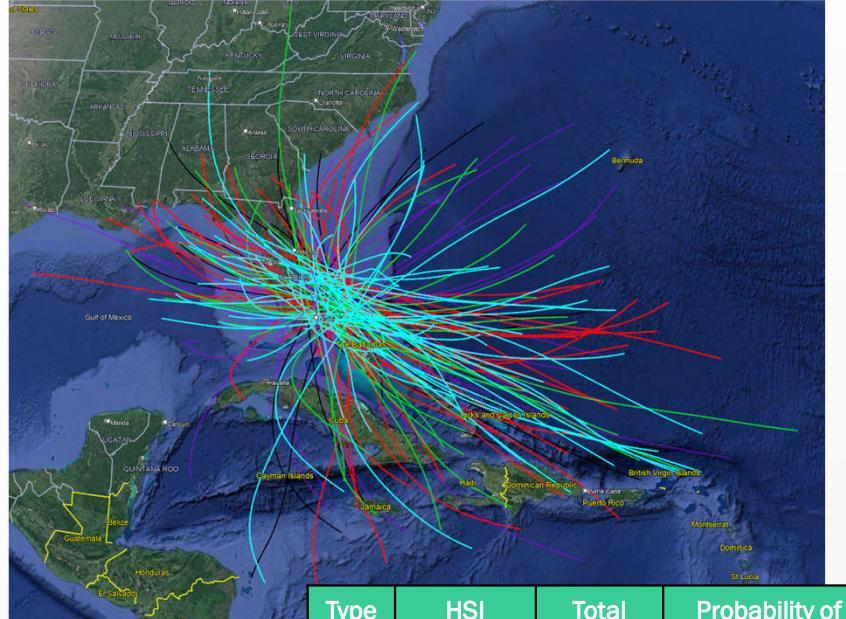
#### Storm Selection and Simulation

Туре	HSI	Total number	Probability of occurrence	Subsampled number for model simulations
1	N/A	2,607	51.7%	0
2	≤2	2,142	42.5%	197
3	2 - 4	227	4.5%	64
4	≥4	64	1.3%	64
Total	N/A	5,040	100.0%	325

1. Reviewed a total 5,040 storms.

2. Identified 2,433 storms impacting Town of Palm Beach.

3. Further categorized by strength using the Hurricane Surge Index (HSI).

4. A subset of 325 storms from various HSI categories selected for model simulations.

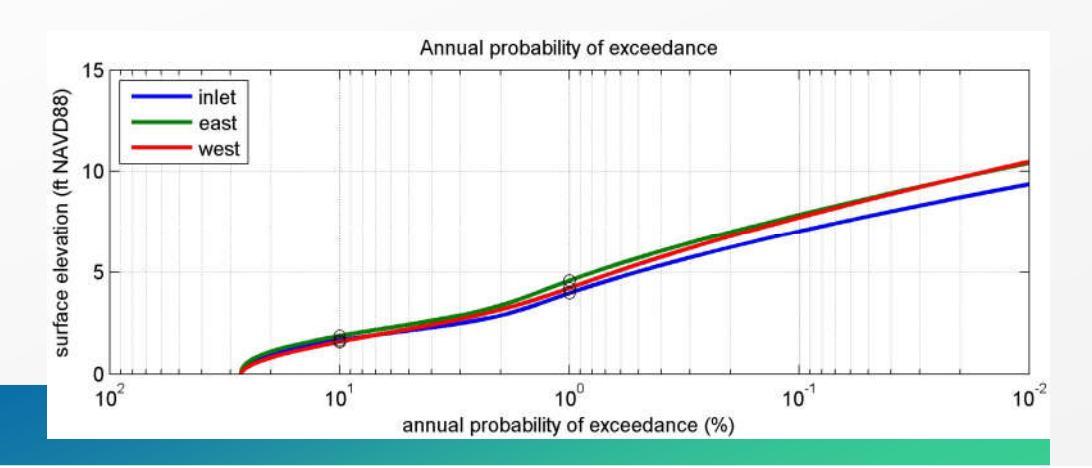
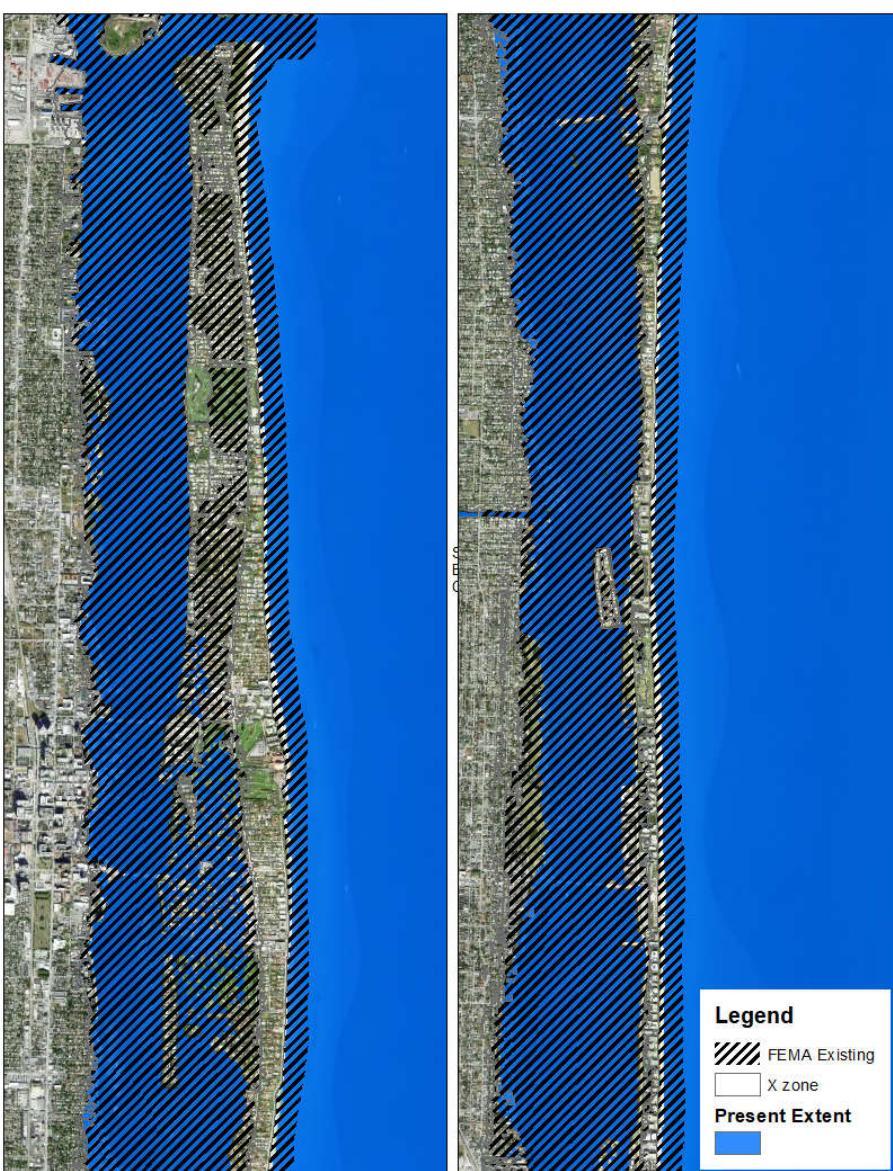
# 1% Extent vs Effective FEMA Special Flood Hazard Area (SFHA)

Our updated statistical analysis of 100-year stillwater elevations was lower than FEMA (at the inlet, Atlantic Ocean and Lake Worth shorelines):

- Up to ~1.8 ft lower along Lake Worth
- Up to ~2.9 ft lower on the Atlantic Ocean

Stillwate	r elevations 1	t NAVD88
	Lake Worth	Atlantic Ocean
FEMA	5.4-5.8	7.2-7.4*
PB-FRM	4.2 (~4-4.5)	4.6 (~4.5-5.5)

\*Includes 2 ft of wave setup

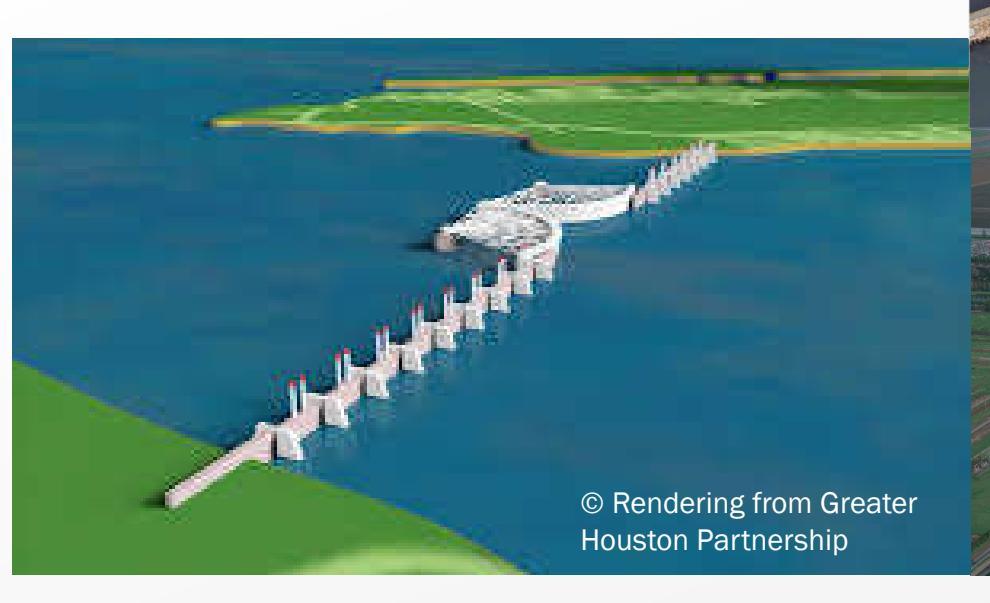
### Implementation and First Alternative-Surge Barrier

Expanded high-resolution model north up Indian River towards Saint Lucie River.

Improves model for evaluating storm surge barrier concept at Palm Beach Inlet.

Even with the Palm Beach Inlet surge barrier closed, storm surge could still enter Jupiter Inlet.

The first alternative connects high elevation points across the inlet, increased to 11 ft to fully block a 100-year event in the 2070 intermediate high SLR.

#### **Existing Conditions Surge Barrier** Existing Elevation: (NAVD88, ft) Surge Barrier Elevation AVD88, ft) 12.0 12.0 10.25 10.25 8.5 8.5 6.75 6.75 5.0 5.0 3.25 3.25 - 1.5 1.5 -0.25 -0.28 -2.0 .2.0 WOODS HOLE

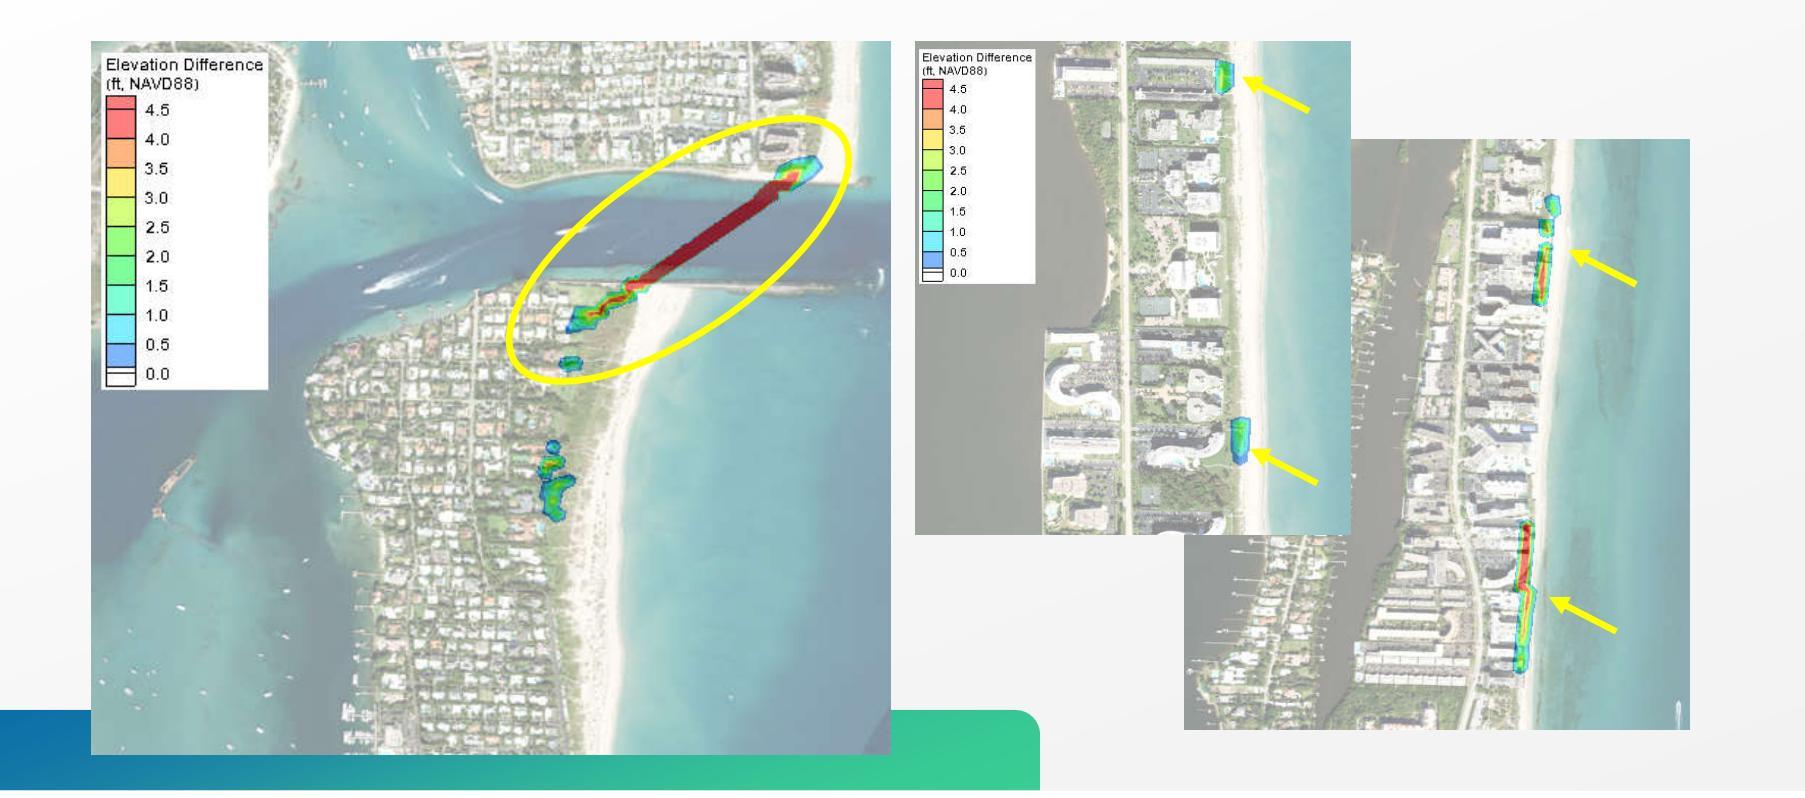
## Second Alternative - Surge Barrier and Continuous Coastal Bank

Limited colored areas show elevation applied to form a continuous bank along the Atlantic Ocean Shoreline. Emphasizes the benefits of natural limestone ridge and <u>highlights effectiveness of the Coastal Program</u>.

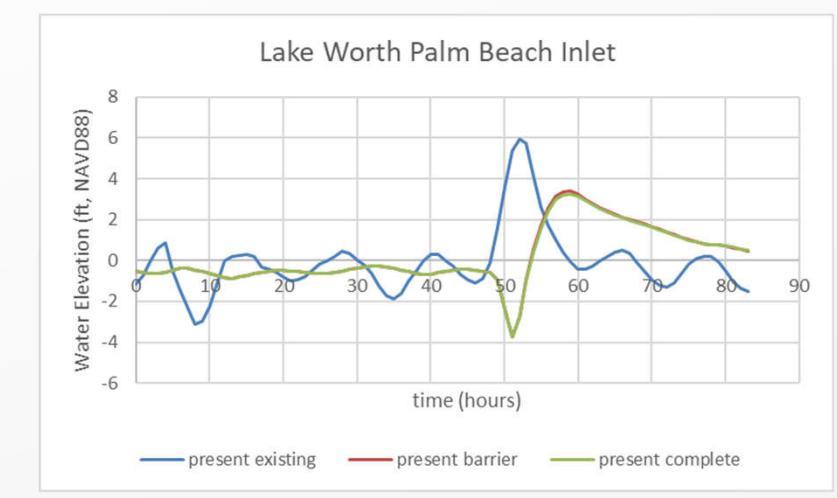
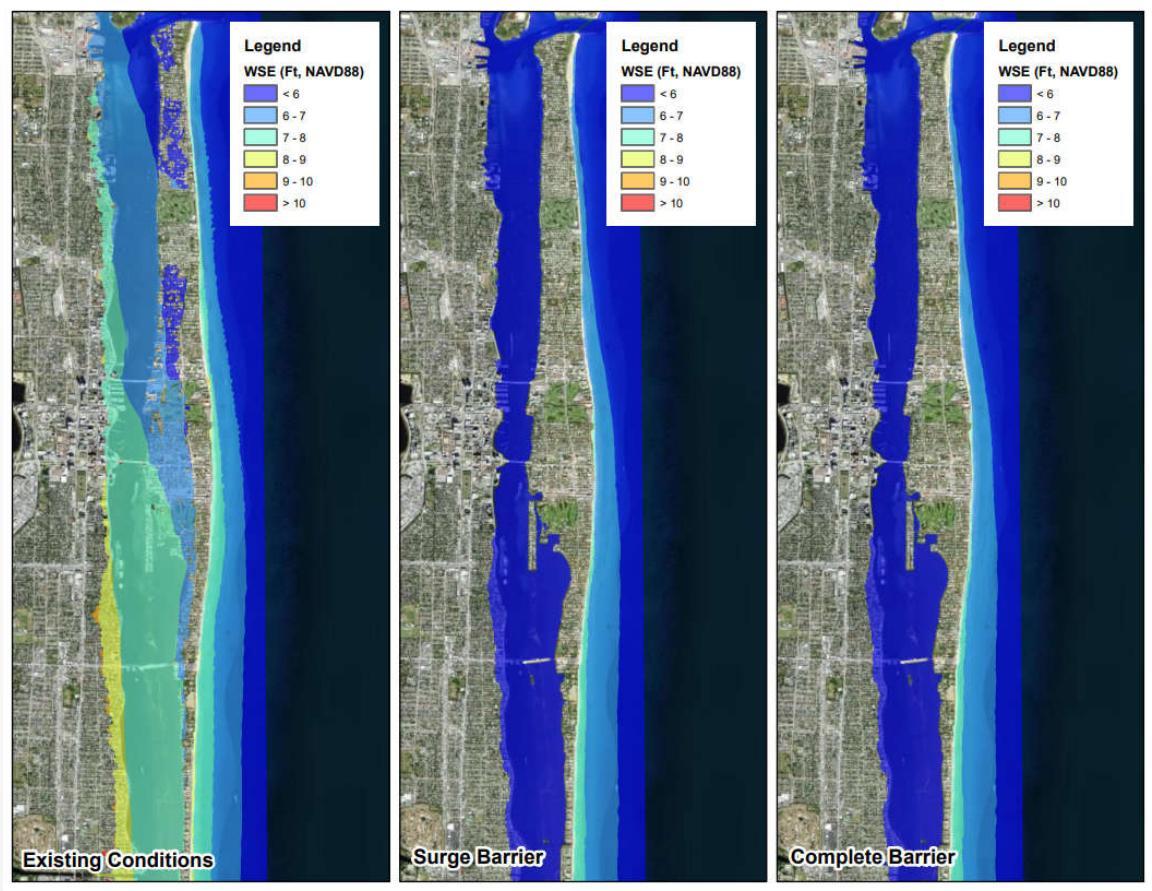
#### **Present Day Surge Barrier Results**

The elevation was reduced by a substantial amount inside Lake worth with the Surge Barrier.

There was an additional reduction of approximately 0.2 ft from the complete barrier.

Present Day Reduction (ft)									
	Palm Beach Inlet	Worth Ave	Ibis Island							
Surge Barrier	2.5	4.3		3.7						
Complete Barrier	2.7	4.5		4.0

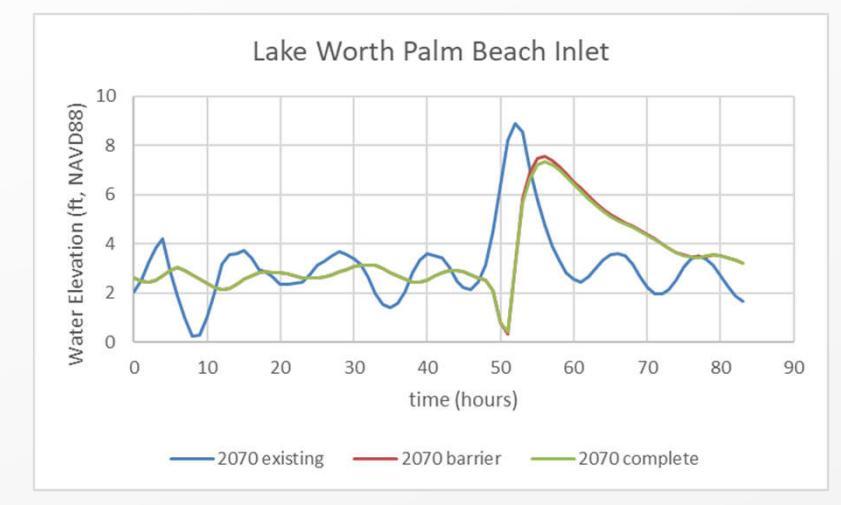
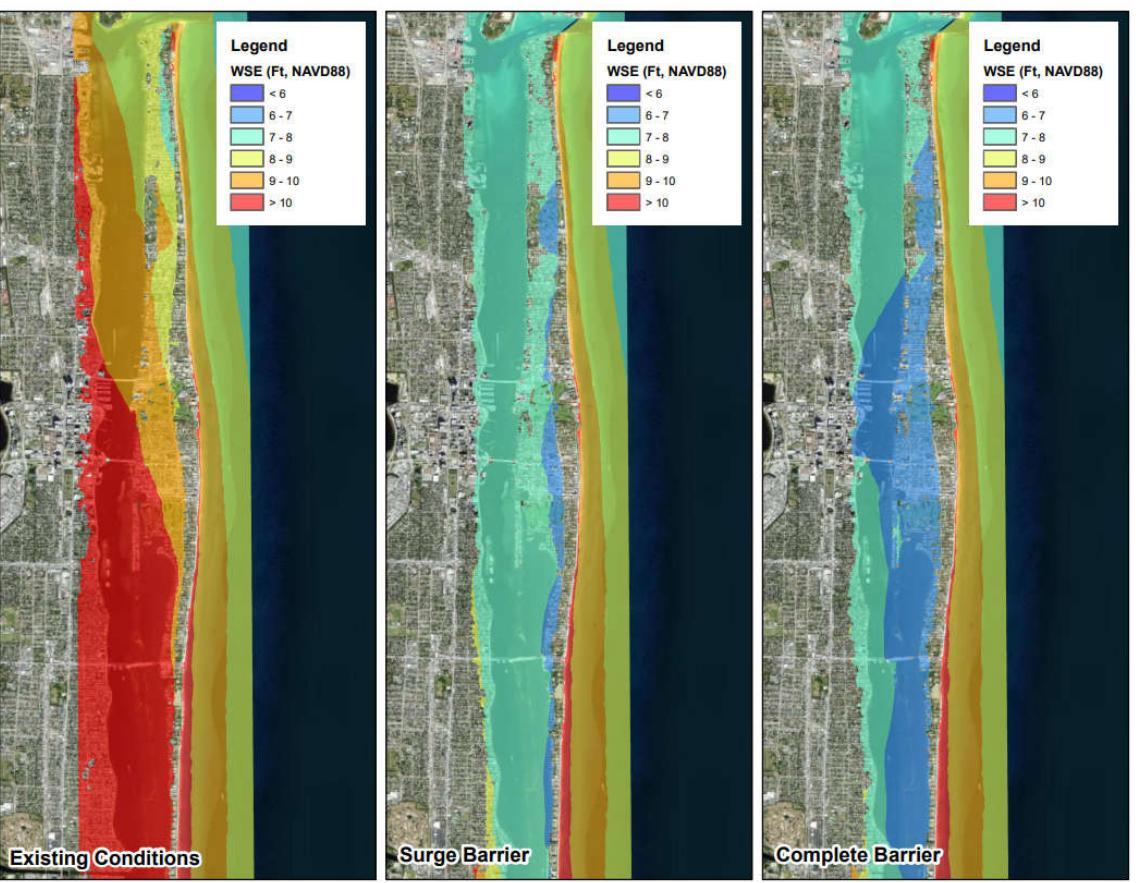
#### 2070 Intermediate High Surge Barrier Results

In the 2070 Intermediate High climate condition, the surge barrier was less effective due to the already increased sea level. This reduction could still be helpful.

2070 Int High Reduction (ft)									
	Palm Beach Inlet	Worth Ave	Ibis Island							
Surge Barrier	1.4	3.2		3.1						
Complete Barrier	1.6	3.6		3.6

- o Results indicate potential for surge barrier to reduce peak flooding
- Deliverable will be included with Final Vulnerability Assessment to satisfy FDEP scope
- Solution is beyond the responsibility of Palm Beach alone
- Town consider whether to pursue further work (e.g., request US Army Corps study, engage other communities)
- Alternative is substantial action on Lake side via Level-Up recommendations
