# Town of Palm Beach

## Master Plan for the Town Docks and Accessory Structures

## Executive Summary

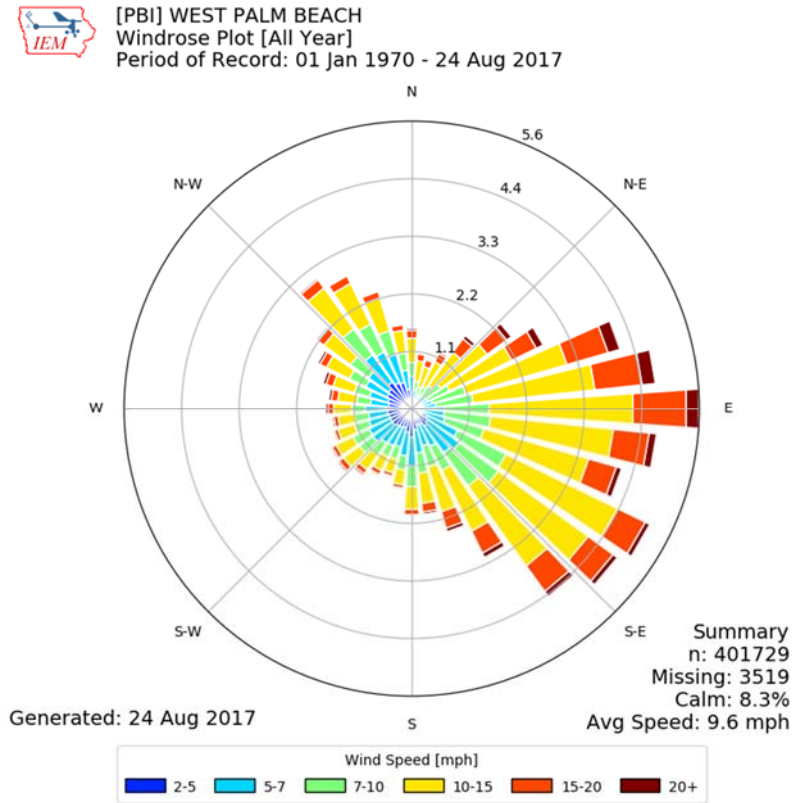
**Figure 3.2: Wind Rose for West Palm Beach Airport (ISU, 2017)**

Hurricane force wind speeds, water level, and expected vessel size are used to develop design criteria for the dock elements. However, average wind conditions are also important elements for determining potential wave conditions.

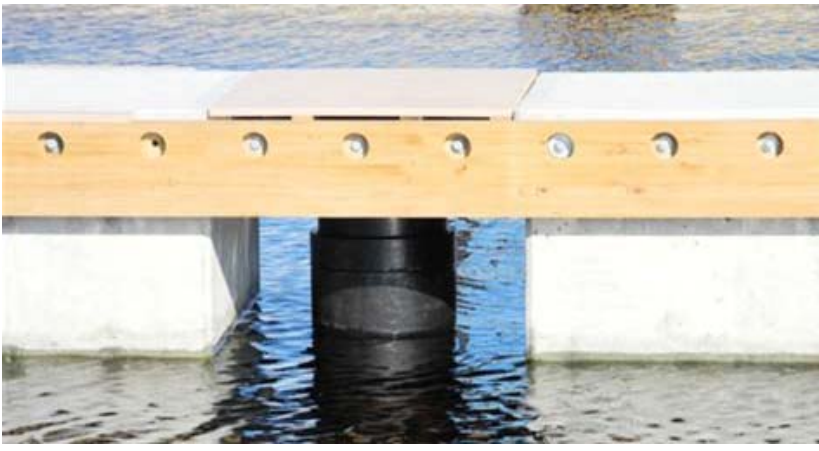
Figure 4.1: Dock with a Telescoping Pile (Bellingham)

Telescoping piles consist of two steel pilings. The outer piling is driven into the bed rock and acts as a sleeve for the inner piling, which is fitted in a socket affixed to the dock structure (Figure 4.1). There are several benefits to this system including greater deck space, avoiding any mooring impediments, and improved aesthetics.

Telescoping piles can be more expensive than protruding pile designs but should be considered during the engineering and design phase. They could be bid as an alternative if price is a significant concern.

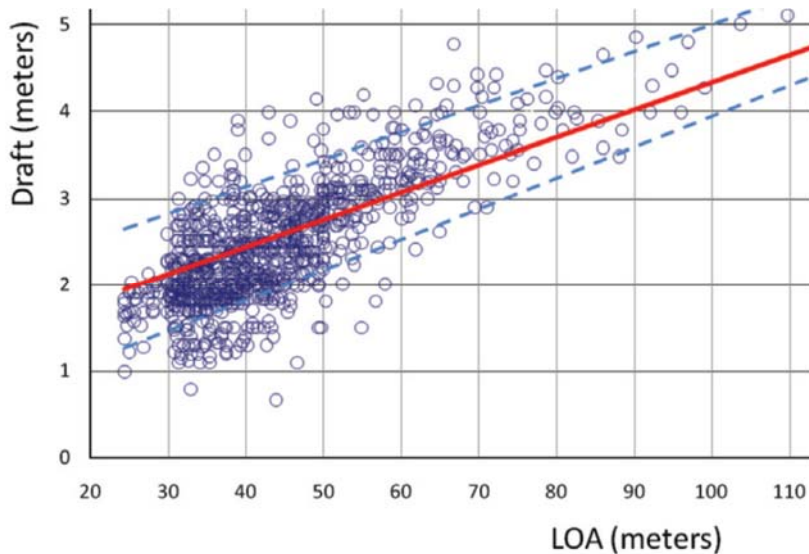
Figure 4.2: PIANC Guidance on Vessel Length vs Draft

Given a 50-year planning horizon, it is recommended that the Town position themselves for potential future dredging of the ICW and use -14.7 feet MLLW as a limiting depth. Deeper dredging at this time may minimize the need for future maintenance dredging, and be more cost effective in the long term. While a dredge depth of -14.7 feet MLLW could accommodate a 340-foot long vessel, this size is not keeping with the vision of the Town Docks; therefore, it is recommended that the Town Docks have slips designed for vessels up to approximately 230 feet in length.

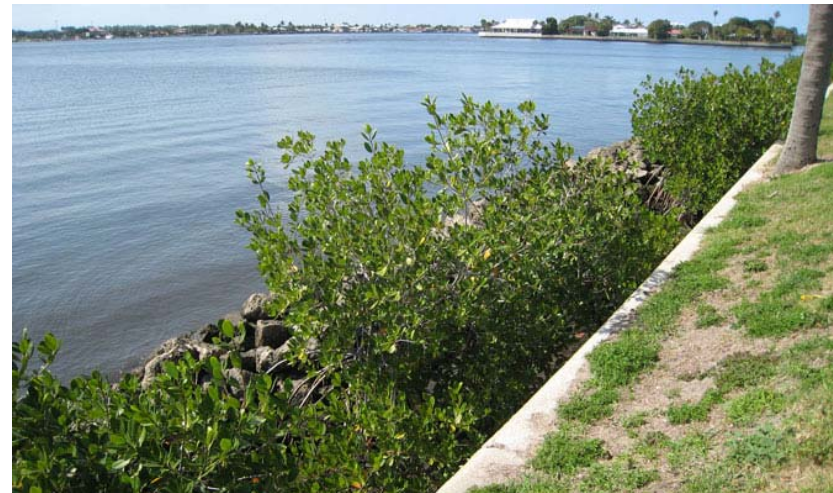
A living shoreline (sloped boulder face planted with mangroves) constructed along the face of the bulkhead could help reduce wave reflection compared to the current smooth vertical bulkhead. The Town constructed a 2,000-foot mangrove planter adjacent to the Par 3 Golf Course, which was highly successful, and this concept could be applied (Figure 4.4).

**Figure 4.4: Living Shoreline at the Par 3 Golf Course (PBC, 2018)**

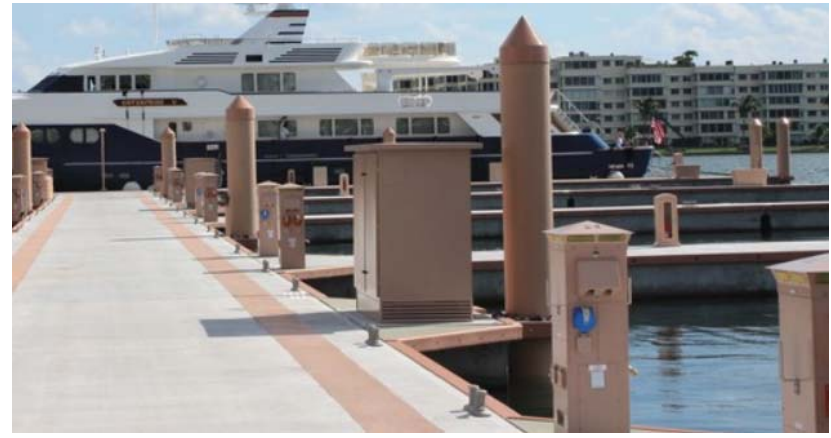
**Figure 6.1: Typical Pedestal for Electrical, Water and Internet/Phone connection (Palm Harbor)**

Figure 6.1 shows a typical pedestal that vessels can hook up to that includes electrical, water, and communication connections.

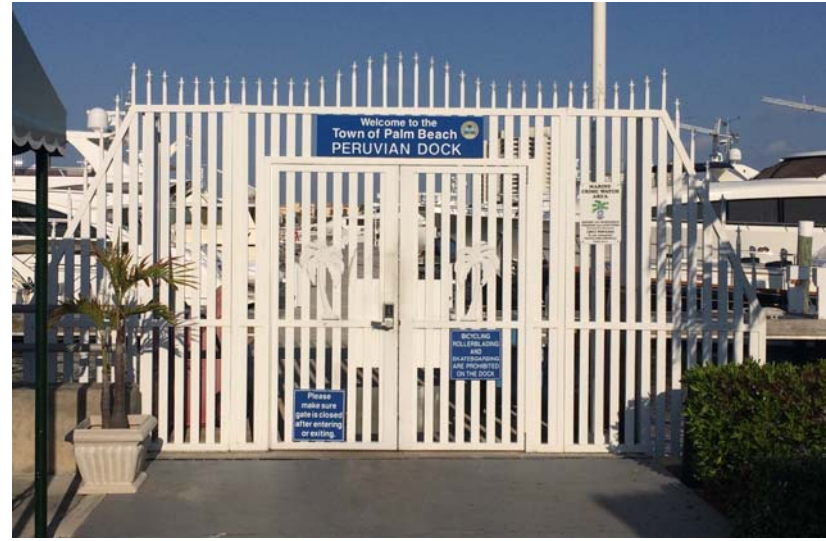
**Figure 6.2: Gate and Keypad at Peruvian Dock**

Currently, each dock has a gate with an entry keypad (Figure 6.2) to limit public access to the docks. There are security cameras throughout the facility that dock staff can watch in real time as well as review footage. Security guards patrol the area when dock staff are off duty, and Town Police watch the area as part of their regular patrols.

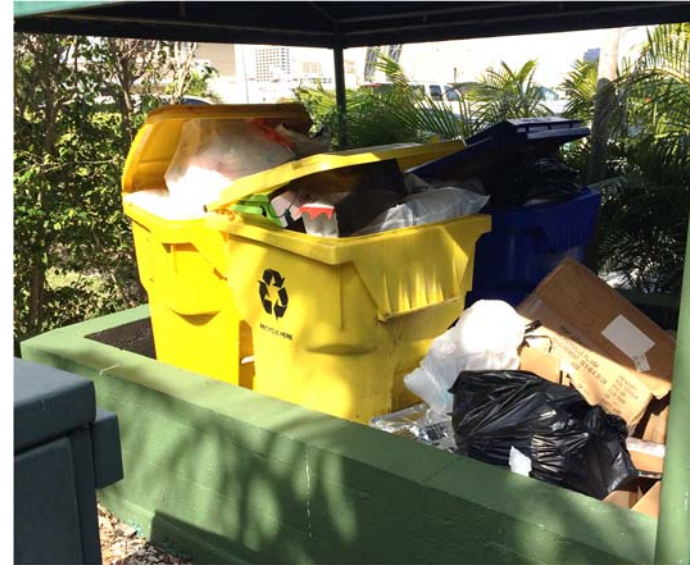
**Figure 6.3: Trash at Australian Dock Collection Area**

Trash and recycling bins are located within the parking lot at each dock. However, the volume of trash has increased due to an increasing trend towards on-line shopping and associated packaging (Figure 6.3). Feedback from the public and dock patrons is that the trash collection areas are often unsightly. One option is to relocate all trash collection to the Department of Public Works (DPW) area and install a trash compactor to minimize the trash volume. Additional dock staff is recommended to facilitate daily collection and transport of trash to the DPW. This will improve aesthetics and allow existing trash collection areas to be converted to additional parking.

*Relocate trash and oil collection to DPW.*

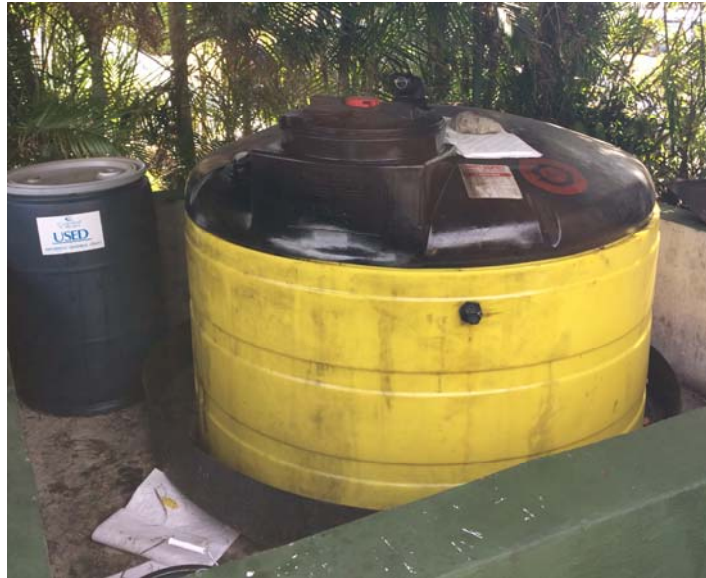
Figure 6.4: Oil collection area

The Town Docks currently provide an oil disposal service (Figure 6.4). This is a typical service provided at up-scale marina facilities, and it is recommended that the Town Docks continue to provide this service. However, rather than have the unsightly container at the Australian parking lot, one option is to relocate the oil collection area to the DPW. An additional staff member may be required to collect and transport the oil to the facility. This will improve aesthetics of the Australian Dock parking area. This area could be converted to additional parking.

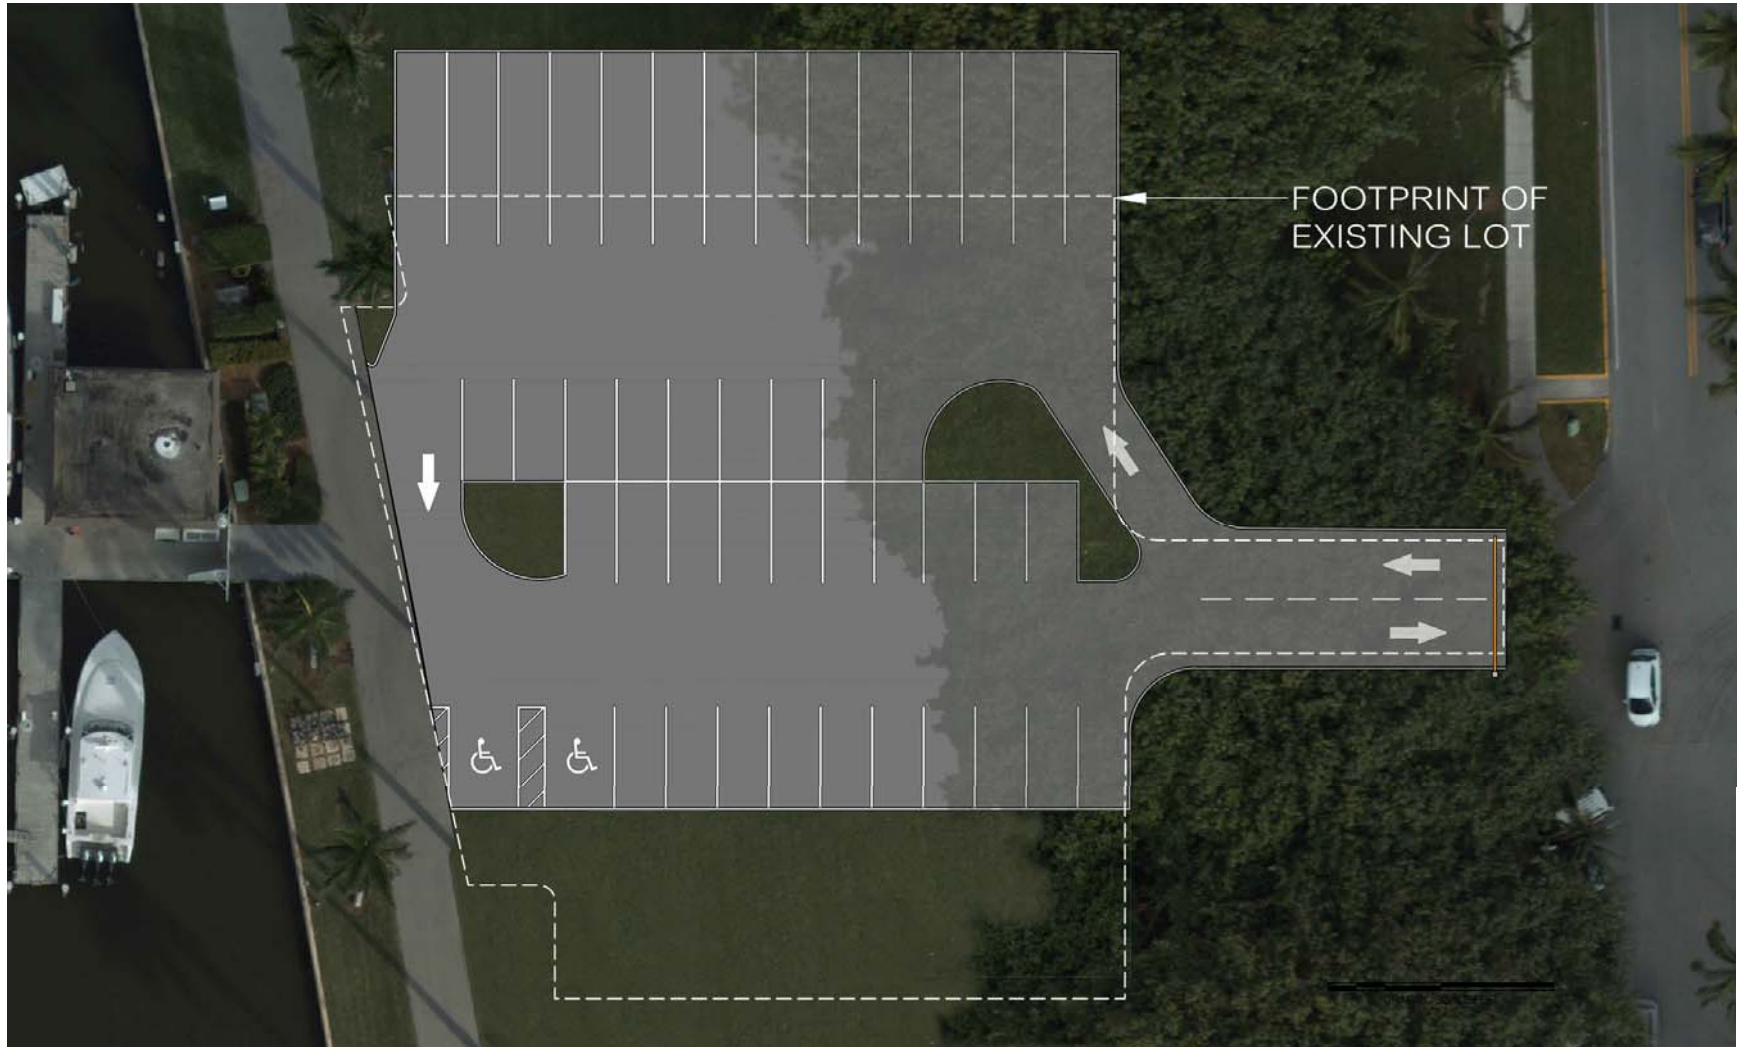
Figure 7.1: Proposed Revision to Brazilian Dock Parking Lot

- Brazilian Dock – increase by 15 to 59 spots (Figure 7.1)
- Australian Dock – increase by 4 to 59 spots (Figure 7.2)
- Peruvian Dock – unchanged at 32 spots

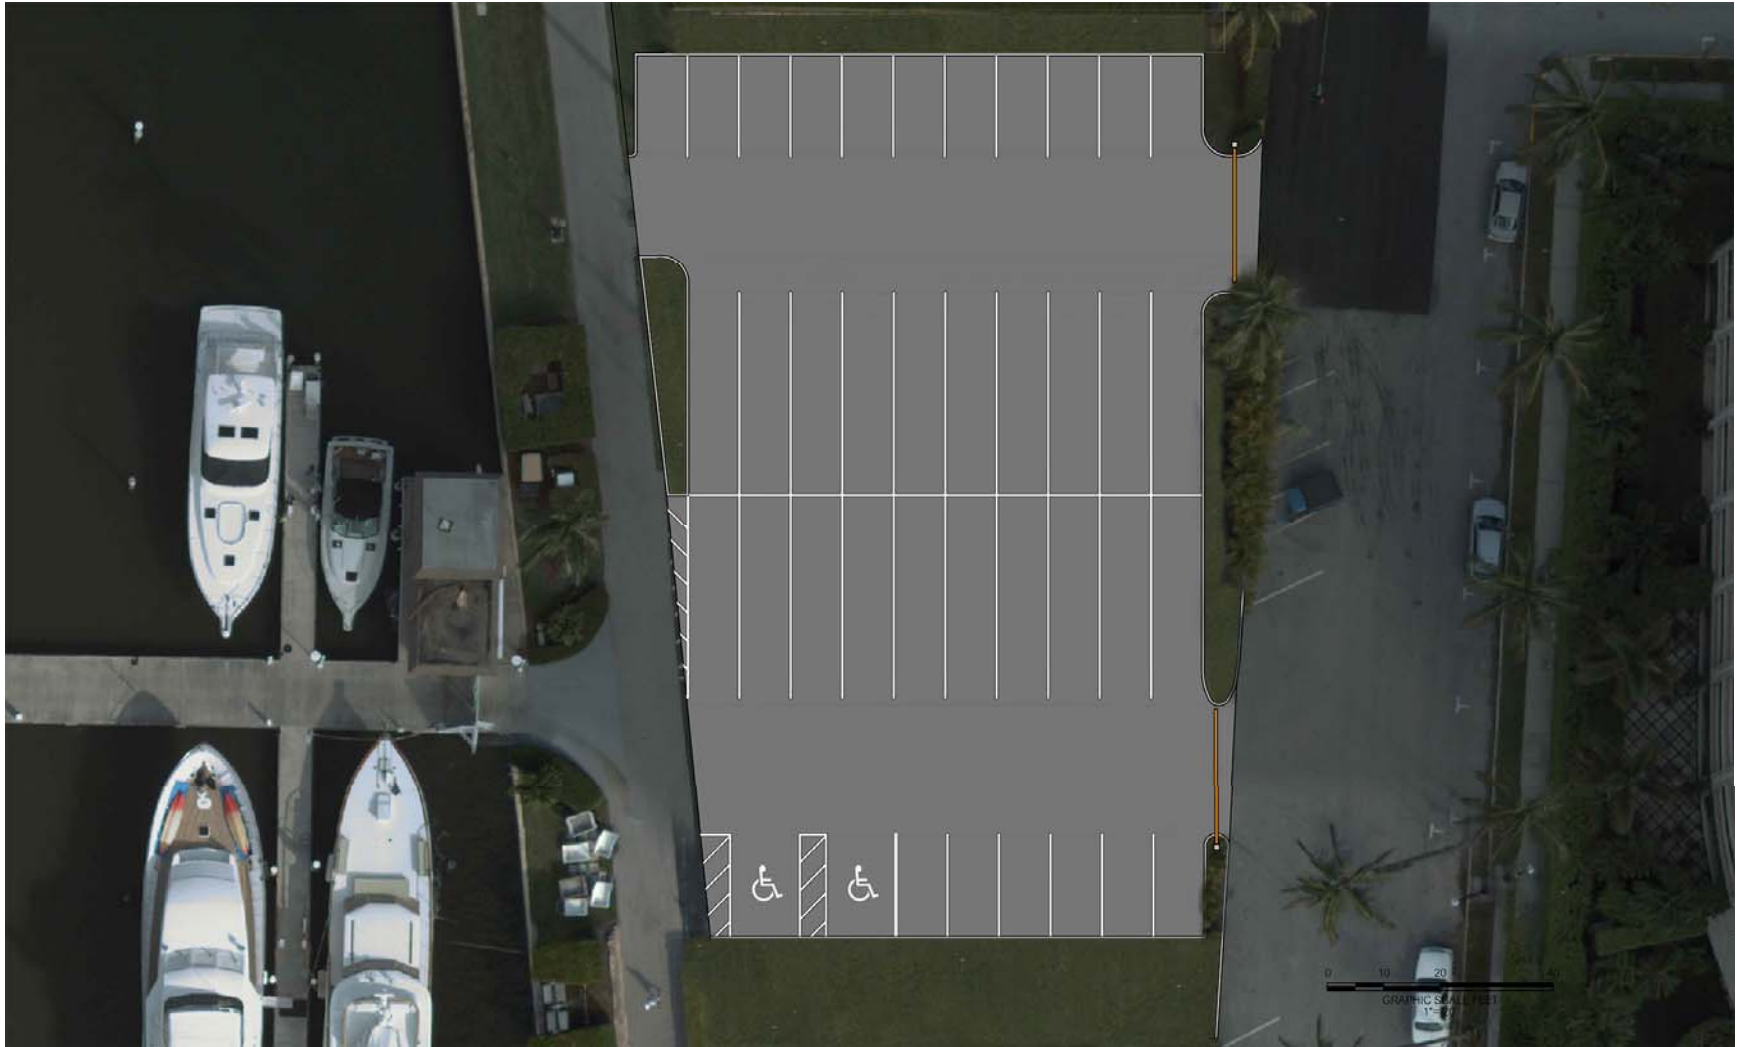
Figure 7.2: Proposed Revision to Australian Dock Parking Lot

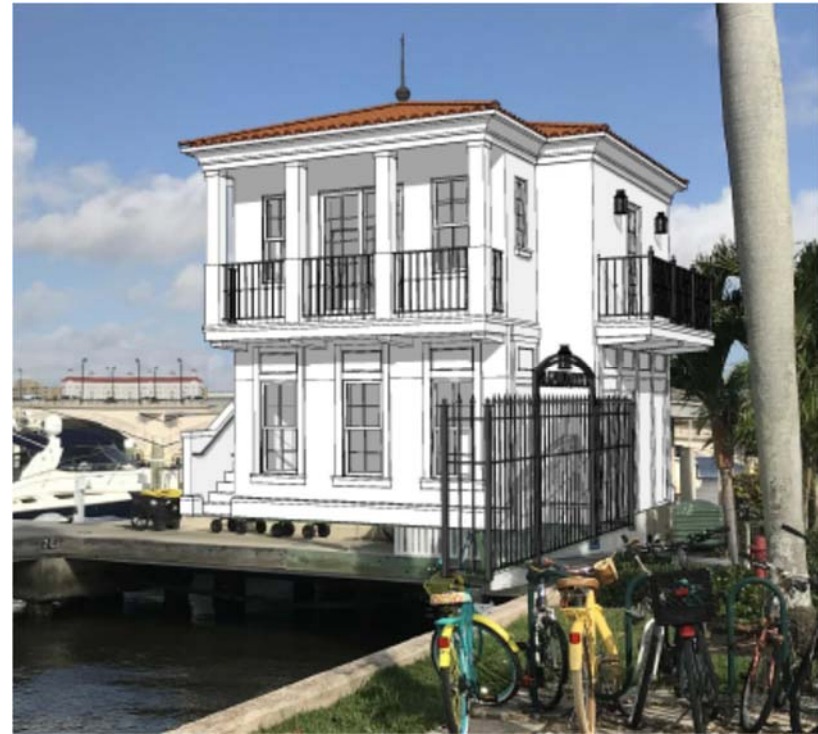
This is the largest building of the three, and it is proposed to demolish the existing structure and replace it with a two-story building within the same slab footprint (Figure 8.1). This provides the best option to increase the available space while not increasing the building footprint and minimizing sight-line obstruction because it is behind the large banyan of trees. The Dockmaster and staff offices would be relocated to this building allowing for a larger reception area.

**Figure 8.1: Architectural Rendering of the Proposed Brazilian Dock Building**

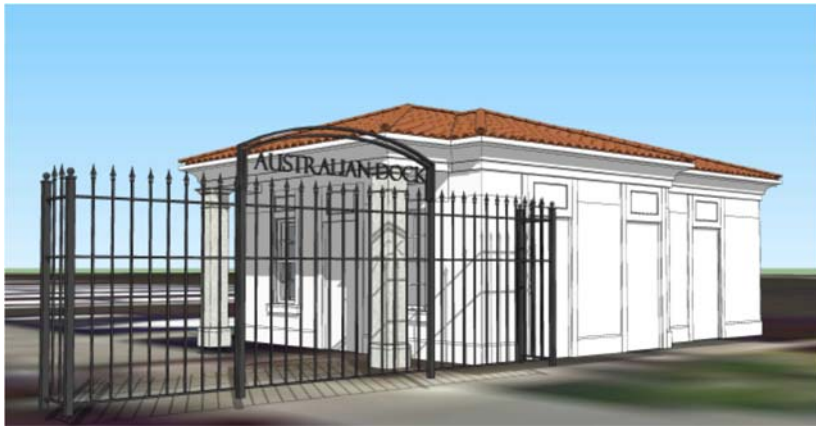
It is proposed to demolish this building and replace it with a single-story building within the 640 sf existing footprint (Figure 8.2). It will have two restrooms (with one shower), an electrical room, and a storage area.

**Figure 8.2: Architectural Rendering of the Proposed Australian Dock Building**

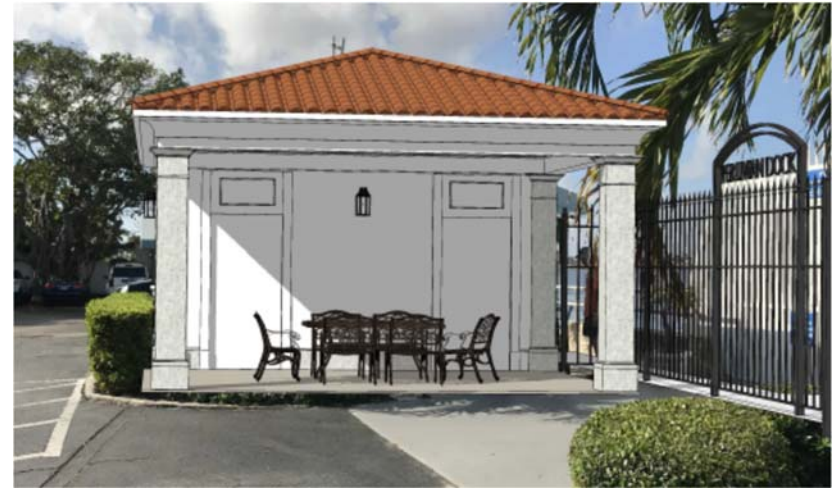
**Figure 8.3: Architectural Rendering of the Proposed Peruvian Dock Building**

It is proposed to maintain the electrical room and convert the storage room into a restroom within the same building footprint. The covered but outdoor seating area outside the building will remain, but rather than a metal framed awning, converted to a fixed roof cover with two pillars.

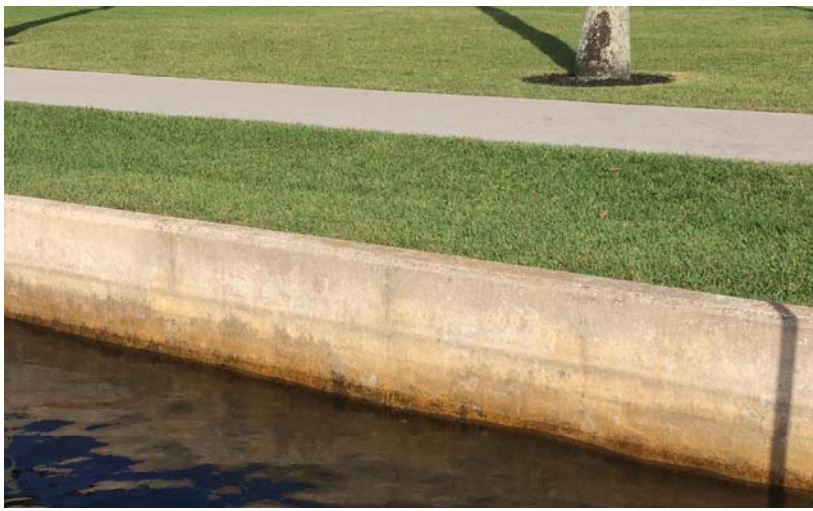
The bulkhead is comprised of steel sheet pile, with a vertical concrete face and 11-inch wide concrete cap. The cap elevation is approximately 5.5 feet MLLW. Scour at the base of the seaward side of the bulkhead has exposed the sheet pile.

**Figure 8.4: Bulkhead Fronting the Town Docks**

It is recommended that the bulkhead be replaced by constructing a steel sheet pile bulkhead less than one foot in front of the existing bulkhead. A concrete cap will be placed on top of the sheet pile, and the system will be tied into the existing bulkhead. It is proposed to raise the elevation of the cap of the new bulkhead by two feet to account for sea level rise and provide additional storm surge protection. This would still be lower than the current outfall section of the bulkhead. It would also be possible to create a continuous seating area along the wall by refinishing and widening the surface of the current wall for a sitting surface and using the new bulkhead as the backrest. A seat wall height is typically 1.5 to 2 feet high.

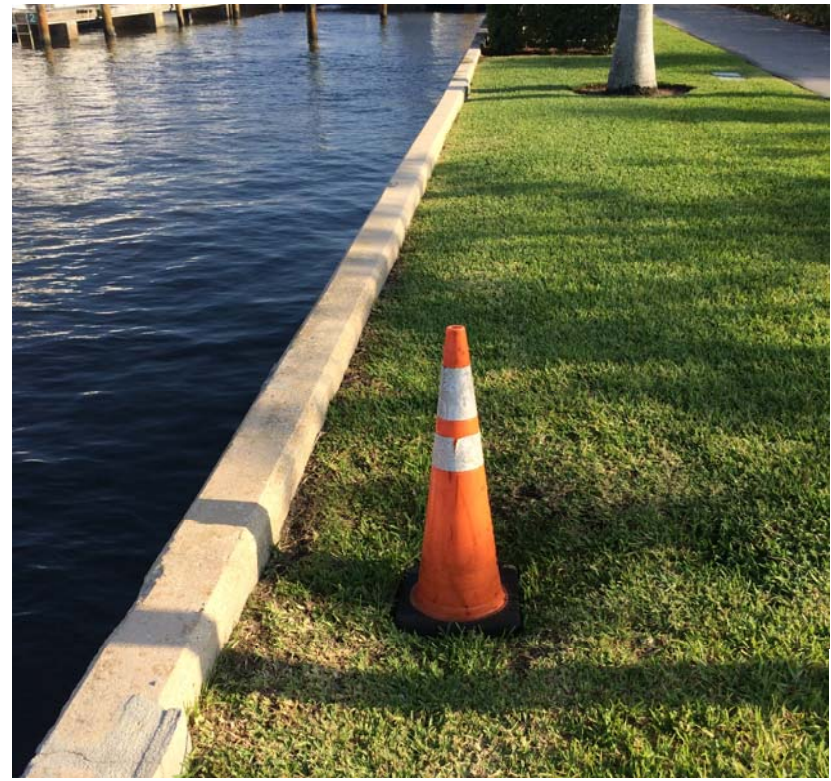
There are two areas where backfill is being lost behind the bulkhead, which indicates a crack in the bulkhead. There are also several areas where the bulkhead cap is cracked and

**Figure 8.5: Backfill Loss behind the Bulkhead**

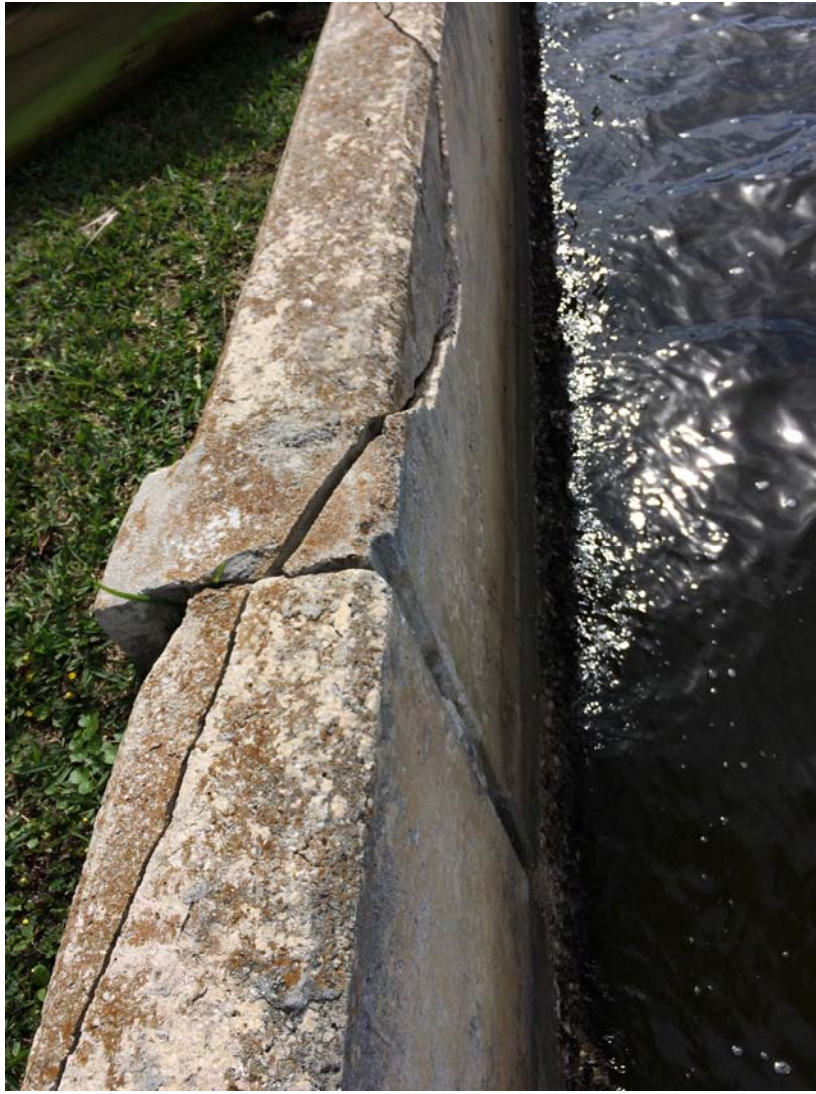
Figure 8.6: Cracking in the Bulkhead

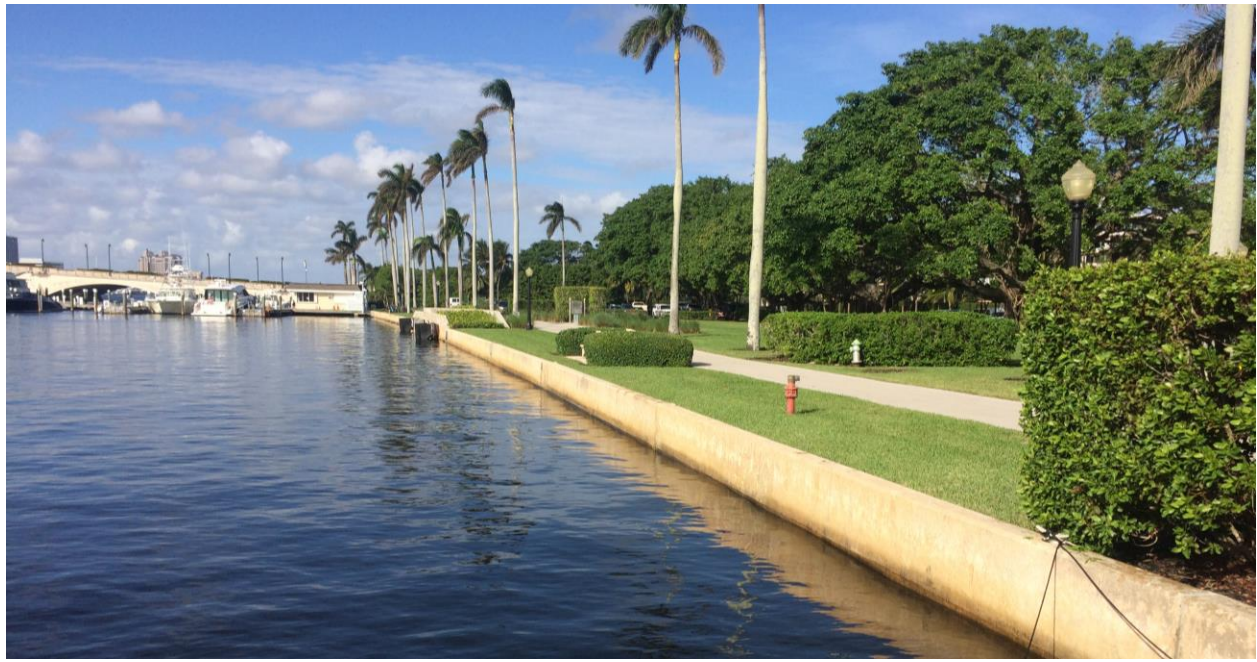
In summary, the bulkhead appears to be fair condition though in need of spot repairs where the cap is cracked and backfill is being lost. Continued deterioration of the bulkhead is expected over time with repairs being required more frequently. The Town should consider rehabilitating the bulkhead within the next several years.

Figure 2.1: Sta 8+80 looking north. View of seaward face of the bulkhead at high tide.

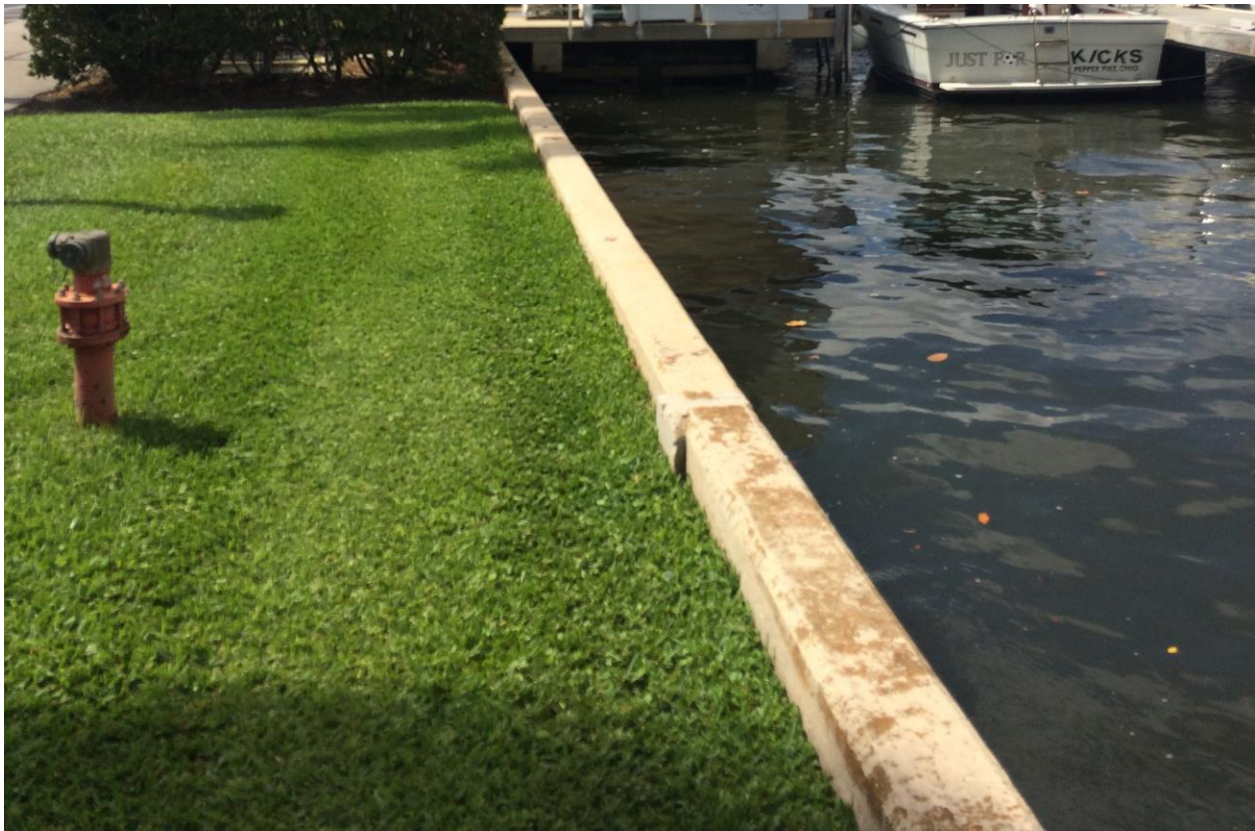
The bulkhead from Sta 0+16 to Sta 14+00 is uniform in construction style. It is comprised of an 11-inch wide concrete cap with 1.5-inch chamfers. Overall, the cap is in fair condition though showing its age with pitting and cracking. Backfill extends to the cap in some areas, while in others, there is approximately a six-inch lip between the grass and the seawall (Figure 3.1).

**Figure 3.1: Sta 8+00 looking south. View of backfill close to the bulkhead cap elevation.**

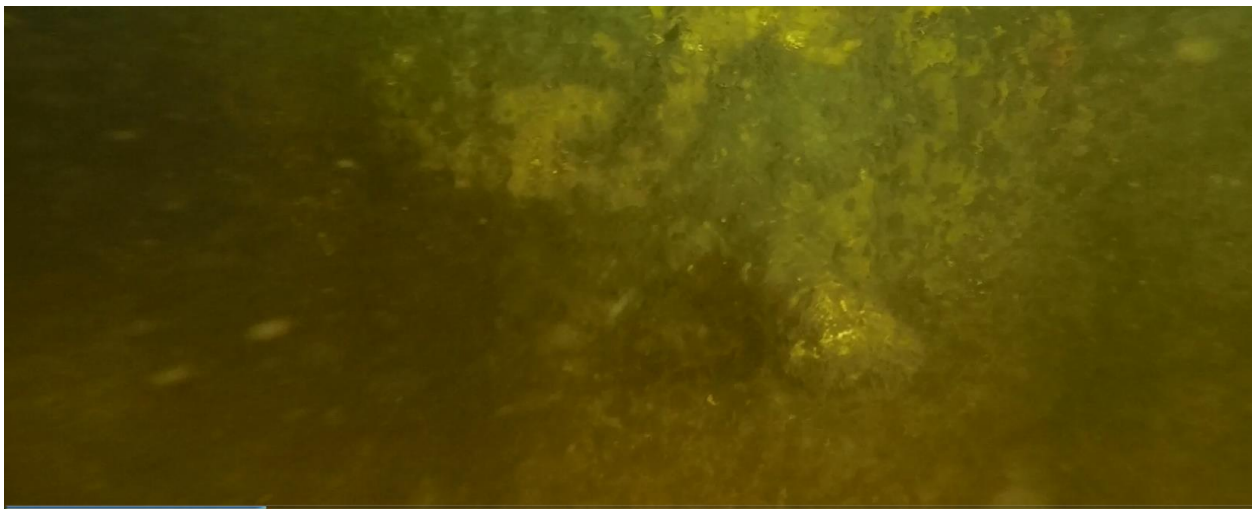
**Figure 3.3: Sta 2+90. Apparent end of a tie back.**

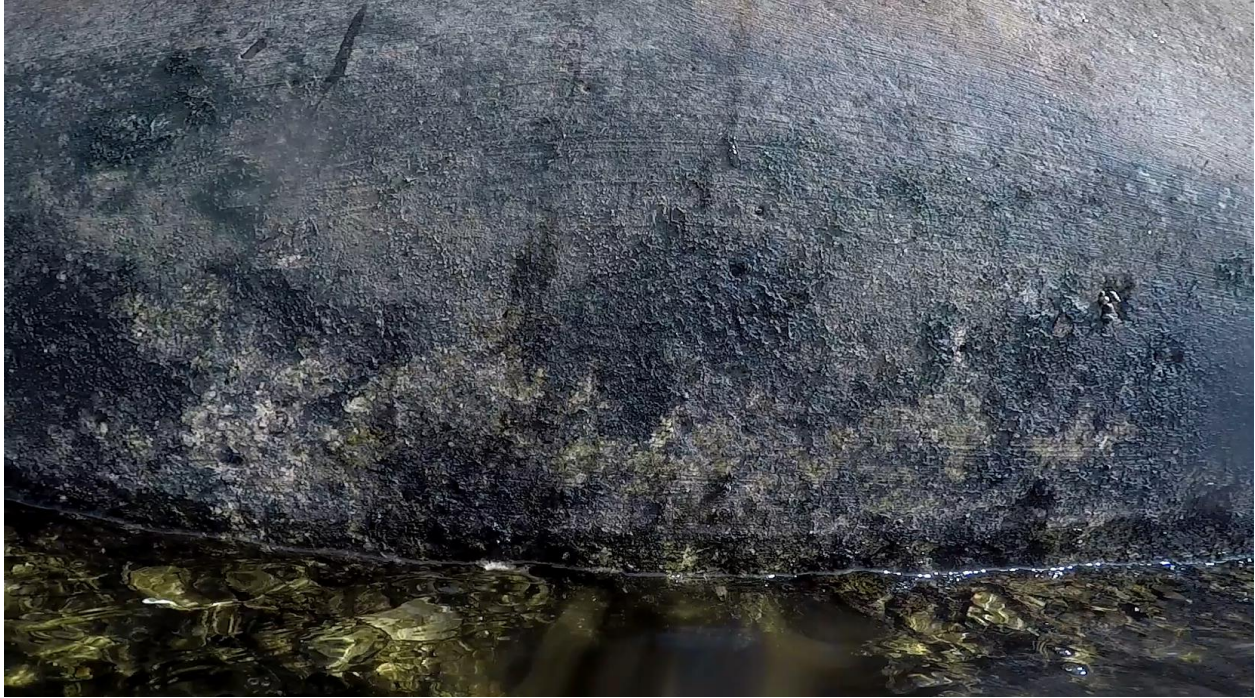
The concrete face has marine growth starting close to the high water mark (Figure 3.4), though the marine growth is more dense below the mean low water elevation (Figure 3.5). Some rust coloration is visible around some marine growth suggesting that the sheet pile extends into the concrete cap portion of the bulkhead, but it was not possible to determine the top elevation of the sheet piling (Figure 3.6).

**Figure 3.4: Sta 2+90. Typical bulkhead face transition from exposed concrete to the concrete covered in marine growth within in the intertidal zone.**

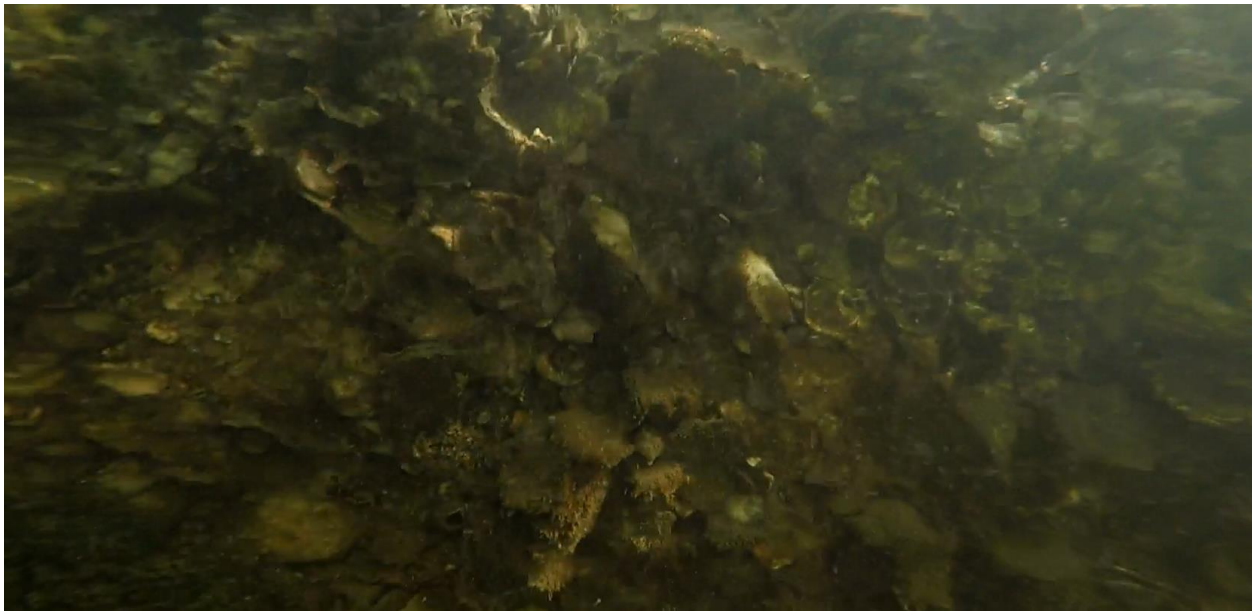
**Figure 3.5: Typical marine growth on the concrete face of the bulkhead.**

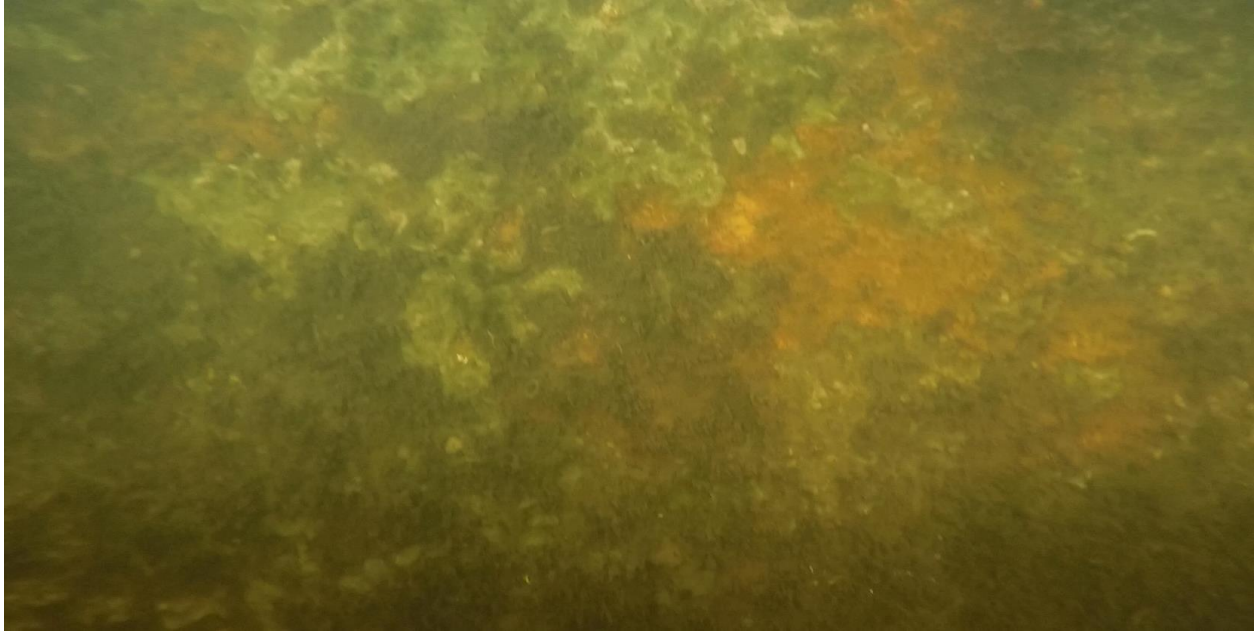
**Figure 3.6: Sta 3+30. Infrequent rust coloration of marine growth suggestion corrosion within the bulkhead.**

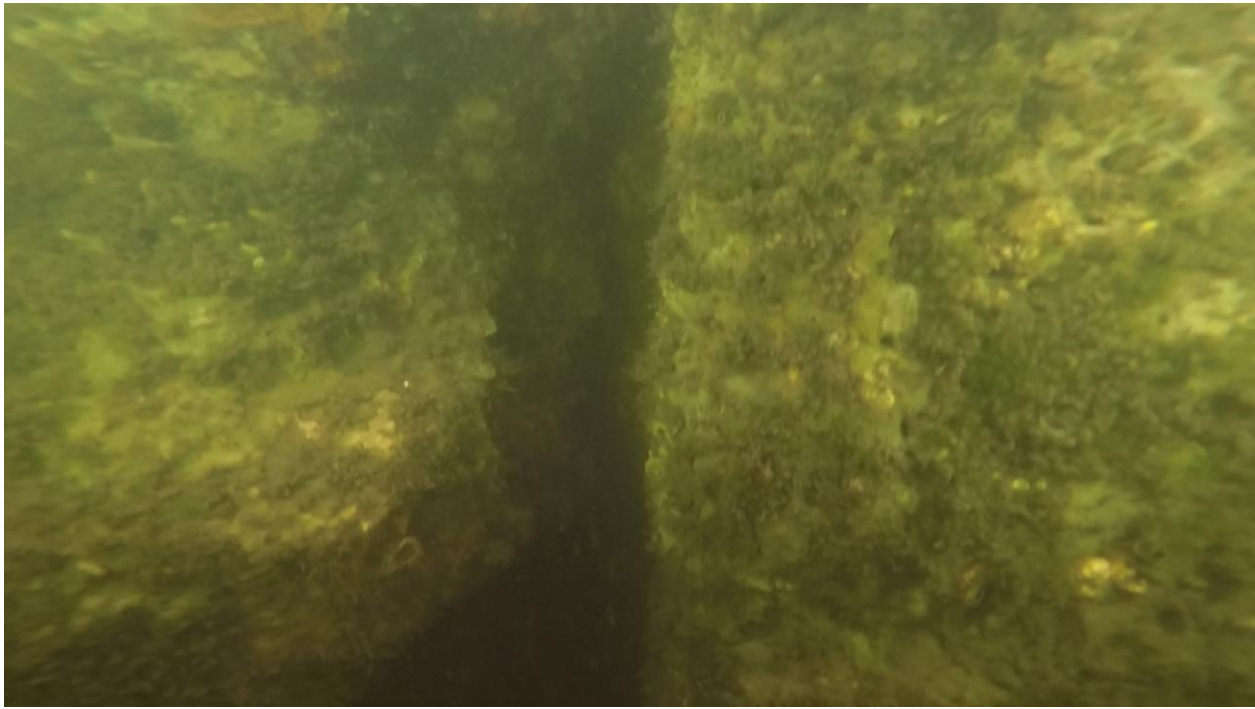
**Figure 3.7: Sta 0+70. Crack at an expansion joint in the vertical concrete face.**

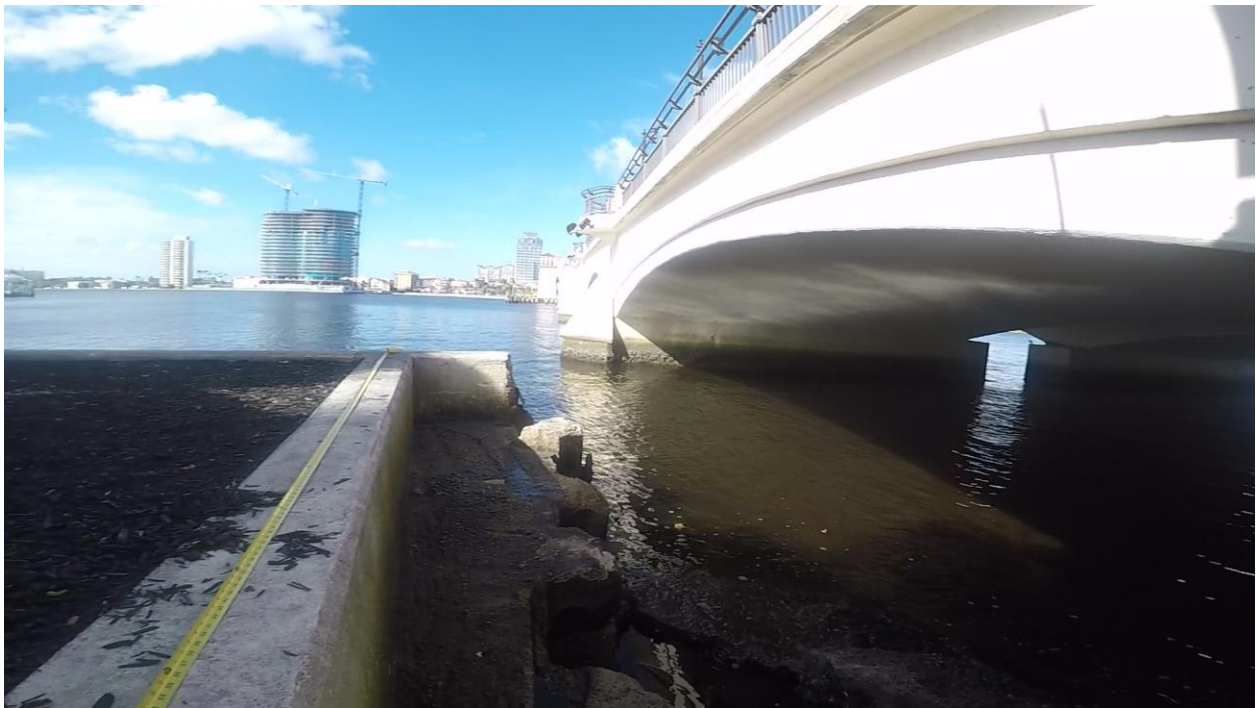
This section of the bulkhead is different in construction style from the majority of the bulkhead fronting Lake Drive Park. This section extends 15.5 feet due west from the Royal Park Bridge abutment to the main north/south section of the bulkhead. It appears that this bulkhead has been repaired multiple times, though none of the repairs appear to be recent. This section of the bulkhead is comprised of a concrete bulkhead with a deep (six-inch wide, six-inch deep) corrugated face (Figure 3.8). There are some remnants of a sheet pile face, though it looks as though this has been removed while leaving concrete fill behind it. There is concrete rubble in front of the vertical face. There is a newer six-inch wide, two-foot high concrete cap that is offset from the lower face of the wall by 1.5-feet.

There are numerous cracks in the lower face of the bulkhead, though there was no apparent loss of backfill to indicate that these cracks extend far enough back to violate the integrity of the bulkhead.

Figure 3.8: Sta 0+02 looking west. Corrugated face and offset cap.

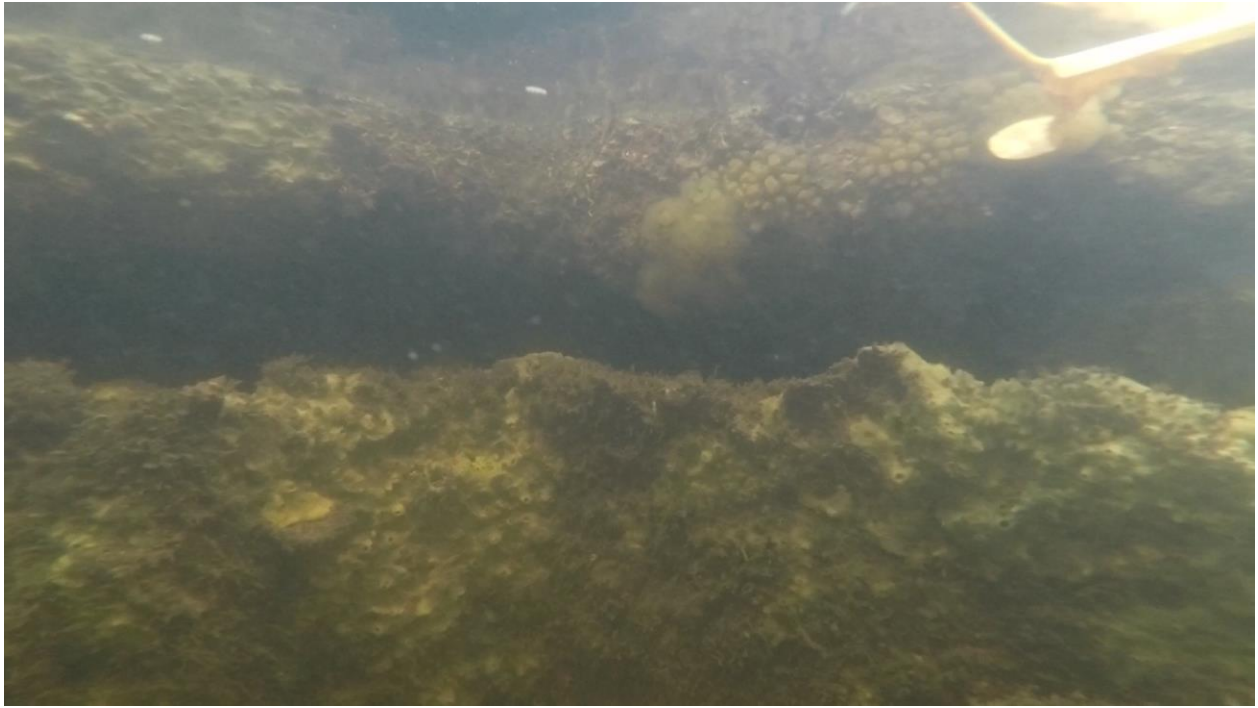
**Figure 3.9: Sta 0+03. Horizontal cracks in the concrete bulkhead.**

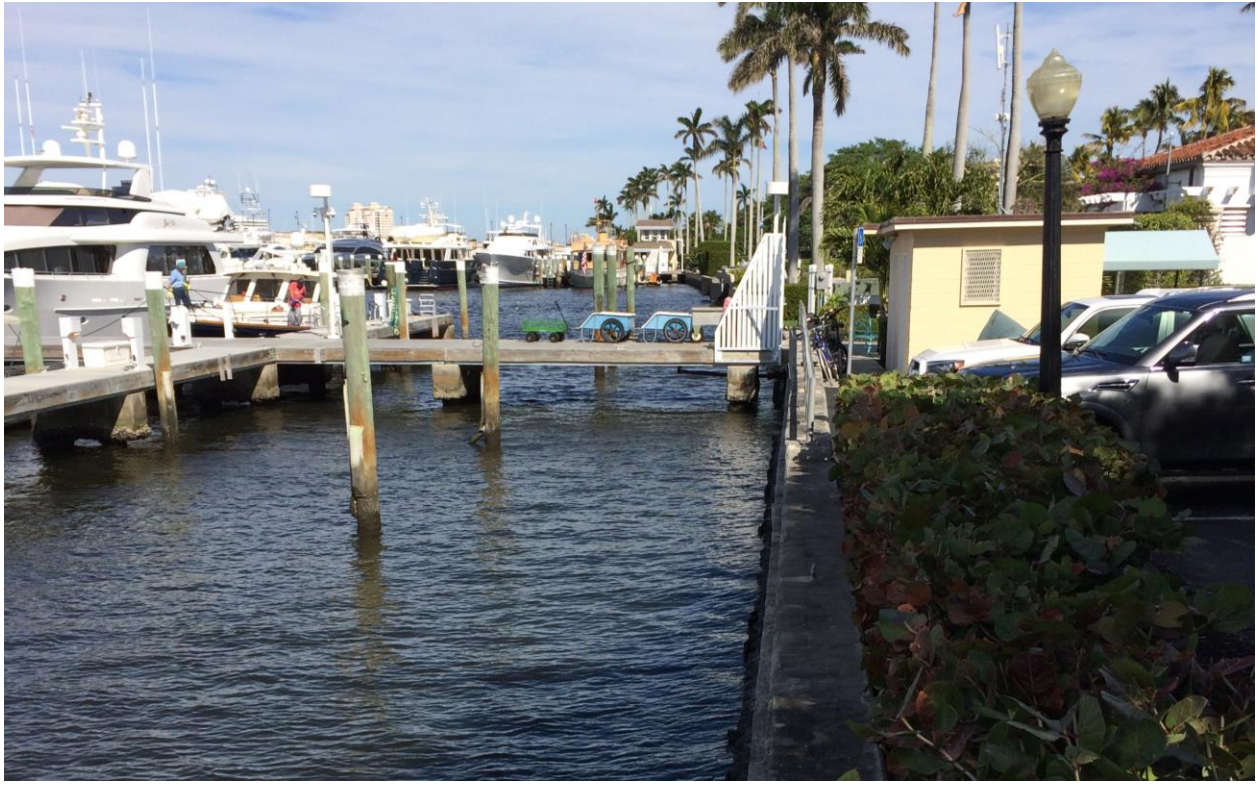
The bulkhead structure in front of the Peruvian Dock parking lot from Sta 14+55 to Sta 15+50 (Figure 3.10) is different in construction style from the bulkhead fronting Lake Drive Park, though similar to the return wall between Sta 0+00 and Sta 0+16. It is comprised of sheet pile with concrete back fill that doesn't breach the surface at low tide. A concrete parapet, offset approximately one-foot from the landward edge of the corrugated face, serves as the remainder of the bulkhead. When viewed from above the water line, the change from the bulkhead style extending the majority of Lake Drive Park to this new bulkhead is best approximated by the start of a three-inch wide, horizontally oriented lip that extends from Sta 14+55 to the southern end of the seawall.

**Figure 3.10: Sta 15+45 looking north along the bulkhead along the Peruvian Dock Parking Lot.**

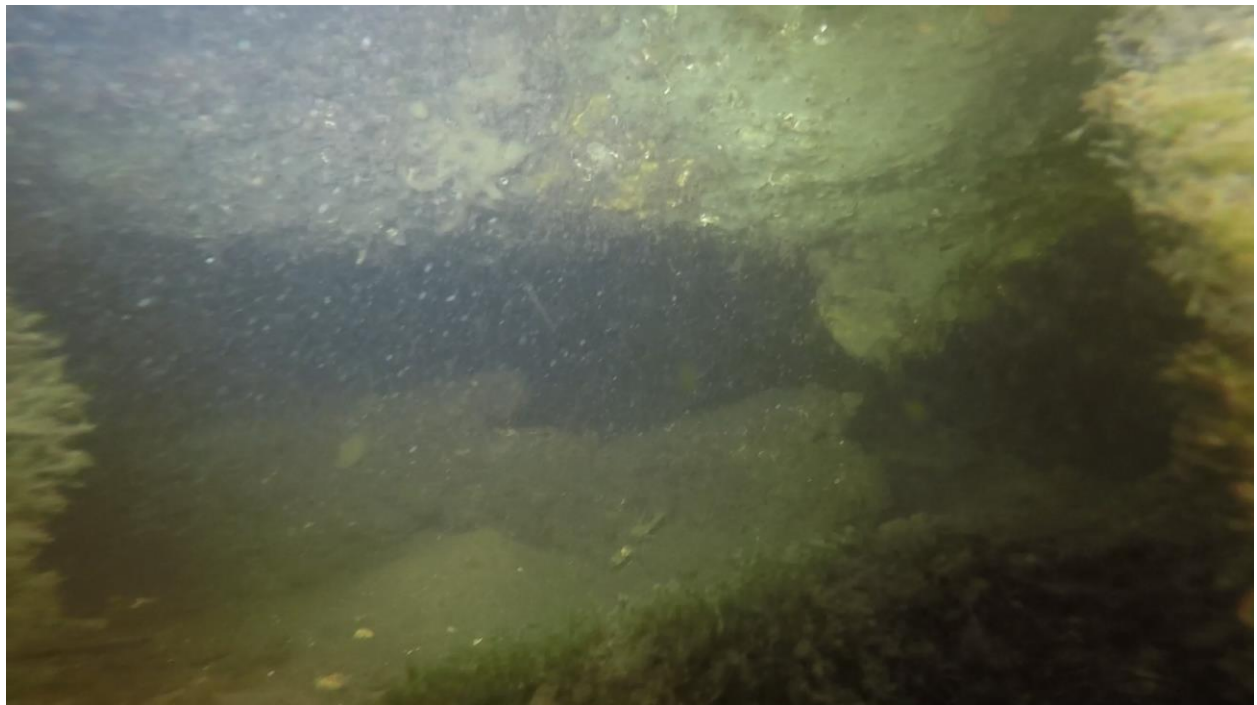
Figure 3.12: Sta 15+15. Gap underneath the corrugated section of the bulkhead and vague outline of a secondary sheet pile wall in the background.
