# Town of Palm Beach

## Master Plan for the Town Docks and Accessory Structures

## Executive Summary

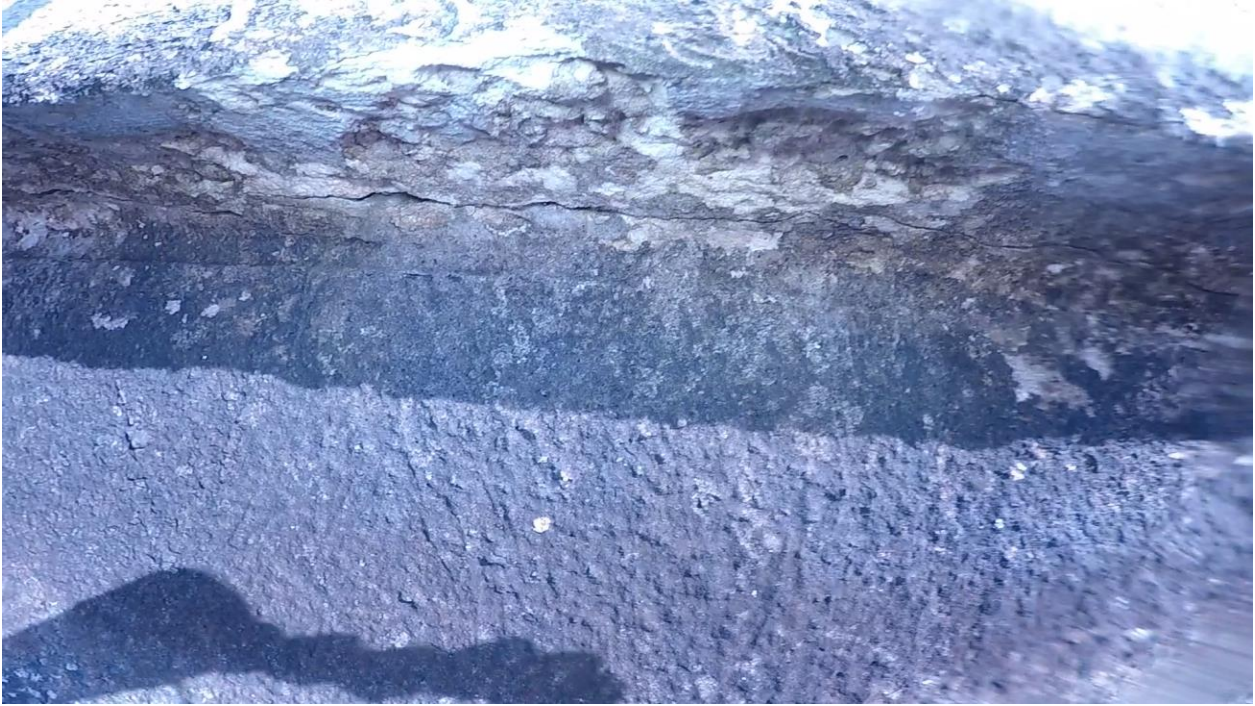
**Figure 3.13: Sta 15+00. Cracking, spalling and deterioration underneath the lip along the parapet bulkhead section.**

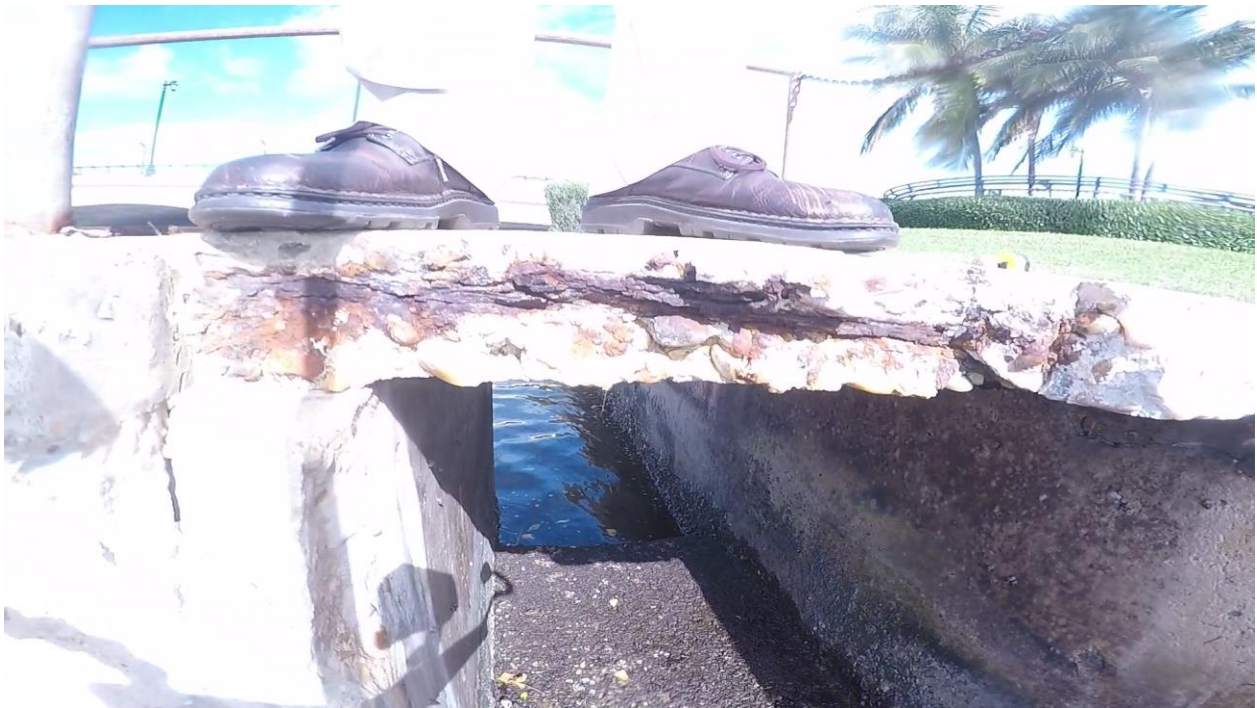
Figure 3.15: Sta 0+88 looking north. Spalling and rebar exposure and corrosion of the walkway to the outfall structure.

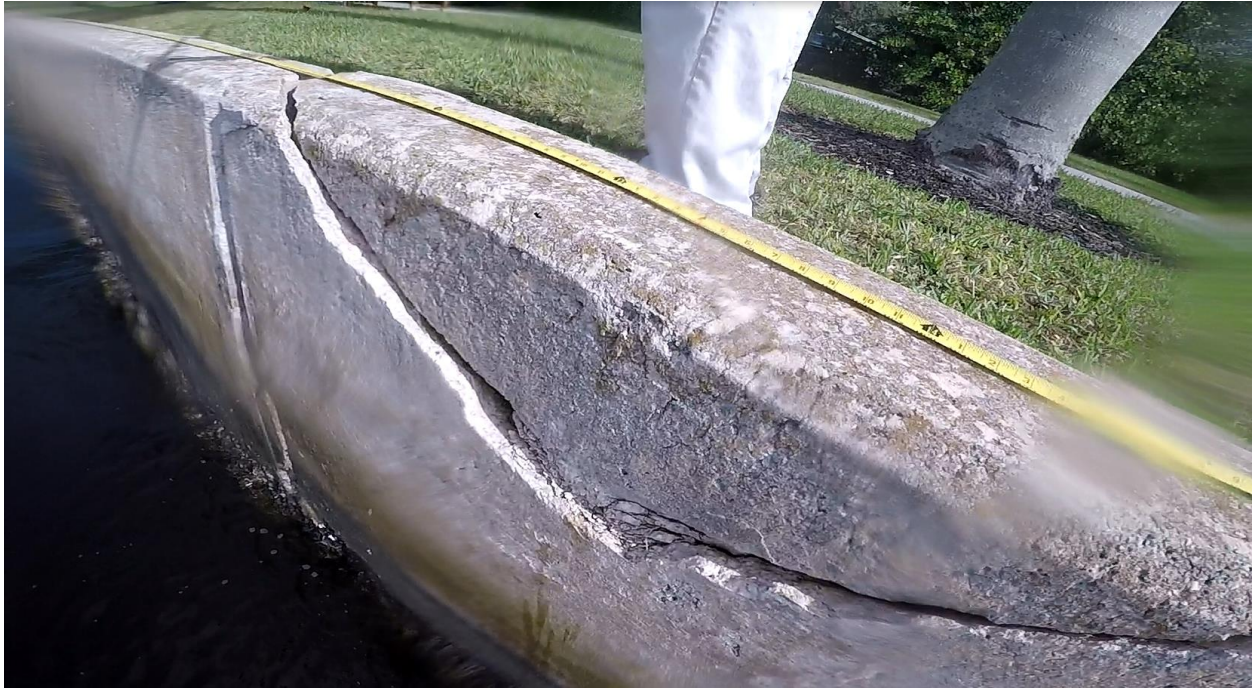
Figure 3.16: Sta 2+10. Crack and dislocated concrete cap.

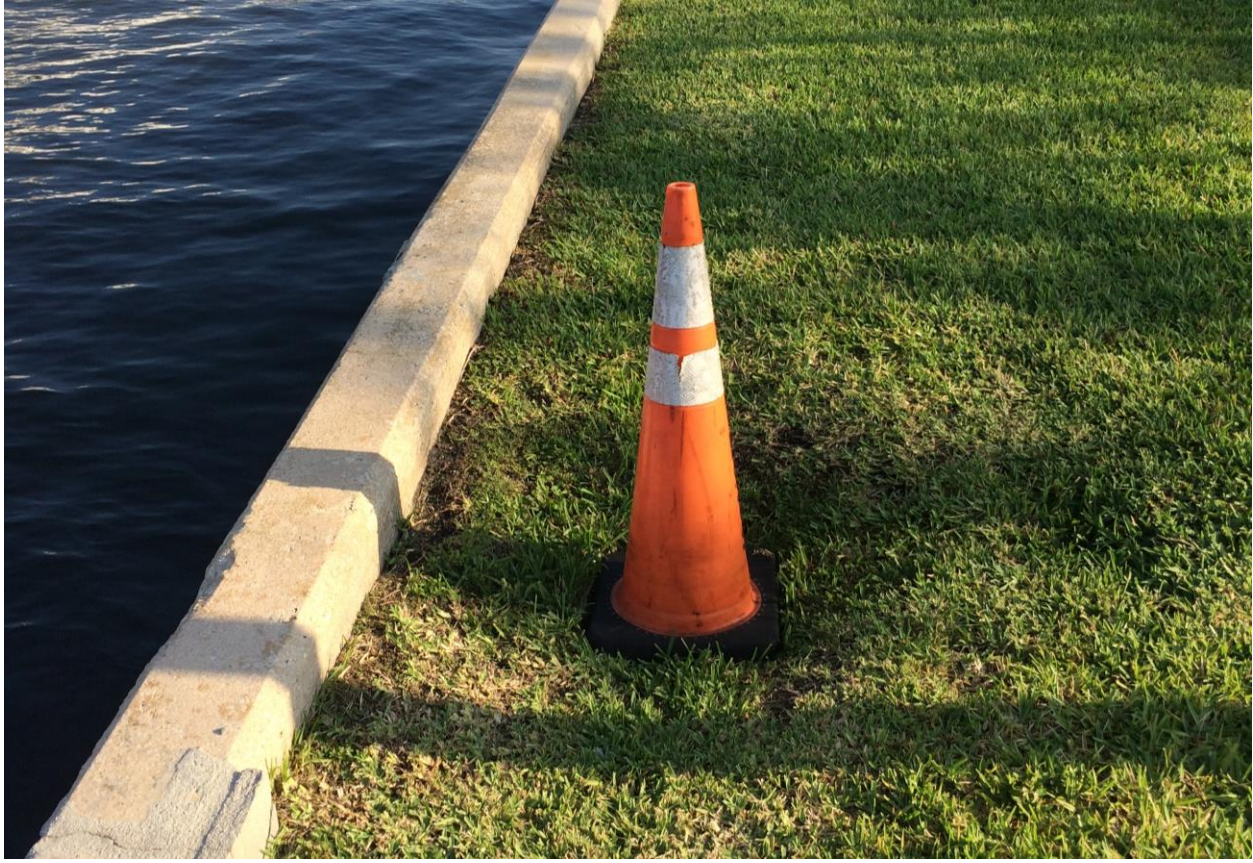
Figure 3.17: Sta 10+80. Area with backfill loss.

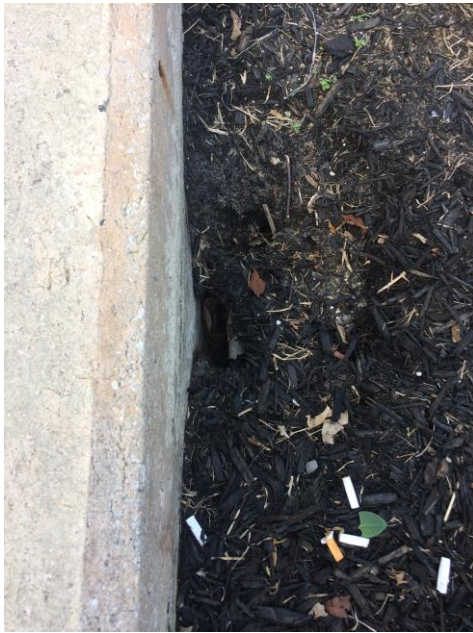
Figure 3.18: Sta 9+40. Area of backfill loss in front of Australian Dock office.

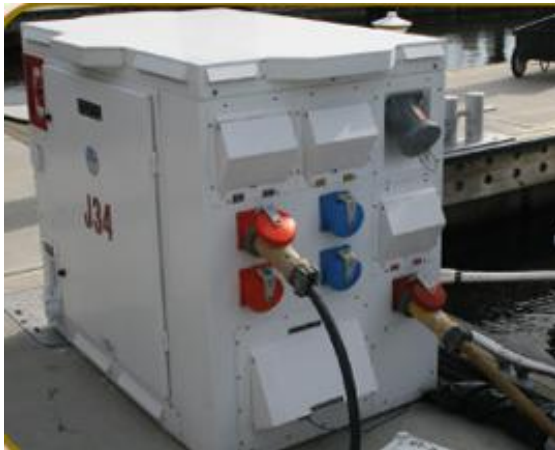
centers that can provide a variety of power options which includes 480v, 240v and 208v 3 phase with up to 200 amps of service as shown below. The exact configuration will be determined based on final marina design. To reduce the size of wire runs needed from the shore side to these units each unit contains step

down transformers to provide the power options mentioned above. This type of installation typically will reduce the overall cost of the electrical infrastructure by as much as eight percent.

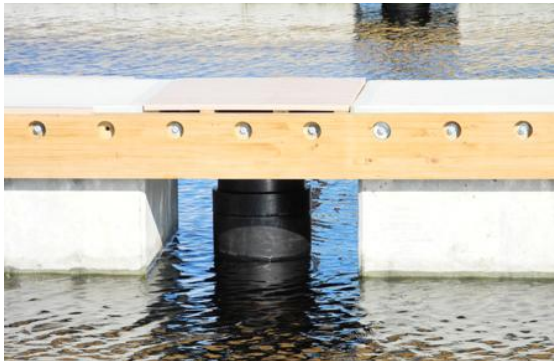
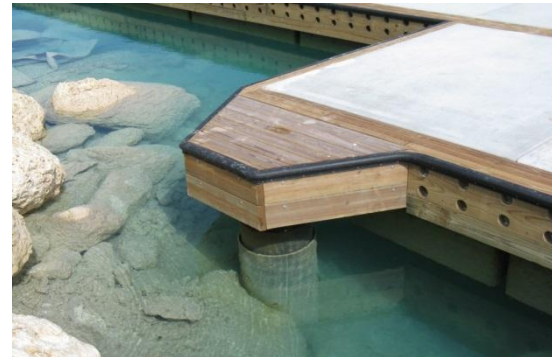
Telescoping piles consist of two steel pilings the outer piling is driven into the bed rock and acts as a sleeve for the inner piling which is fitted in a socket affixed to the dock structure. There are several benefits to this

type of pile system. First, there is not a vertical piling above the dock surface to impede the mooring of a yacht. Notice in the adjoining picture the pilings and the stern of the yacht could swing over the dock and come in contact with a piling causing damage to both the dock as well as the yacht. Second, the usable surface area of the docks is extended providing a safer operating environment and third when no yachts are in the marina the residences have a

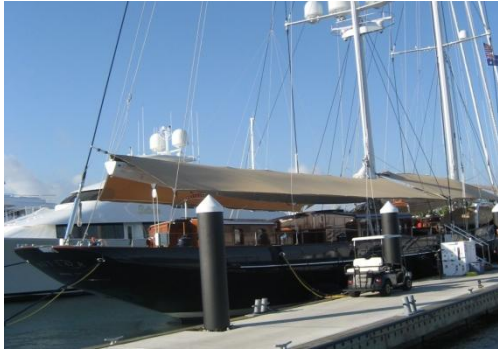
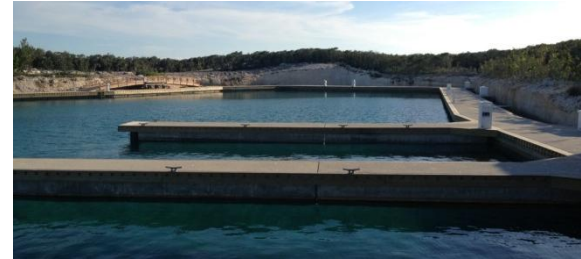
clear and unobstructed view over the water as compared to the typical floating dock marinas both are pictured here.

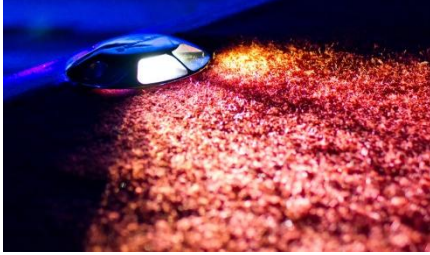
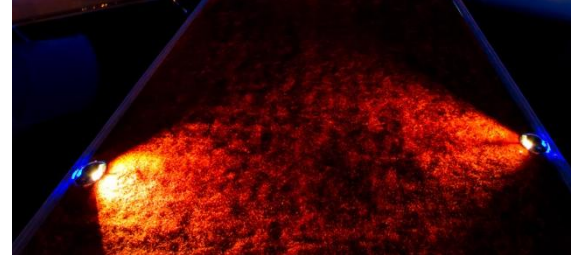
The pathway lighting pictured here are two examples of the type of beam the pathway light projects. The light fixture is made from die cast stainless steel designed for a harsh marine environment and casts a

flat wide beam of light onto the dock walkway without glare or any upward projection of light. The physical dimensions of the light fixture is less than one inch high and approximately four inches in diameter with no sharp edges minimizing the chance of snagging dock lines or tripping over the fixture. Combinations of light colors can be customized for specific applications. This type of light fixture should also be considered for other applications on the landside walkways and parking areas of the marina.as well. Depending upon the surface the light is projected upon can provide different effects.

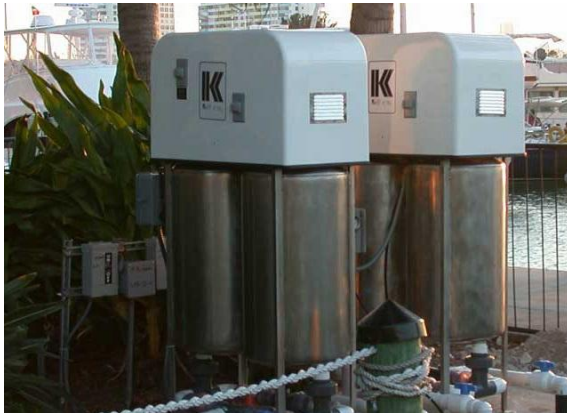
an in-slip centralized pump out system that is comprised of three main components, a land side suction pump shown here on the left and multiple on dock connection points strategically located throughout the marina to minimize the distance from the yachts holding tank discharge connection to the dockside connection point and a transition cart shown here on the right necessary to connect the yacht to the marina's centralized pump-out system. MMS is

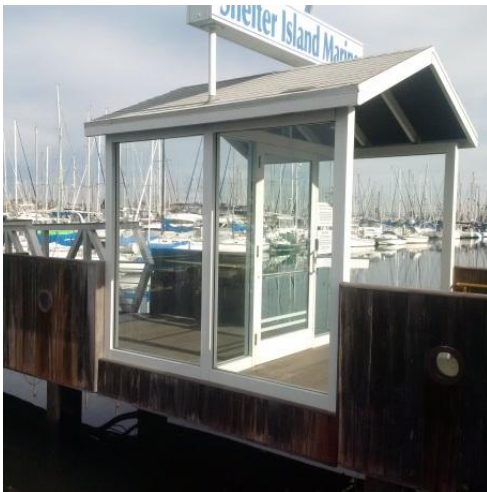
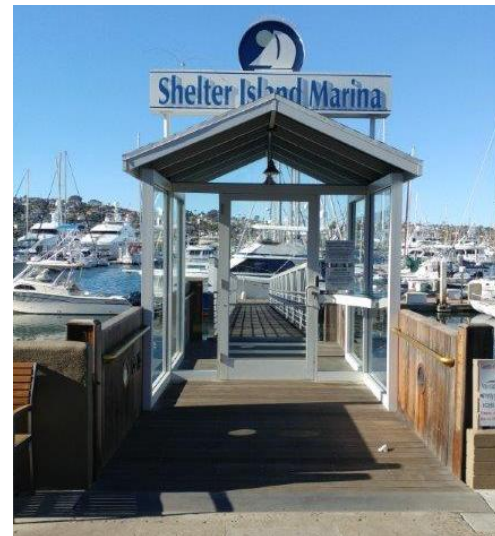
Access to docks in the marina should be limited to yacht owners and crew. All others who request access to the docks should be controlled by the marina's management and security staff. The goal is to create a barrier that is aesthetically pleasing yet highly secure. MMS is recommending a glass barrier as shown here. This type of secured entry does not create a visual barrier between the landside and the waterside yet will keep unauthorized individuals off the docks. MMS is recommending

that each entry point have the capability of being remotely controlled from the marina office. Each entry point should be equipped with a video camera, two way voice communications to the marina office, a keyless entry/exit system that has recording capabilities to identify each user and a warning system should the entry gate be left open for any extended length of time.

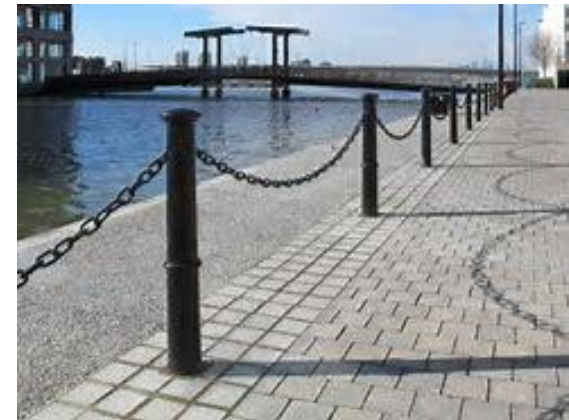
To keep a park like atmosphere MMS is recommending permeable grass paver parking lots rather than asphalt. Permanent parking spaces can be defined as well as a number of patterns can be imbedded to compliment the application as well as the amount of green grass showing. Using this approach to parking could expand the parking options to accommodate those peak periods without infringing on other public parking. The areas could be sectioned off using a removable bollard and chain approach as shown here to restrict parking to certain areas and only open up those areas as the need arises while keeping the park like atmosphere.

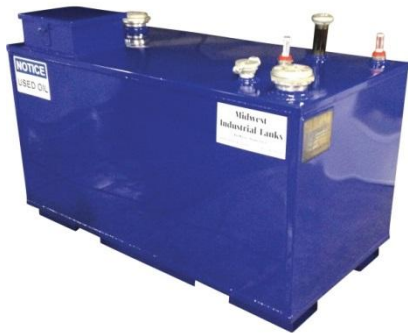
MMS recommends a 500 gallon double-walled steel clamshell design waste oil tank that meets Spill Prevention, Control, and Countermeasure (SPCC) regulations eliminating the need for a secondary containment tank. In addition to disposing of waste oil on a yacht there are oil filters and oily pads that are also discarded. To prevent these items

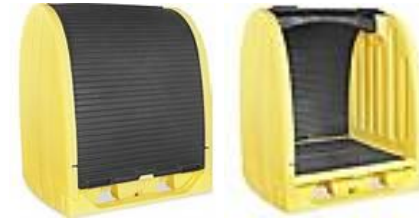
from ending up in the general trash the marina should provide a drum enclosure similar to the one pictured here. This drum enclosure can hold four fifty-five gallon drums and has a sump to hold any spills that can happen when handling used filters and absorbent pads.

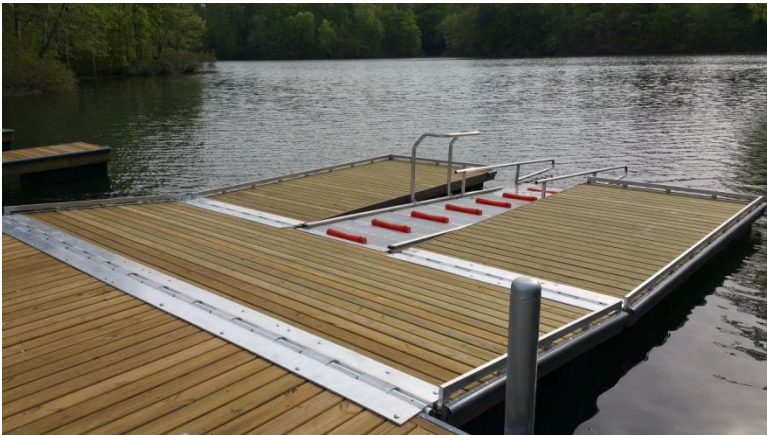
There are a number of launching ramps specifically designed for kayaks. Pictured here is an example of such a floating launch ramp that could be placed in a park like setting where there is minimal current and boat traffic. If space permits a wash down area would be welcomed as well as lockable storage racks that could be constructed and rented eliminating the need for kayakers to have to take home their kayaks when finished. MMS believes that such a facility would be welcomed by the community.
